SUBJECT: **Customer Satisfaction Program 20N11 - Supplement #2**
Certain 2016 - 2019 Model Year Explorer Vehicles equipped with a Roof Rail
Roof Rail Cover Detachment

REF: **Technical Service Bulletins 19-2364 and 20-2154**
2016-2019 Explorer – Roof Rail Covers Loose

CERTAIN 2016-2019 MODEL YEAR EXPLORER VEHICLES — ROOF RACK REPAIR

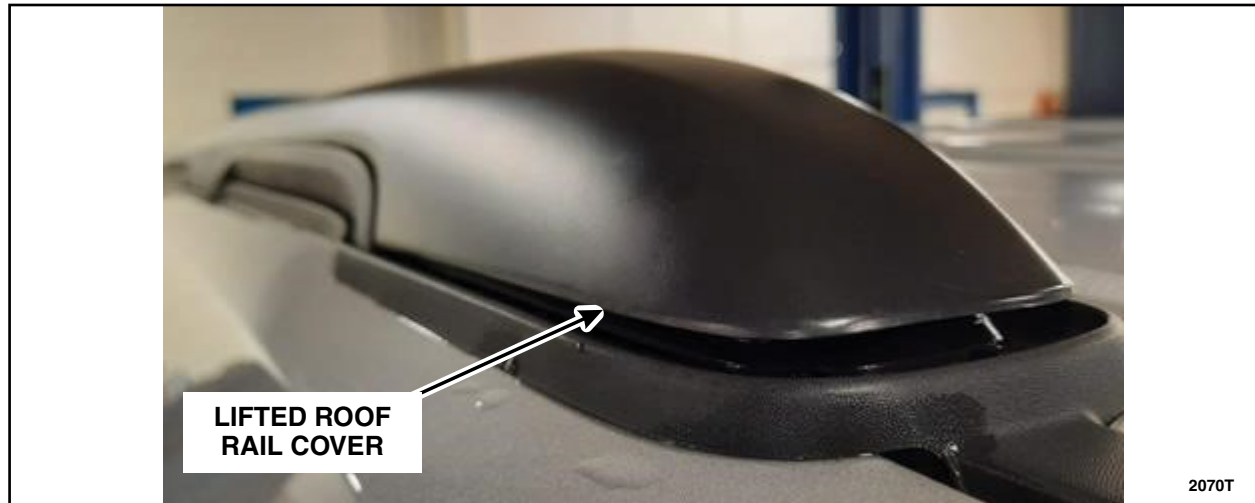
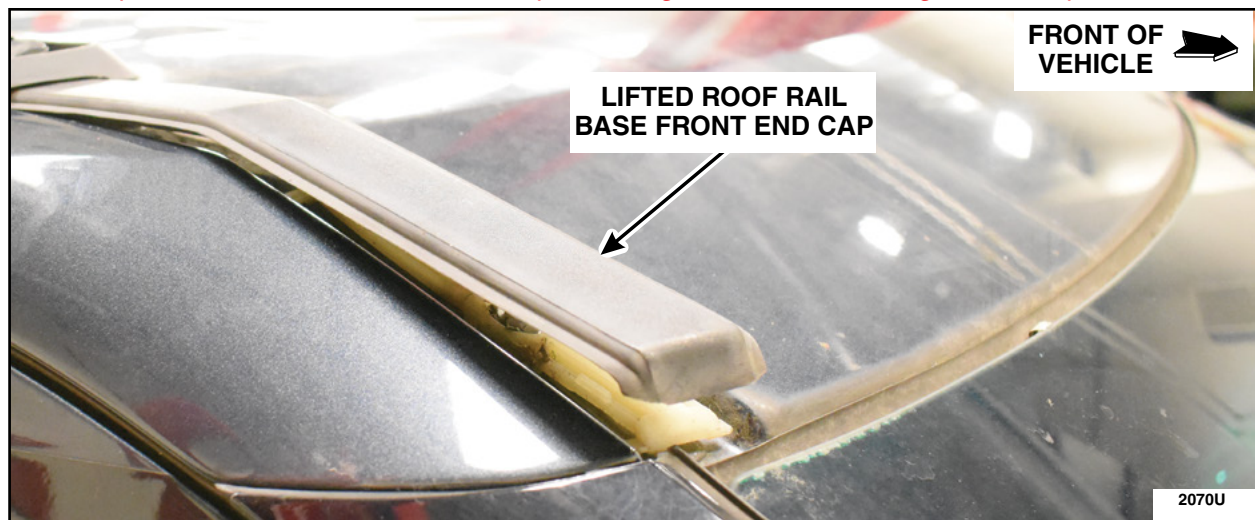
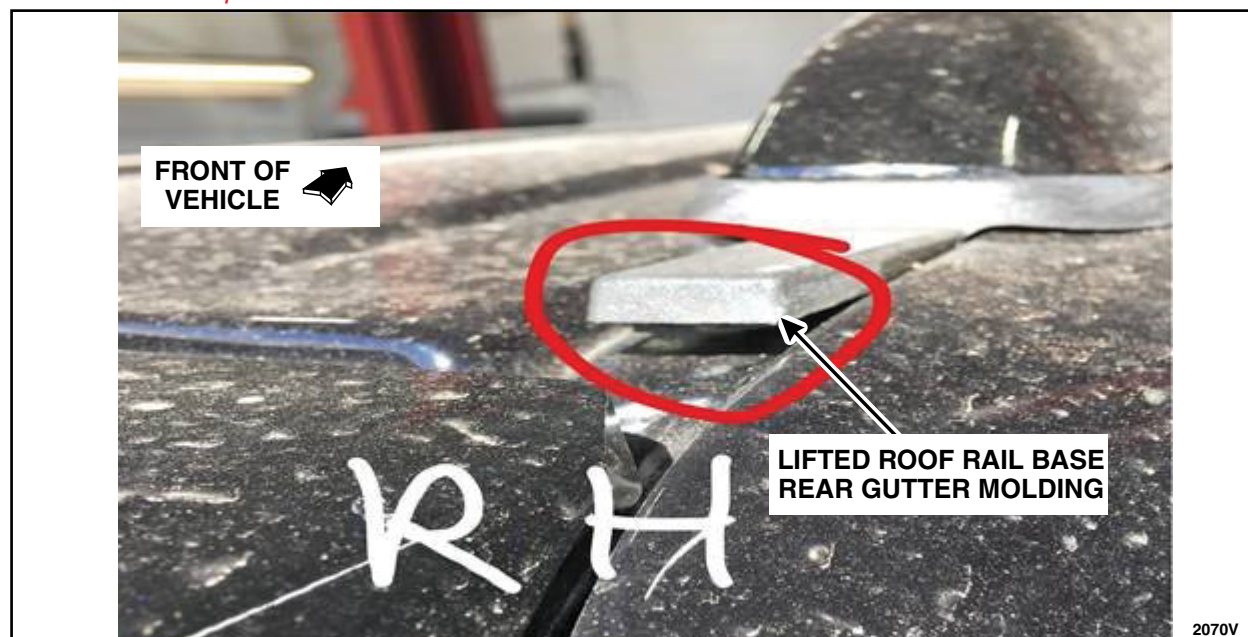
A loose or lifted roof rail cover in the front or rear does not indicate the need for parts to be replaced, the root cause needs to be identified in the inspection procedure. See Figures 1, 2 and 3.

NOTE: The roof rail base front end caps do not need to be replaced if the roof rail passes inspection. Only replace the roof rail base front end caps if damage has occurred during transfer of parts.

NOTE: The roof rail base rear gutter molding does not need to be replaced if the roof rail passes inspection. Only replace the roof rail base rear gutter molding if damage has occurred during transfer of parts.

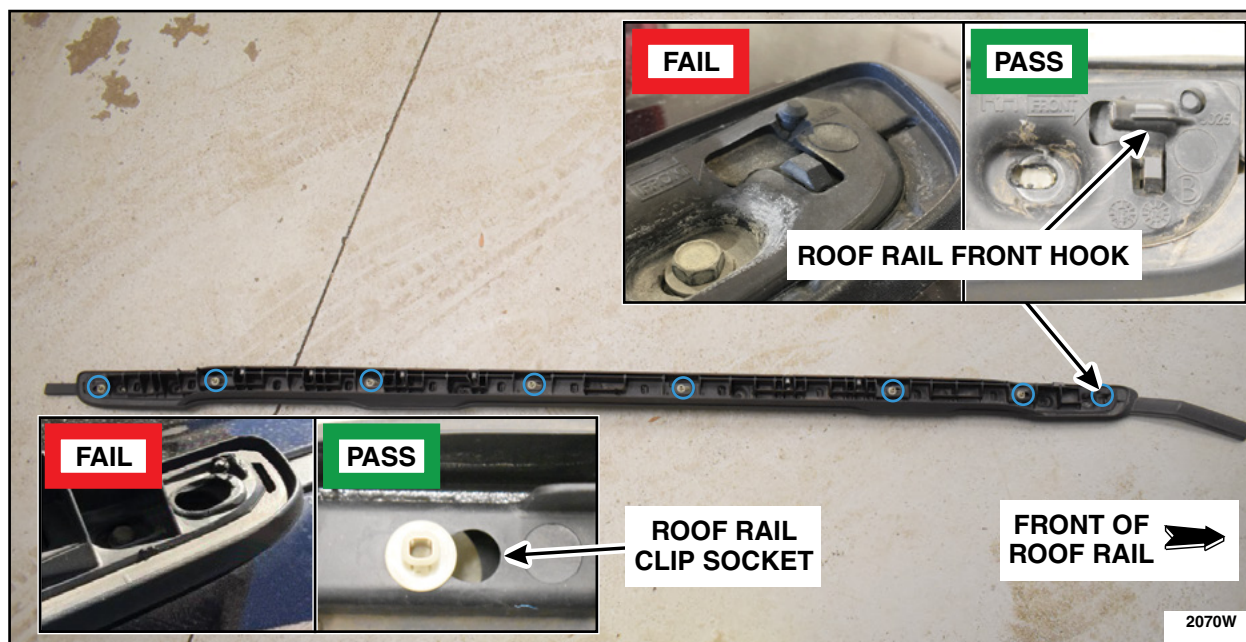
FIGURE 5

b. Inspect both the RH and LH roof rail base. See Figure 5.

i. If broken, take photos of roof rail base for both the RH and LH.

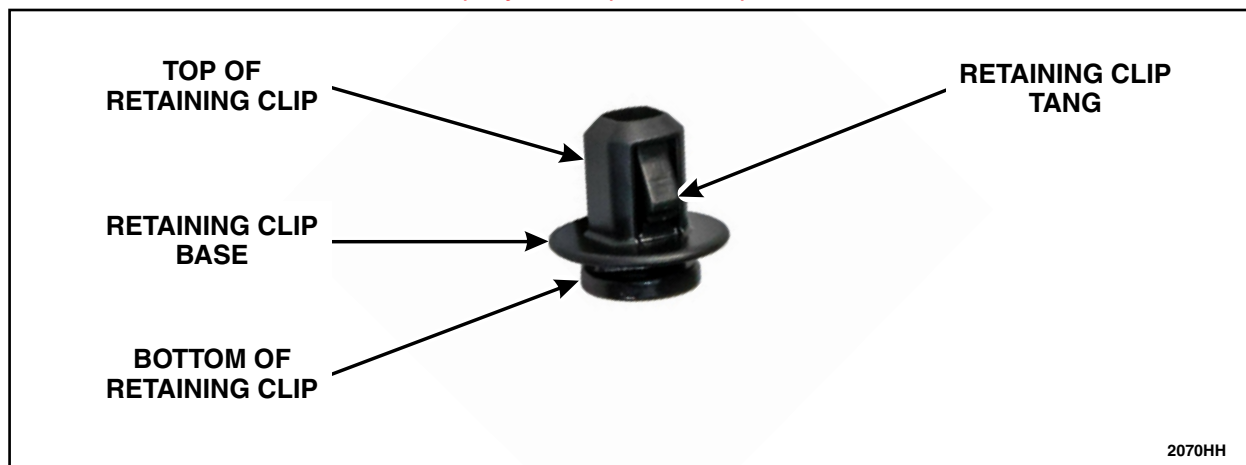
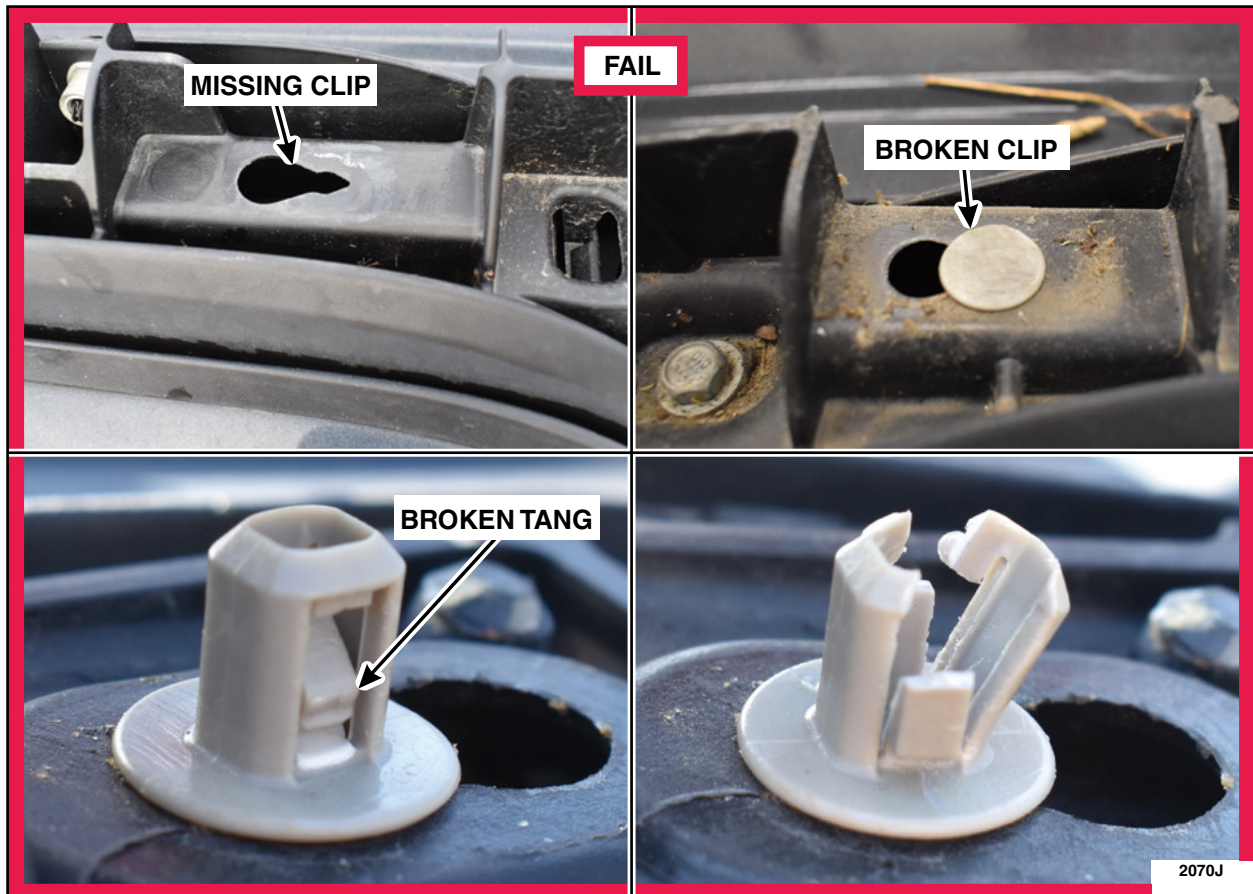
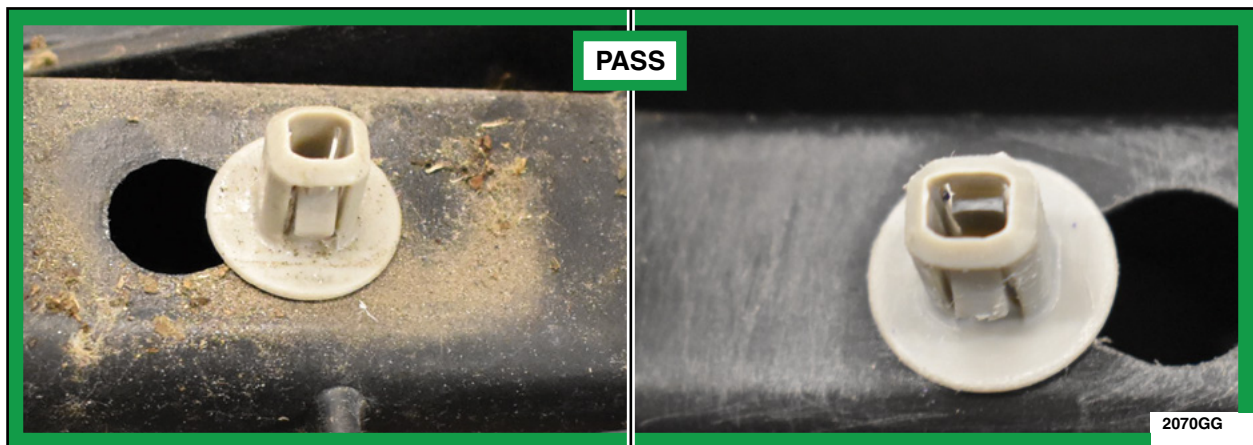
*c. Inspect the 14 retaining clips without removing them from the roof rail base.
See Figures 6, 7 and 8.*

- *Different colors.*
- *Different styles.*
- *No major damage identified.*

- *Missing.*
- *All or partial of the top missing from the clip base.*
- *Broken retaining tang.*
- *Covered in epoxy from a previous repair.*

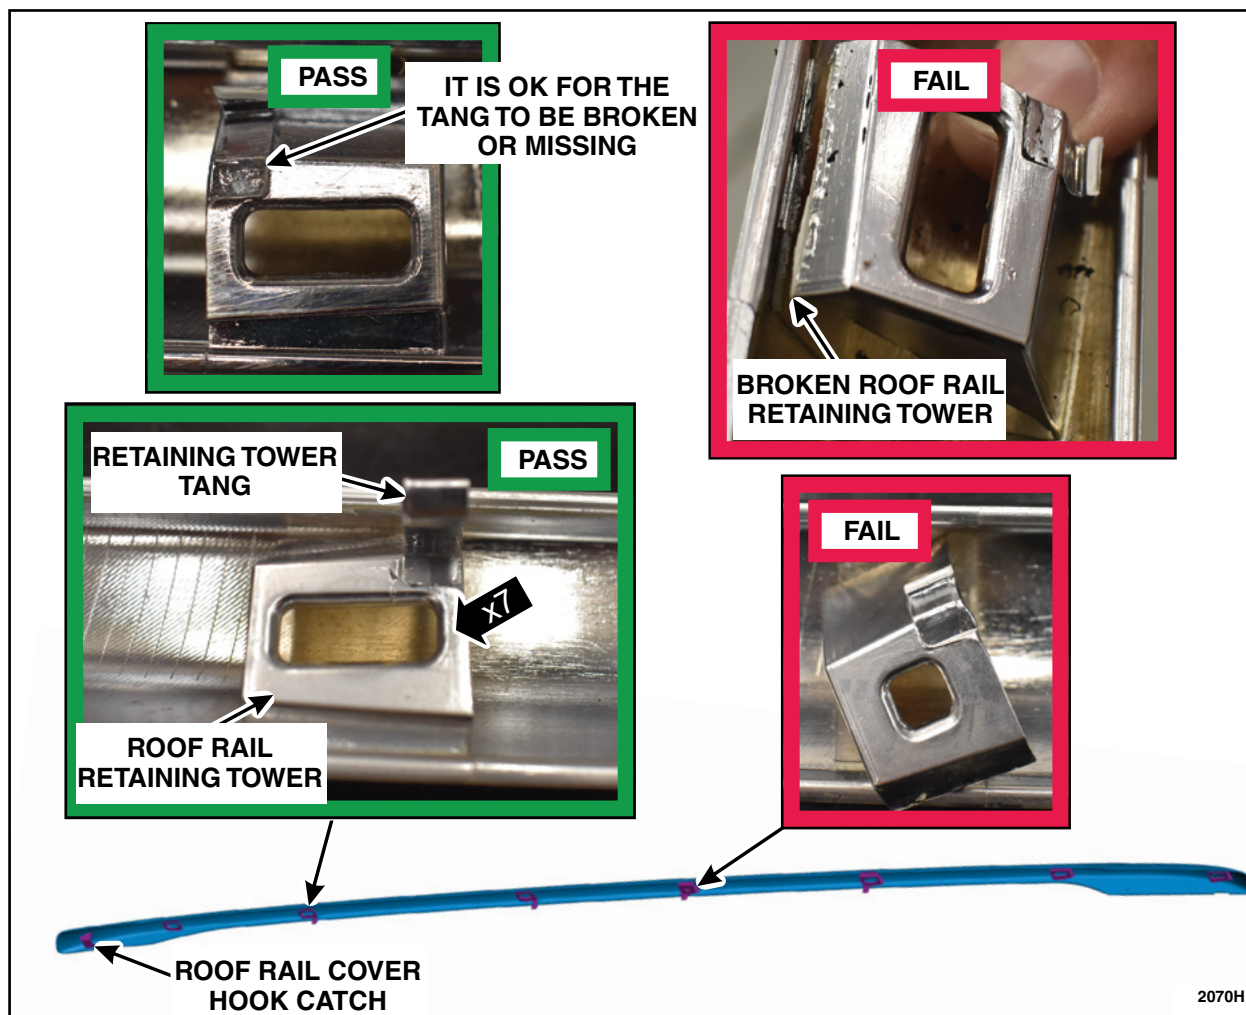
FIGURE 9

d. Inspect the retaining towers (7 each side) on the interior or underside of both the RH and LH roof rail covers. See Figure 9.

i. Broken tangs do not require replacement.

ii. If broken, take photos of retaining towers on the roof rail covers.

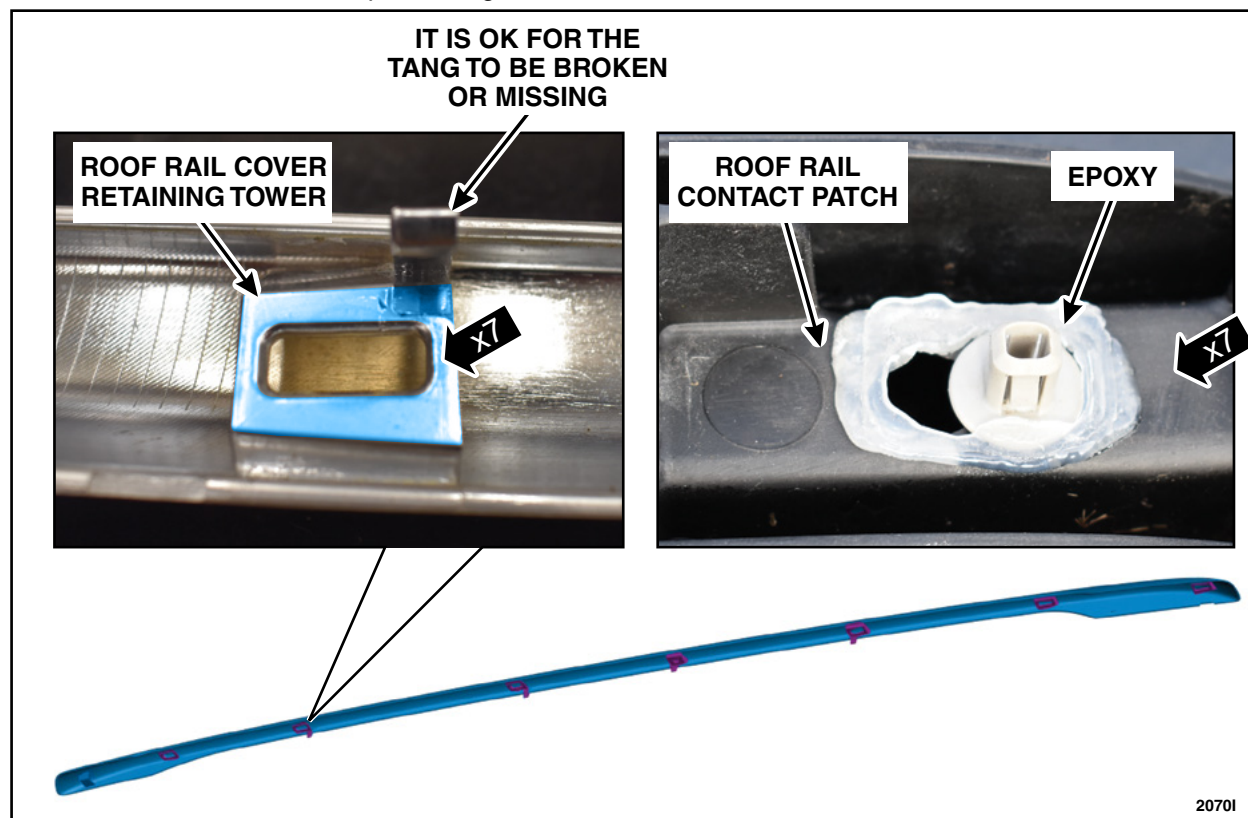
FIGURE 11

1. If Technical Service bulletin (TSB) 19-2364 or 20-2154 was performed, evidence of RTV or epoxy will be seen on the roof rack cover and or roof rail contact patch. Inspect the roof rack cover retaining tower and roof rail contact patch for signs of RTV or epoxy adhesive. See Figure 11. Was evidence of RTV or epoxy found?

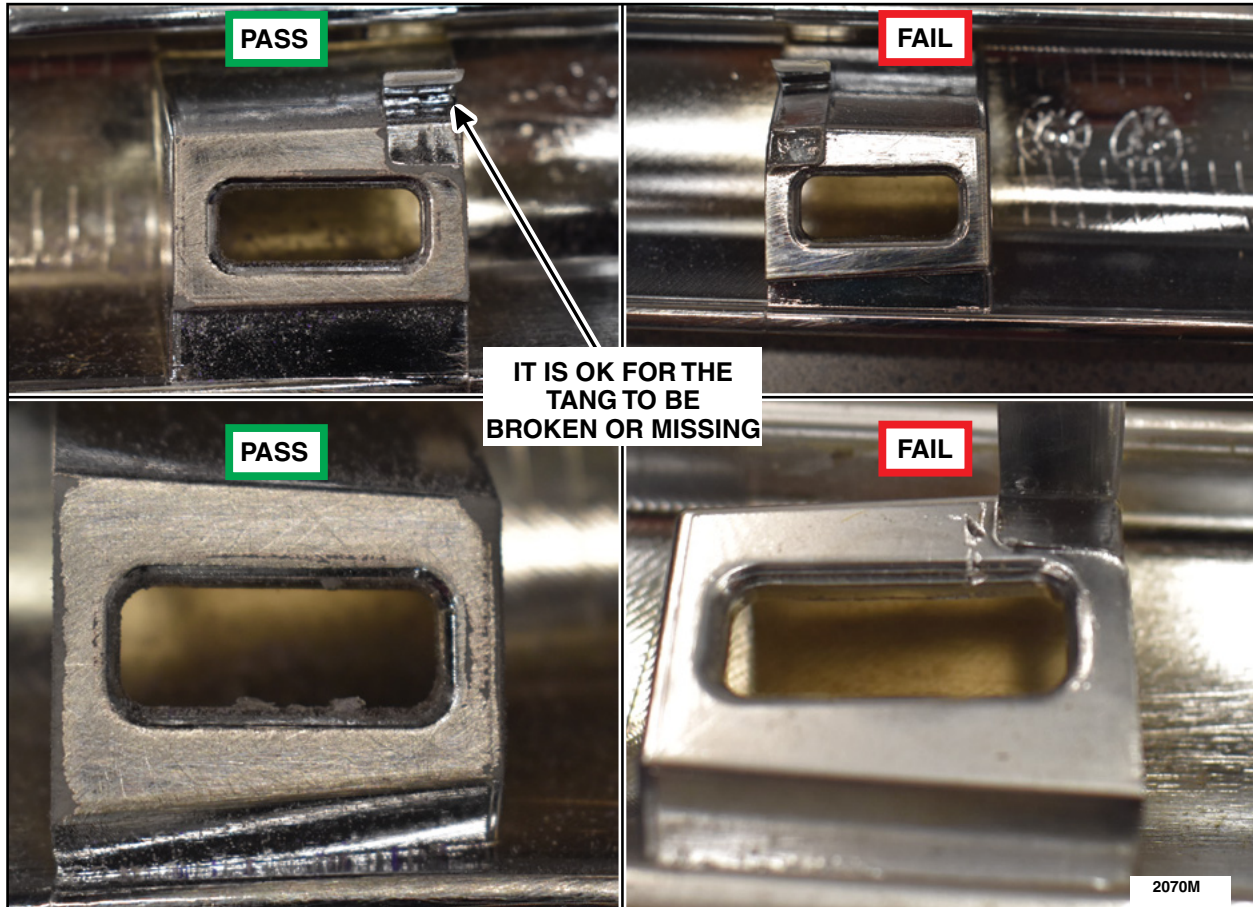
FIGURE 14

4. Without proper abrasion the adhesive will not hold. See Figure 14. Has proper abrasion been achieved?

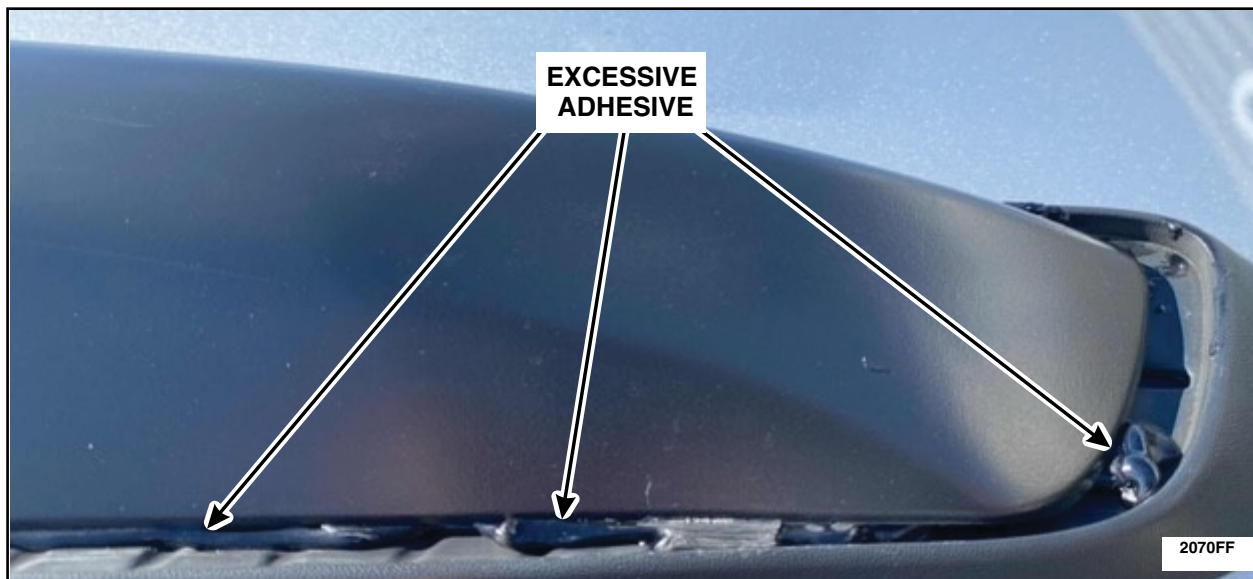
FIGURE 20

NOTE: This is an example of poor workmanship and does not follow the technical instructions. The vehicle should not be returned to the customer in this state.

6. Clean off any excessive adhesive. See Figure 20.
