## PRODUCT CAMPAIGN BULLETIN

**APPLICABILITY:** 2017-19MY Impreza  
2018-19MY Crosstrek

**SUBJECT:** Ignition Coil Short Circuit

**NUMBER:** WUQ-02R

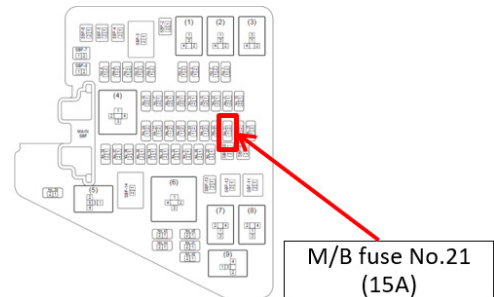
**Step 3:** Remove the lid from the under-hood Main Fuse Box (M/B) and inspect Fuse 21. Is Fuse 21 blown?

**YES:** Proceed to **Step 4** and inspect all 4 of the ignition coils closely.

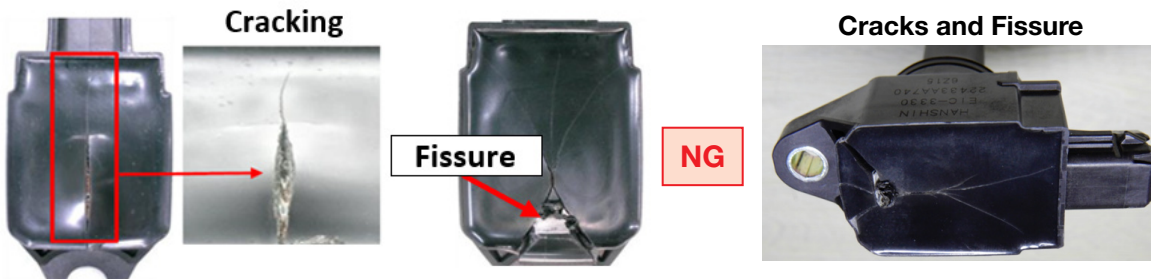
Ignition Coil Check Points

**Step 4:** Inspect all 4 ignition coils CLOSELY for any damage, cracking, fissures, etc. Coil removal is NOT necessary as any damage will be external. Were any cracks, fissures or other damage found on any of the 4 ignition coils?

**YES:** Replace any damaged coil(s) (rare case) following the procedure in the applicable Service Manual then proceed to **Step 5** and using the SSM, check for any stored DTCs.
