David J. Johnson  
 Director  
 Service Engineering Operations  
 Ford Customer Service Division

**SUBJECT: NEW VEHICLE DEMONSTRATION / DELIVERY HOLD  
 Customer Satisfaction Program 21B03 - Supplement #3**  
 Certain 2020 Model Year Super Duty F250-F600 Vehicles Equipped with a 10R140  
 Transmission - Number One Planetary and Ring Gear Assembly

## CERTAIN 2020 MODEL YEAR SUPER DUTY F250-F600 VEHICLES EQUIPPED WITH A 10R140 TRANSMISSION — NUMBER ONE PLANETARY AND RING GEAR ASSEMBLY

### **NEW!** SERVICE PROCEDURE

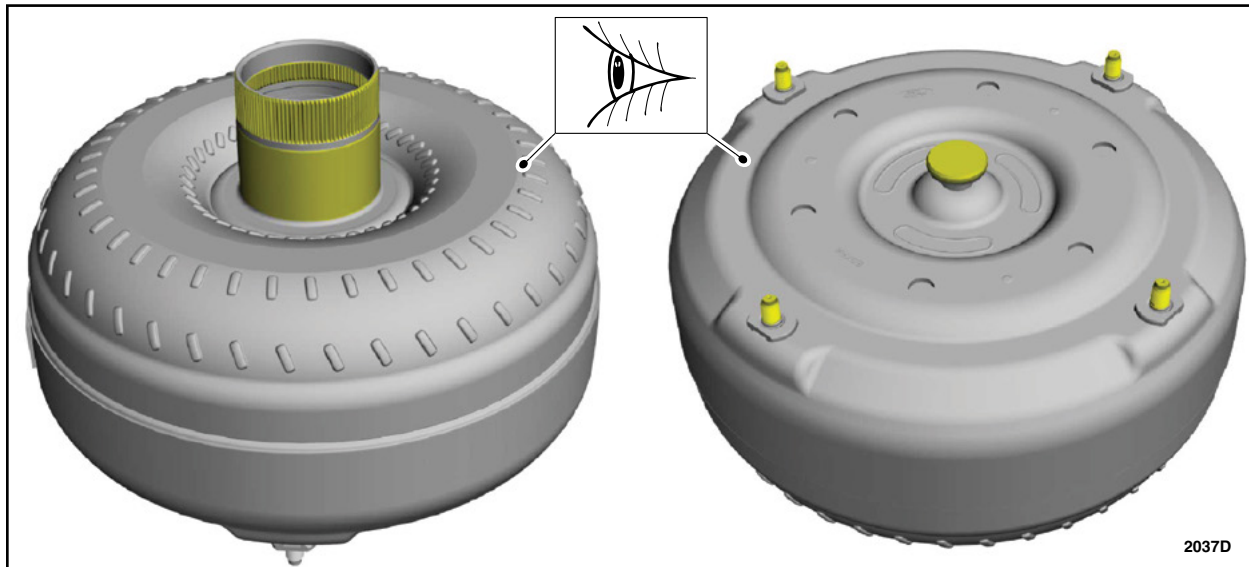
**FIGURE 4**

5. Inspect the torque converter. If you answer yes to any of the following questions a new or re-manufactured torque converter must be installed. See Figure 4.

- Does the sealing surface have a groove worn from the seal?
- Has a torque converter malfunction been determined based on complete diagnostic procedures?
- Is the torque converter stud or studs, threaded pads, impeller hub or bushing damaged?
- Is there evidence of water or antifreeze contamination?
- Does the torque converter exhibit external discoloration (due to overheating)?
  - Overheat discoloration would be a darker color with possible bluing.
  - Discoloration would be a different color than the rest of the torque converter.

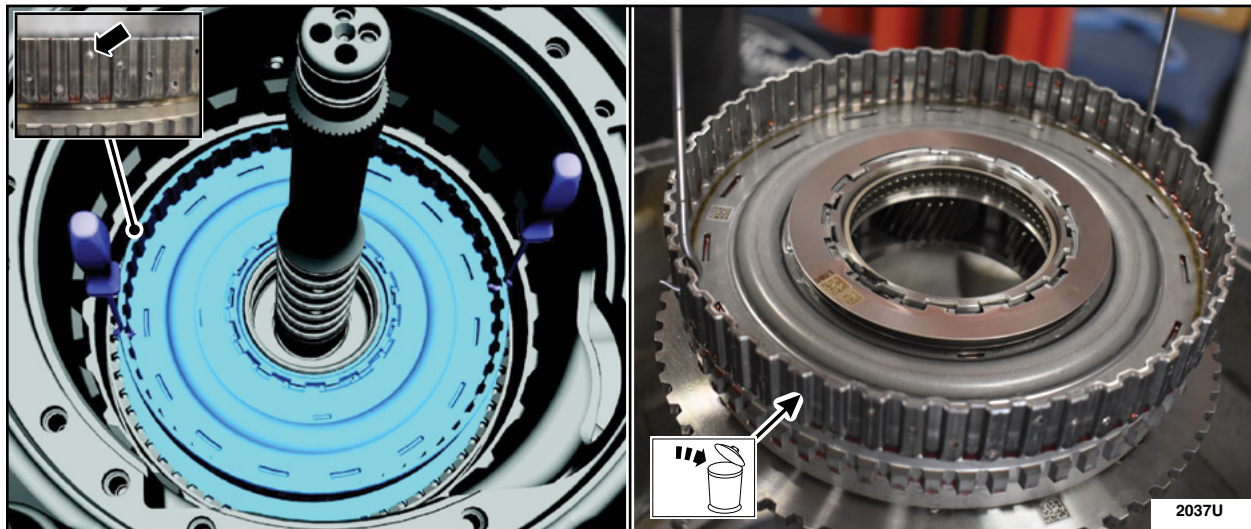
FIGURE 13

16. Using two pick hooks inserted into holes on the outside gear, remove and discard the number one planetary carrier. See Figure 13.

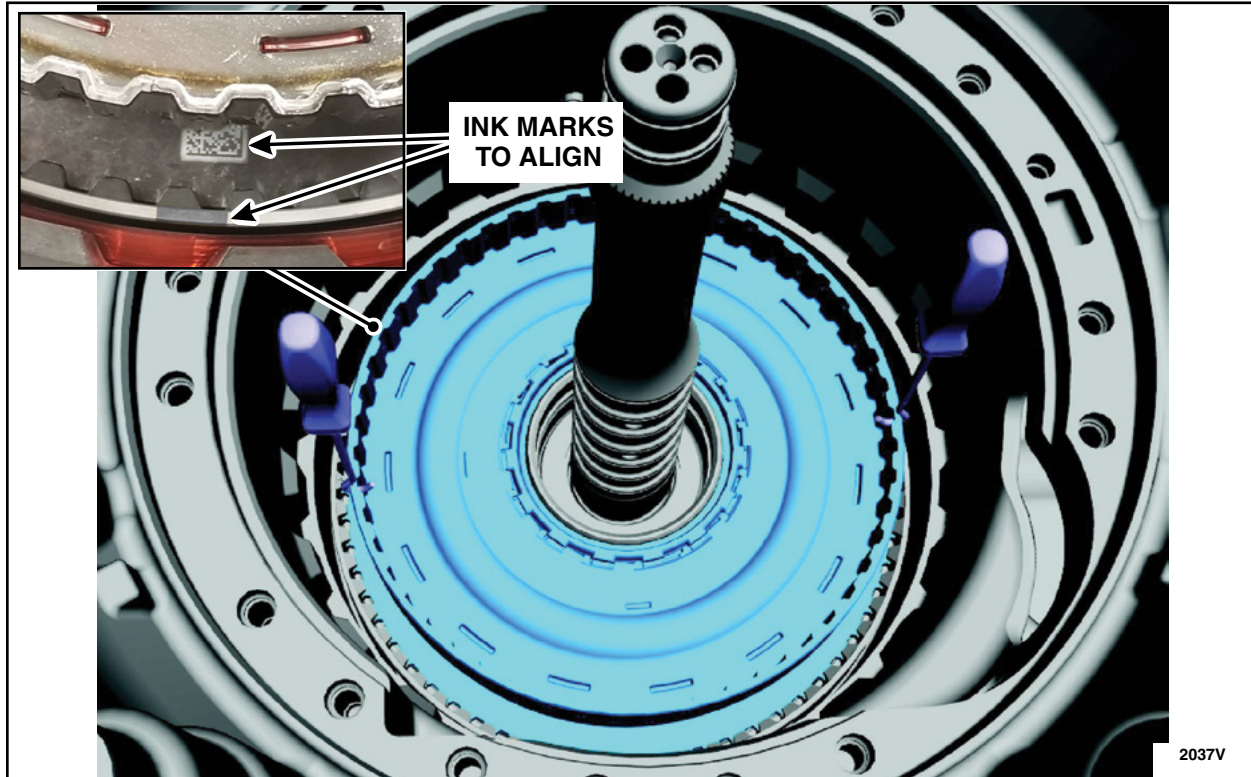
**FIGURE 14**

**NOTE:** The ink marks must be aligned or a transmission vibration can occur.

17. Using two pick hooks, install the new number one planetary carrier with the ink markings aligned.  
See Figure 14.

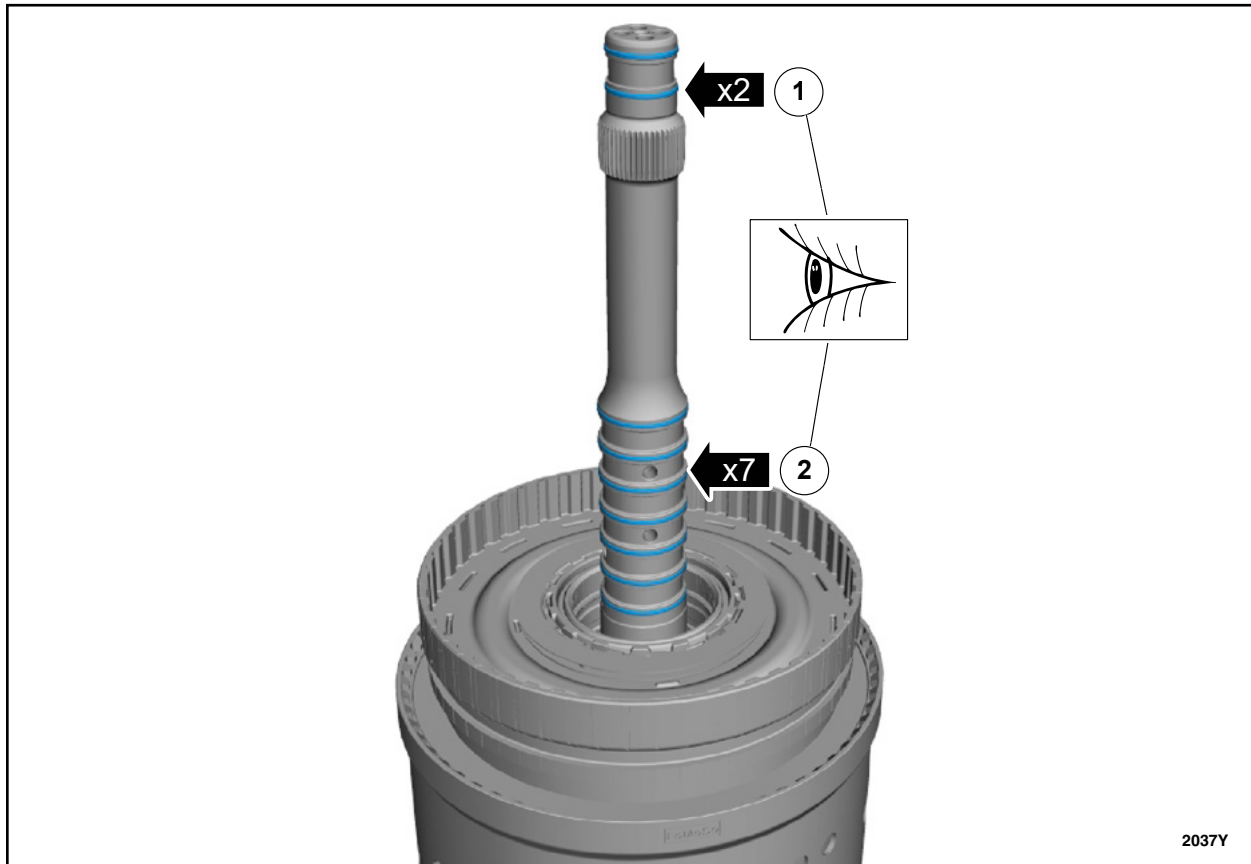
FIGURE 17

20. Inspect the input shaft seals for damage. See Figure 17. Do any of the input shaft seals show signs of damage?

If **YES** - Remove the damaged seals, then proceed to Step 21.
