June 17, 2021

**SUBJECT: NEW VEHICLE DEMONSTRATION / DELIVERY HOLD  
 Customer Satisfaction Program 21B03 - *Supplement #4***  
 Certain 2020 Model Year Super Duty F250-F600 Vehicles Equipped with a 10R140  
 Transmission - Number One Planetary and Ring Gear Assembly

**NEW VEHICLE DEMONSTRATION / DELIVERY HOLD  
Customer Satisfaction Program 21B03 - *Supplement #4***

Certain 2020 Model Year Super Duty F250-F600 Vehicles Equipped with a 10R140 Transmission  
Number One Planetary and Ring Gear Assembly

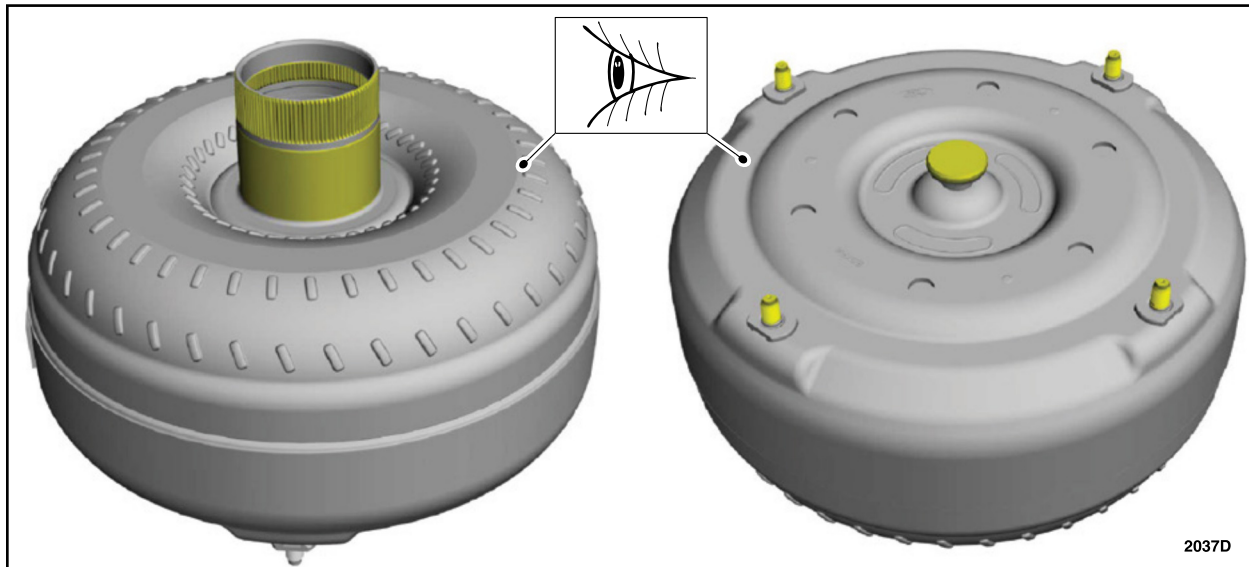
**FIGURE 4**

5. Inspect the torque converter. If you answer yes to any of the following questions a new or re-manufactured torque converter must be installed. See Figure 4.

- Does the sealing surface have a groove worn from the seal?
- Has a torque converter malfunction been determined based on complete diagnostic procedures?
- Is the torque converter stud or studs, threaded pads, impeller hub or bushing damaged?
- Is there evidence of water or antifreeze contamination?
- Does the torque converter exhibit external discoloration (due to overheating)?
  - Overheat discoloration would be a darker color with possible bluing.
  - Discoloration would be a different color than the rest of the torque converter.

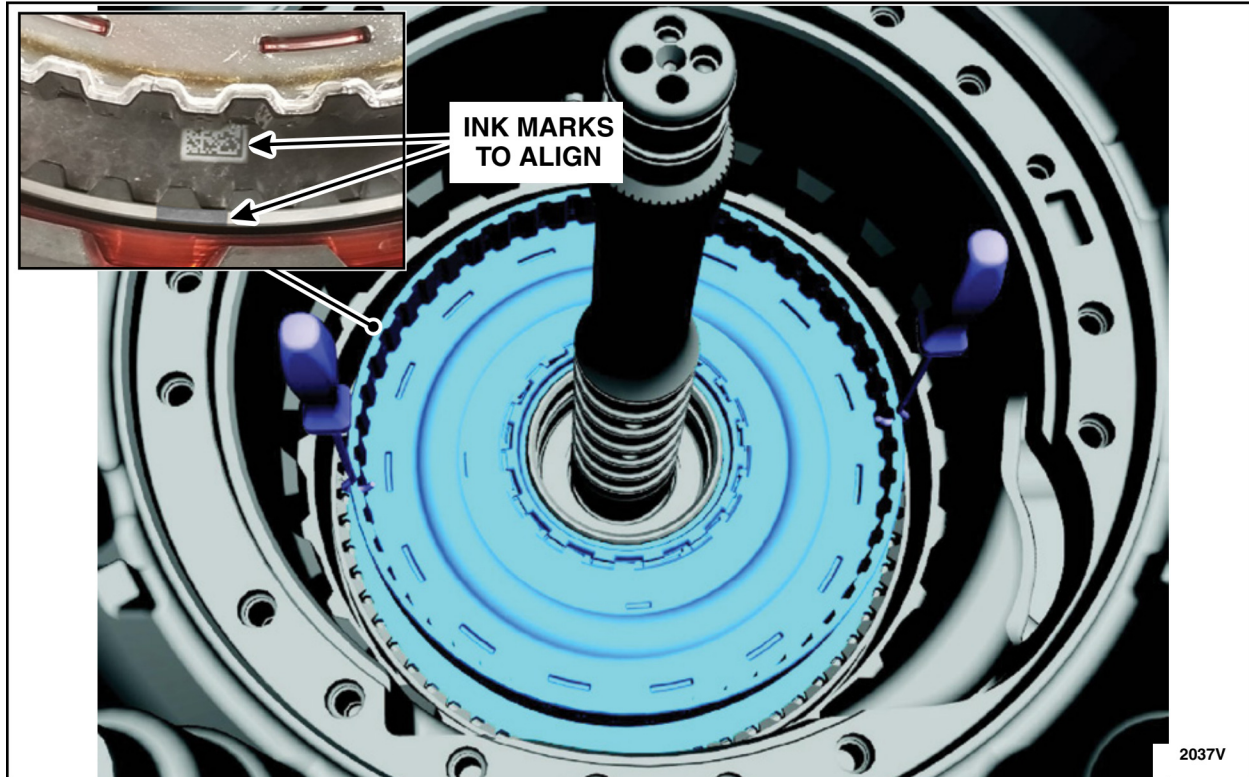
**FIGURE 14**

**NOTE:** The ink marks must be aligned or a transmission vibration can occur.

17. Using two pick hooks, install the new number one planetary carrier with the ink markings aligned.  
See Figure 14.

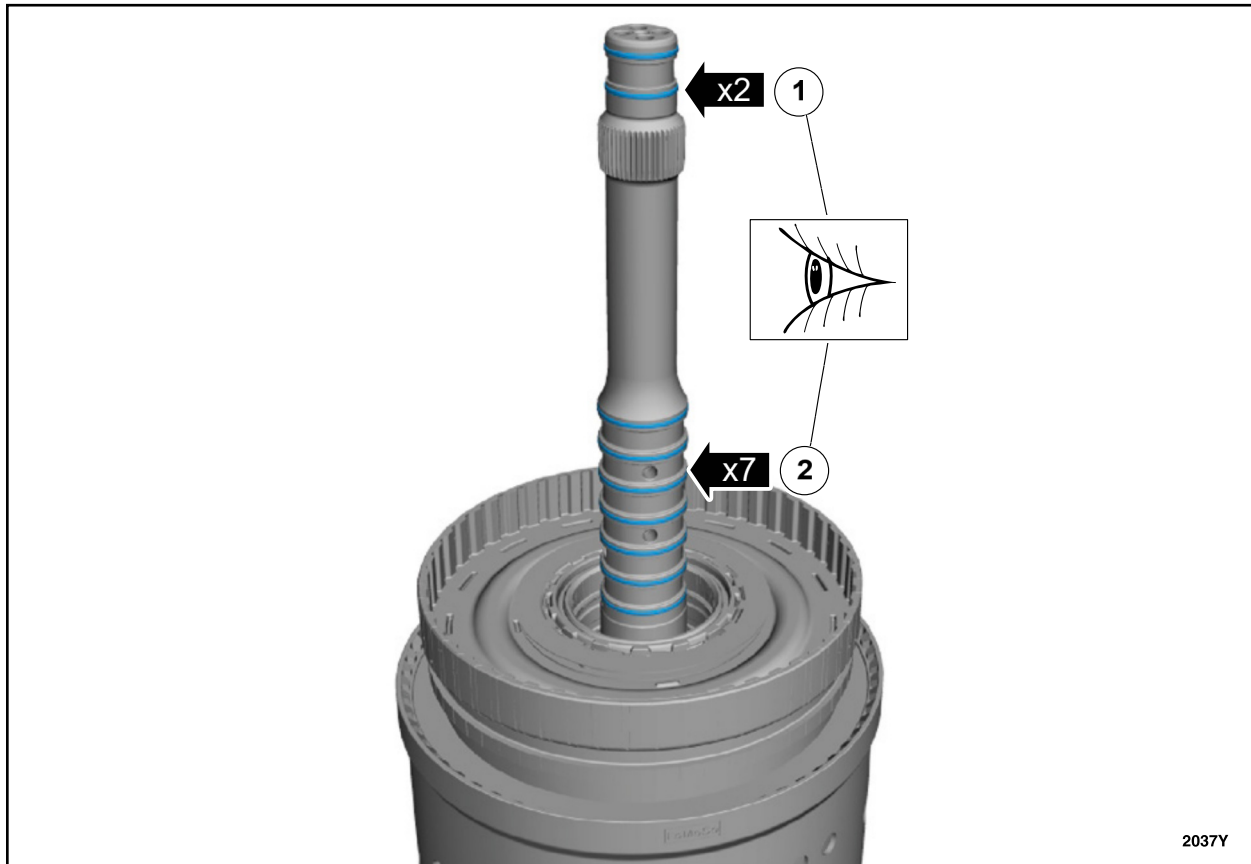
FIGURE 17

20. Inspect the input shaft seals for damage. See Figure 17. Do any of the input shaft seals show signs of damage?

If **YES** - Remove the damaged seals, then proceed to Step 21.

If **NO** - Proceed to Step 27.
