SERVICE PROGRAM BULLETIN

APPLICABILITY:	2015-2016MY Legacy 2.5L	NUMBER:	WUJ-95R
	2015-2016MY Outback 2.5L	DATE:	02/11/20
SUBJECT:	Exhaust Pipe Front (EPF) Bellows Cracking	REVISED:	07/30/21

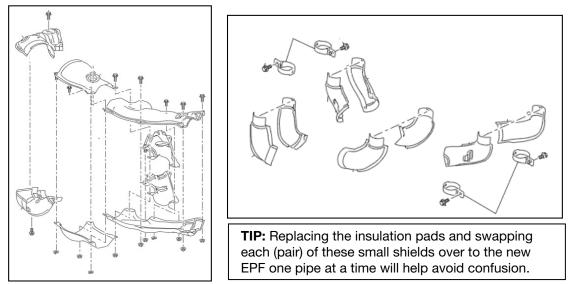
IMPORTANT: As each heat shield is **CAREFULLY** removed, use a permanent marker to outline the shape and positioning of each fiberglass insulation pad found on the inside of it whenever possible. A complete set of new insulation pads is included in the EPF kit and **ALL are to be replaced at reassembly**.

Use a wire brush to remove any insulation and / or adhesive residue. Proper positioning of the new insulation pads is key to achieving a rattle-free repair.

• Before applying any of the new insulation pads, wipe the inside and outside of the shields clean of any residual oil / penetrant used with a mild solvent on a clean shop cloth. Use caution to not remove the position markings for the replacement insulation pads.

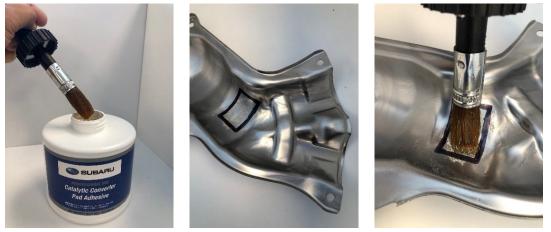
• Remove the brush cap from the adhesive container and apply a small amount of the material to each shield toward the center of where the new insulation pad will be positioned. Marking an outline for where the adhesive should be applied can also be used as shown below.

- For reference, a "dab" or two of adhesive about the size of a silver dollar is plenty. There is no need to cover the entire insulation pad area. Keep in mind, the adhesive is only used to hold the new insulation pads in place during EPF reassembly as they will be held ("clamped") in position once all the retaining hardware is tightened.
- Apply the adhesive to the shield then press the new insulation pad onto it and all the contours of each shield. Repeat for each remaining shield and insulation pad.

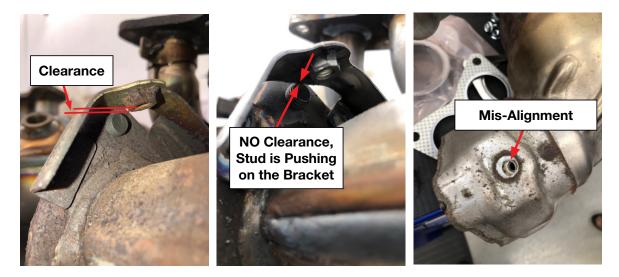
• Take a minute to test fit the shields covering the catalytic converter section to the new EPF. The photo sequence below shows one of the original EPF's outlet flange studs having clearance between it and the converter shield mounting bracket. The same stud on the new EPF is shown pushing against the edge of the bracket. This caused a mis-alignment of the shield mounting bolt hole and corresponding bracket bolt hole. Some <u>VERY CAREFUL</u> manipulation of the mounting bracket restored the proper bolt hole alignment.

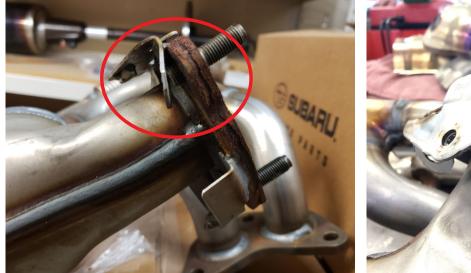
Some reports have been received regarding the mounting bracket tabs as pictured below. Occasionally, the fastener holes in the bracket are not fully aligned with the holes in the center exhaust pipe mounting flange. The pictures show one of the center exhaust pipe mounting studs displacing the bracket tab. If this happens, it may cause the bolt hole for the converter shield to become mis-aligned (or, it may have no effect at all). This condition MAY require some <u>VERY CAREFUL</u> manipulation of the mounting bracket to re-align it with the converter shield bolt hole.

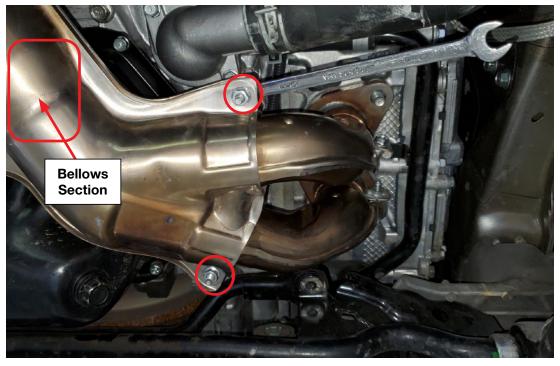
(9.6 ft. lbs.) **EXCEPT** for the two on the driver's side shield shown in the photo below. This shield covers the bellows section of the EPF and if tightened, the dimension of the bellows may be changed enough to keep the EPF assembly from fitting back onto the exhaust studs properly.

- Install the EPF assembly and torque the six cylinder head flange nuts to 30 Nm (22.1 ft. lbs.) <u>THEN</u> tighten the last 2 heat shield bolts shown above to 13 Nm (9.6 ft. lbs.).
- Re-connect the A/F sensor connectors.
- Reinstall the center exhaust pipe with the new gaskets supplied in the kit in reverse order of removal.

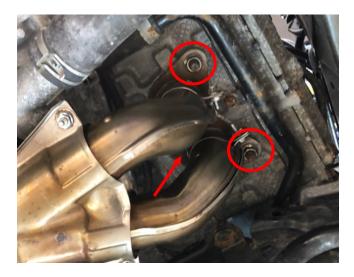
In response to reports of the cylinder head studs coming out when removing the six (6) EPF retaining nuts, the following TIPS will provide helpful solutions:

- It is STRONGLY recommended to not attempt removal of these nuts with the engine hot. Always allow the engine to adequately cool before proceeding.
- Apply a penetrant (e.g. PB Blaster or equivalent) to the nuts while the engine is cooling.

- Use a small wire brush after applying the penetrant to remove any loose rust from the studs where they extend past the top of the retaining nuts. Re-apply the penetrant as needed.

- Use **6-point sockets ONLY** (sockets with "flank-drive" are preferred) to remove the retaining nuts and prevent rounding. Applying a small amount of valve grinding compound to the flats of the retaining nuts can also help prevent rounding them and add some extra grip for the socket.

- USE HAND TOOLS ONLY to break the retaining nuts loose then add penetrant, work them back and forth, add penetrant and repeat until removed.
- As a last resort, CAREFUL use of auxiliary heat can be used. Use of inductive tools is recommended when heating is required as opposed to tools using open flame but, either method may be used successfully and safely based on the Technicians experience level.
