Service Information Letter

August 13, 2021

Units Affected: 2017-2020 Ford F350/F450/F550 chassis with Timbren springs installed (Verify that your unit serial number is affected by reviewing the attached list in this SIL or by accessing your fleet on connect.altec.com/login)

Timbren Springs Inspection

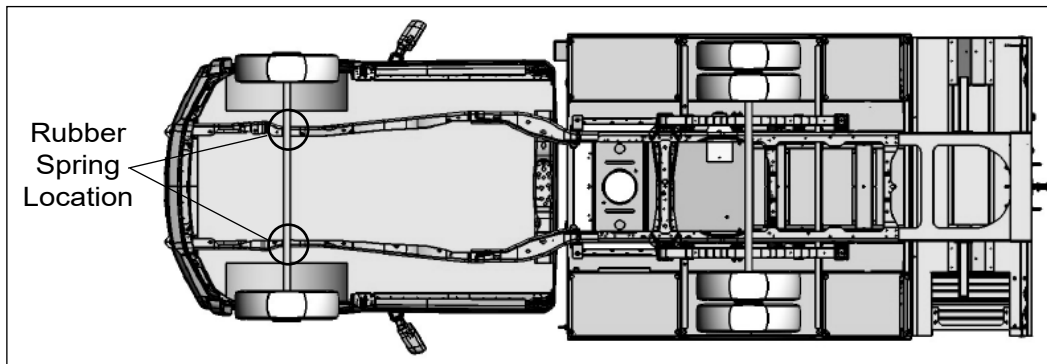
Figure 1 – Under Chassis View

2. Look for a rubber spring located between the chassis frame rail and the axle near the front coil spring at both the street side and the curb side of the chassis (refer to Figure 1). If a yellow cone-shaped rubber spring is present on both sides (refer to Figure 2), no further inspection is needed. Proceed to the Completion Procedure with Two Rubber Springs.

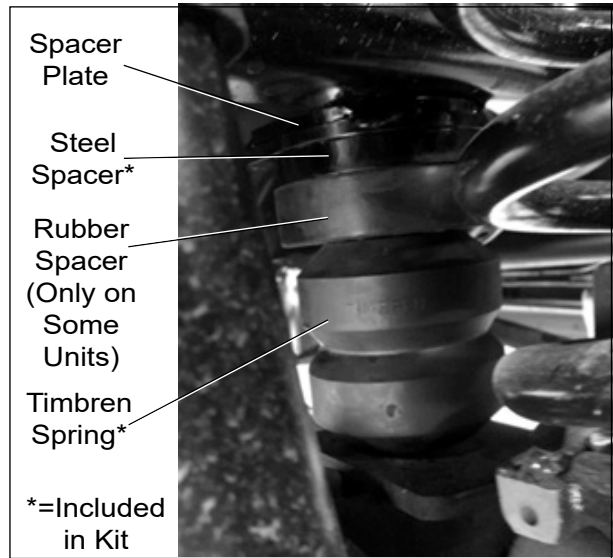
Figure 3 – Black Timbren Spring Installation

3. If both black Timbren springs are missing (refer to Figure 3), call 1-877-GO ALTEC (1-877-462-5832) option 1 and order two Timbren Spring Replacement Kits, part number 991340249. Proceed to the Completion Procedure with Missing Timbren Spring(s)
