Service Information Letter

Units Affected: AT200A aerial devices built on Ford F450/F550 chassis from 2011 to 2016 with non-steel utility bodies (Verify that your unit serial number is affected by reviewing the attached list in this SIL or by accessing your fleet on connect.altec.com/login)

Mounting Frame Inspection, Units with Non-Steel Bodies

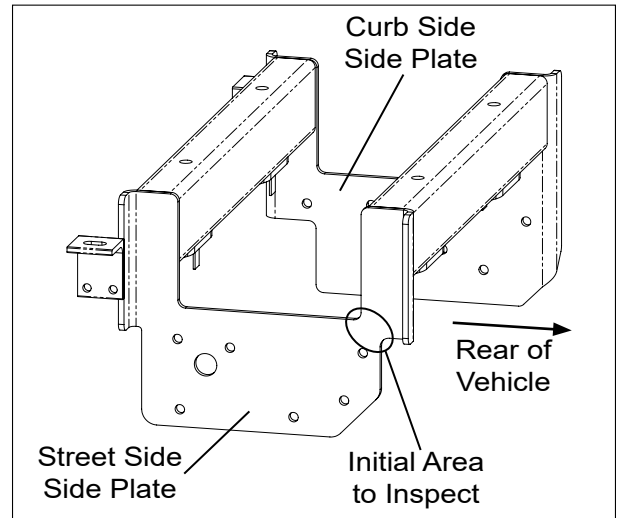
Figure 1 – Mounting Frame Initial Inspection

1. Position the unit on a level surface. Apply the parking brake and turn off the engine. Remove the key from the ignition and secure it. Chock the wheels. Follow your employer’s vehicle lockout/tagout procedure.
2. Find the mounting frame under the vehicle (refer to Figure 1). The initial area to inspect is the narrow section at the rear portion of the side plate on the street side of the mounting frame. Use a wire brush to remove any paint and rust from this area.

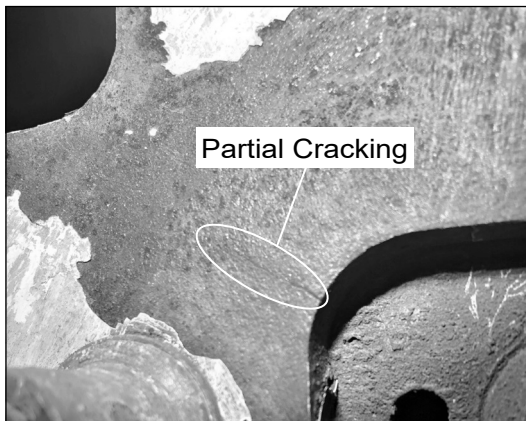
Figure 2 – Partial Cracking Example

3. Using a flashlight, inspect the outer surface and the upper and lower rounded corners of the narrow section of the side plate for the extent of any cracking in the steel plate, as defined below.
 - No cracking means no visible cracking at all in the plate.
 - Partial cracking means a visible crack anywhere in the narrow section that extends only part way across the width or part way through the thickness of the plate (refer to Figure 2).
 - Full cracking means a visible crack across the full width of the narrow section extending through the full thickness of the plate and causing the complete separation of the material (refer to Figure 3).

- If there is no cracking, put the unit back into service. Order the kit as specified on page 1 and install it within one year of the inspection. Do not perform Inspection Procedure B.
- If there is partial cracking, put the unit back into service. Order the kit as specified on page 1 and install it within 90 days of the inspection. Do not perform Inspection Procedure B.
- If there is full cracking, take the unit out of service. The vehicle can still be driven but the aerial device cannot be used until it is repaired. Proceed to Inspection Procedure B to determine the necessary repair procedure.

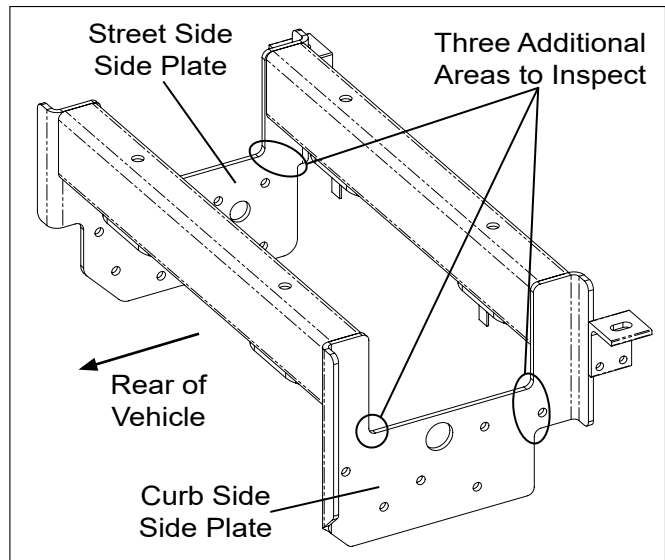
Figure 4 – Mounting Frame Additional Inspection

2. Use a wire brush to remove any paint and rust from the other three corners of the mounting frame (refer to Figure 4).

3. Using a flashlight, inspect the outer surface and the rounded corners of the three corners of the mounting frame as shown in Figure 5 for the extent of any cracking in the steel plate.

- If there is no cracking in any of these three areas, order the kit as specified on page 1 and install it before putting the unit back into service.
- If there is cracking in any of these three areas, call 1-877-GO ALTEC (1-877-462-5832) option 1 and speak to Technical Support for further direction.
