SUBJECT: **Customer Satisfaction Program 21N01 - Supplement #1**
 Certain 2016-2018 Model Year Explorer Vehicles
 High-Speed Cooling Fan Motor Relay

REF: **Customer Satisfaction Program 21N01**
 Dated: August 19, 2021

CERTAIN 2016-2018 MODEL YEAR EXPLORER BJB VEHICLES — HIGH SPEED COOLING FAN MOTOR RELAY

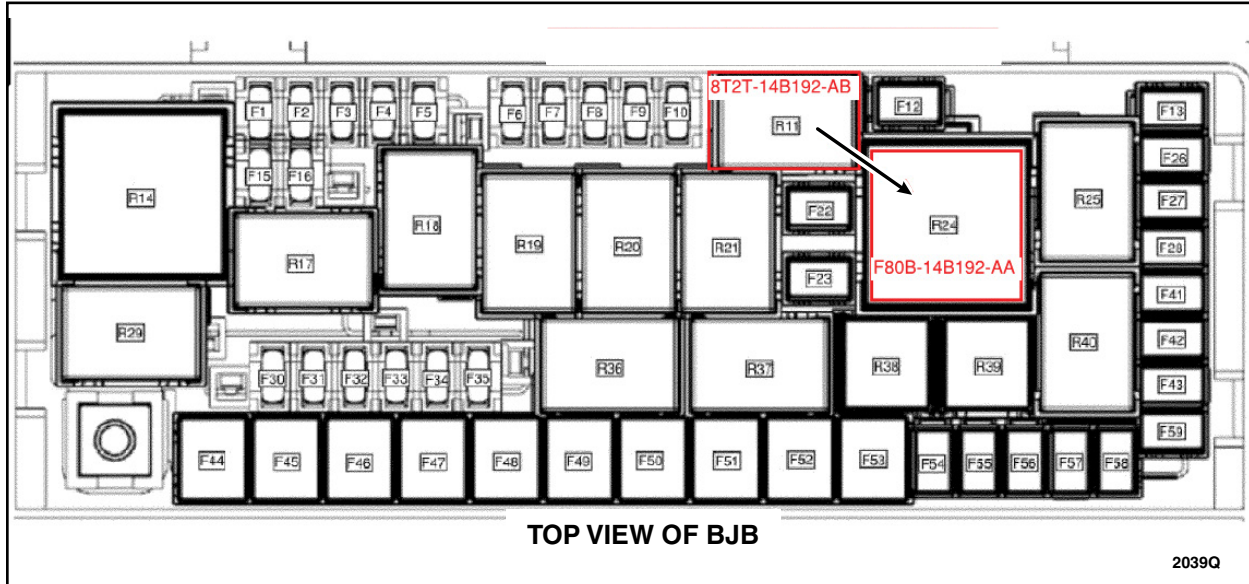
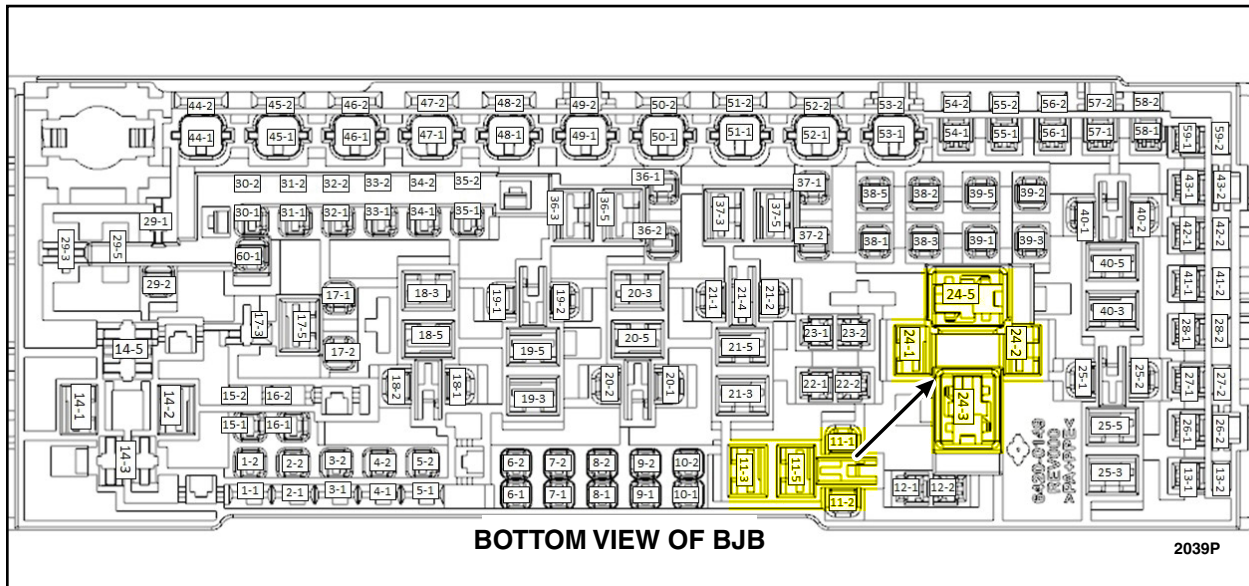
NOTE: The high speed cooling fan relay (R11) will be relocated to the (R24) position in the Battery Junction Box (BJB) as shown in Figures 1 and 2.
