December 15, 2021

SUBJECT: **Customer Satisfaction Program 21N10**
Certain 2015 – 2021 Model Year Mustang Convertible Vehicles
Door Opens to Secondary Latch Position

CERTAIN 2015-2021 MODEL YEAR MUSTANG VEHICLES — FRONT DOOR LATCH REPLACEMENT SERVICE PROCEDURE

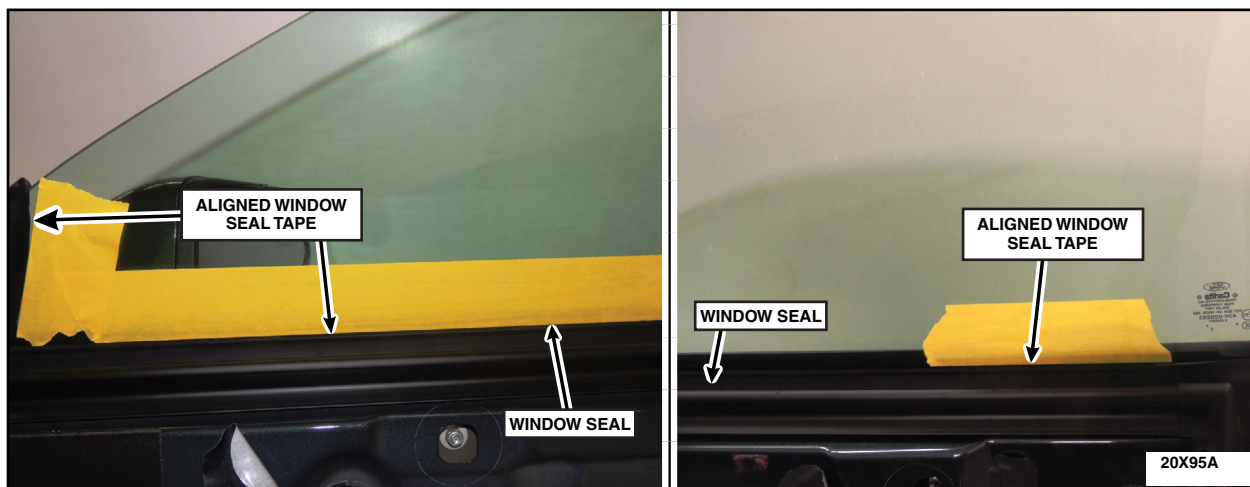
FIGURE 1

NOTE: Right Hand (RH) shown, Left Hand (LH) similar.

1. Remove the front door trim panel. Please follow the WSM procedures in Section 501-05.
2. Align and apply masking tape or equivalent to window glass fore and aft along window seals as reference points for alignment during re-installation of the window glass. See Figure 1.

NOTE: When reinstalling the window glass, align the tape with the window seal to ensure proper fit before tightening the fasteners. Door window glass adjustment is not necessary when following this procedure. See Figure 1.

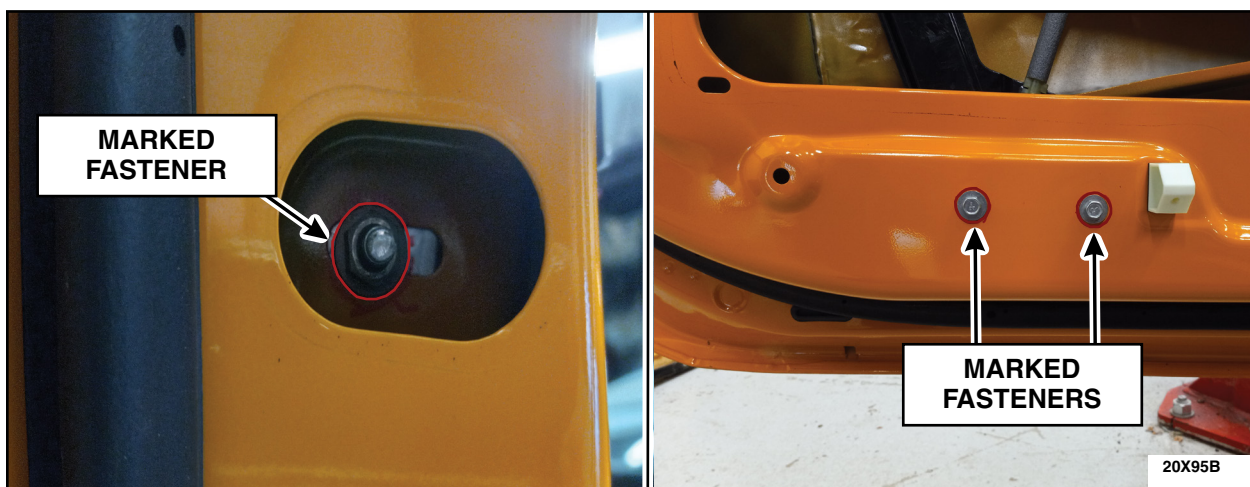
FIGURE 2

NOTE: LH shown, RH similar.

NOTE: BEFORE removing the fasteners, mark all of the fasteners for the aft front door glass run and front door window regulator with a paint pen or permanent marker. See Figure 2.
