Service Update

N222357620 Inadvertent Service Park Assist System Error Message

Release Date: February 2022

Condition	Certain 2022 model year Chevrolet Silverado and GMC Sierra vehicles not equipped with front/rear park assist may have an inadvertent Service Park Assist message displayed on the Driver's Instrument Cluster when the vehicle is started.
Correction	Dealers are to reprogram the instrument cluster.

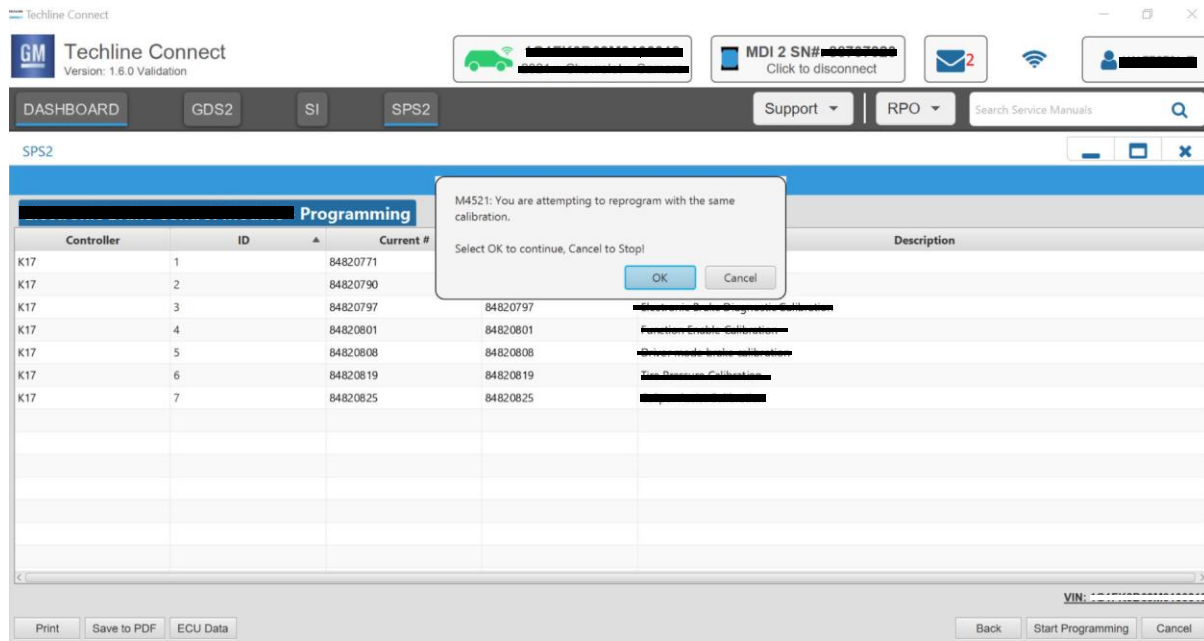
5644477

Important: Techline Connect screens shown above.

Important: If the same calibration/software warning is noted on the TLC Summary screen, select OK and follow screen instructions. After a successful programming event, the WCC is located in the Service Programming System dialogue box of the SPS Summary screen. No further action is required. Refer to the Warranty section of the bulletin.

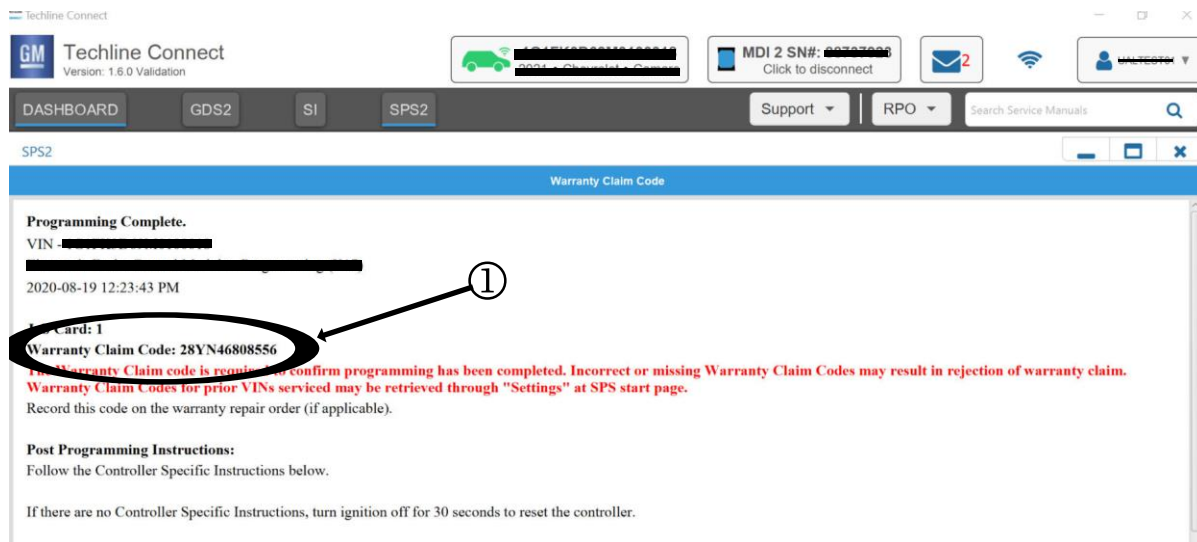
5644478

Note: The screenshot above are an example of module programming and may not be indicative of the specific module that is being programmed. Module selection and VIN information have been blacked out.

Important: To avoid warranty transaction rejections, you **MUST** record the warranty claim code provided on the Warranty Claim Code (WCC) screen shown above on the job card. Refer to callout 1 above for the location of the WCC on the screen.

1. Reprogram the Instrument Cluster. Refer to *P16 Instrument Cluster: Programming and Setup* in SI. Modify as required (e.g., select x module from the controller screen. Then provide step-by-step instructions or refer to SI procedure.

2. Record SPS Warranty Claim Code on job card for warranty transaction submission.
