## SERVICE PROGRAM BULLETIN

**APPLICABILITY:** 2022MY Outback Wilderness

**NUMBER:** WRJ-21R

**SUBJECT:** Left Front B-Pillar / Inspection for Splitting Condition

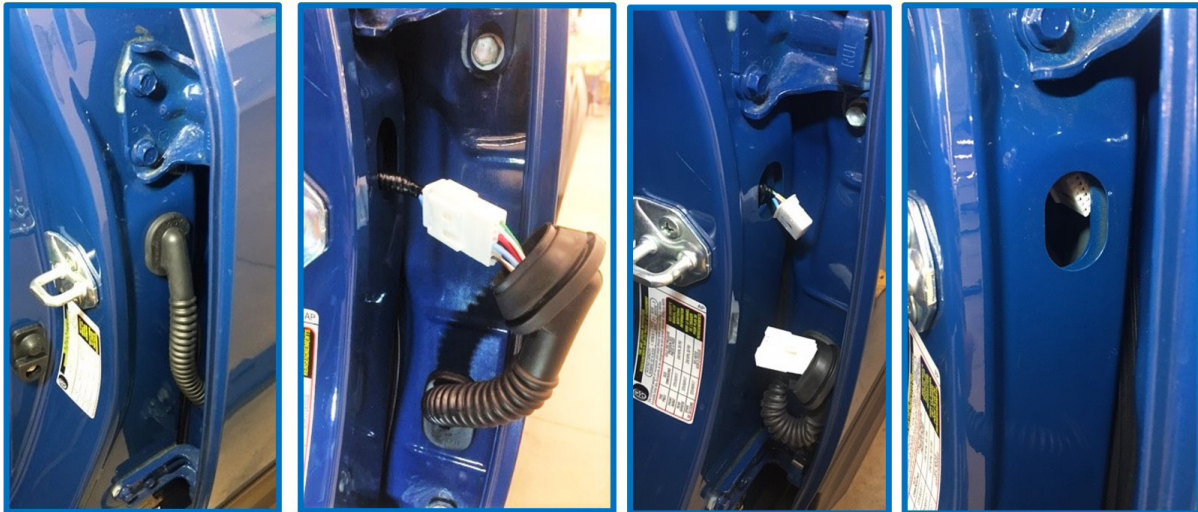
**STEP 3)** Tuck the male connector into the B-pillar to provide room for the inspection flashlight.

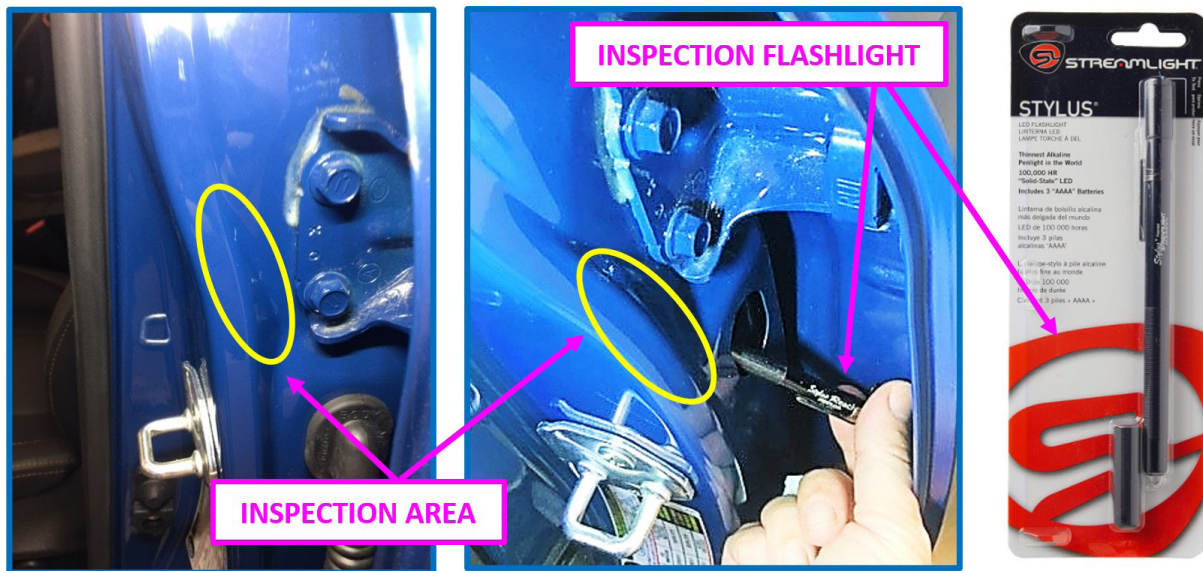
**STEP 4)** Shine the inspection light through door wiring harness hole. Be sure to aim the light in front of the upper left rear door hinge mount. A Streamlight® Stylus penlight was used in the example inspection photos below. Reduce the ambient light in the work area if needed. Examine the area closely for light shining through any splitting identified within the inspection area. See the **EXAMPLE** image of the splitting condition provided below.

**CRITICAL:** Paint pattern inconsistencies such as surface variations and/or blemishing are considered to be acceptable within this area. The splitting condition can ONLY be confirmed when light is found shining through the inspection area.

**Yes** → Create a detailed Quality Monitoring Report (QMR) including the following:

- Clear photos of the split condition showing the inspection light emitting through the B-pillar
- The current vehicle mileage
- Clear photo of the B-pillar VIN label
- Body Repair Facility Estimate for the splitting condition repair outlining a planned welding repair of the condition with the related paint procedure information.

Once the QMR is complete, contact Techline to report the inspection results and receive further direction.
