David J. Johnson  
 Director  
 Service Engineering Operations  
 Ford Customer Service Division

February 8, 2022

**SUBJECT:** **Customer Satisfaction Program 21B11 – Supplement #1**  
 Certain 2014-2016 Model Year Explorer Vehicles  
 2<sup>nd</sup> Row Inflatable Seat Belt

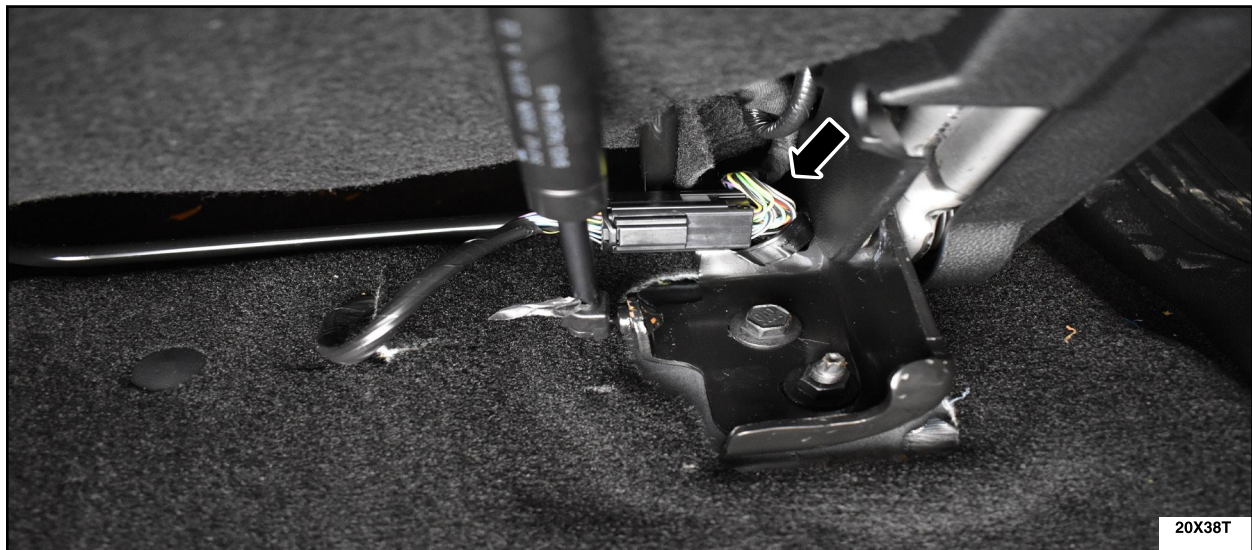
FIGURE 1

**NOTE:** DTC's may indicate possible internal wire damage in the seat wire harness.

2. Fold the Left Hand (LH) and Right Hand (RH) second row seats forward and inspect the wiring harness for damage. Is the wire harness damaged on either the RH or LH seat? See Figure 1.

**If YES** - For RH: Proceed to Wire Harness Repair and Rerouting Procedure on Page 8.  
- For LH: Proceed to Wire Harness Repair and Rerouting Procedure on Page 8.

**If NO** - For RH: Proceed to Wire Harness Stress Relief Procedure on Page 2.  
- For LH: Proceed to Wire Harness Stress Relief Procedure on Page 2.
