David J. Johnson
Director
Service Engineering Operations
Ford Customer Service Division

February 1, 2022

**SUBJECT: RECOMMENDED NEW VEHICLE DELIVERY HOLD -
Customer Satisfaction Program 21B69**
Certain 2021 Model Year Mustang Mach-E Vehicles
High Voltage Battery Module Unsealing

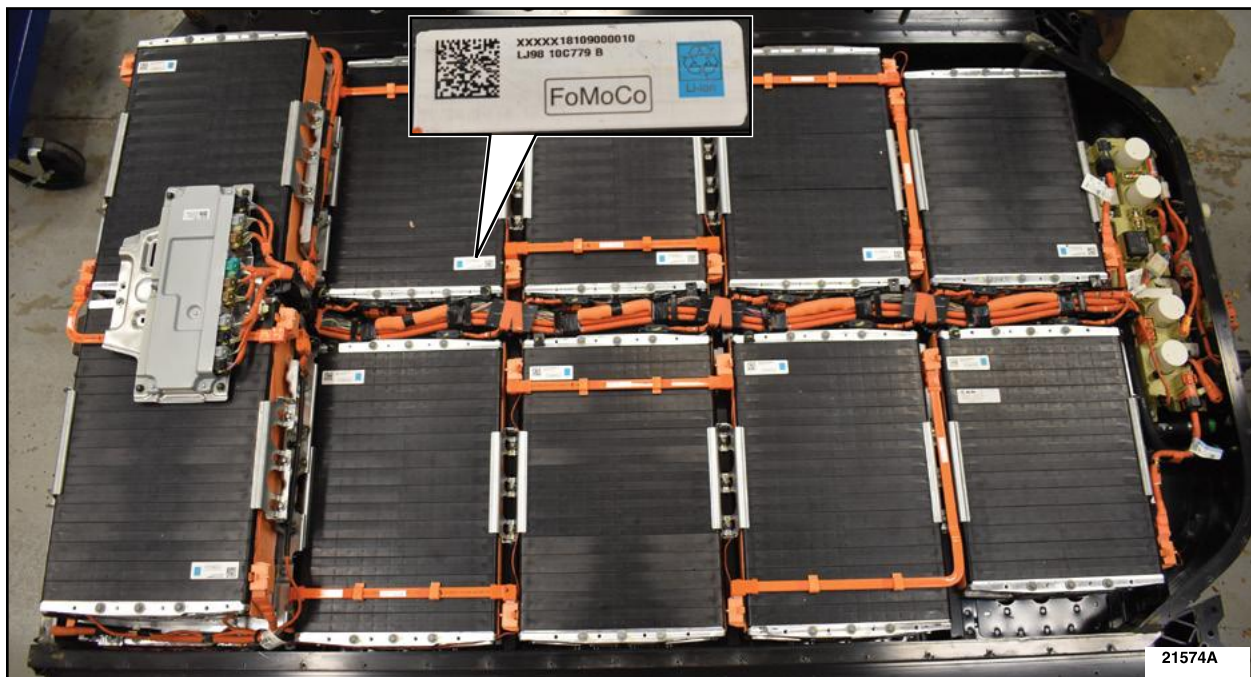
FIGURE 1

2. Using FDRS, perform a Battery Energy Control Module (BECM) battery health check and record the BECM health tool generated target voltage code.
3. Remove the High Voltage Battery Cover. Please follow the Workshop Manual (WSM) procedures in Section 414-03A.
4. Reference Attachment IV: Affected Battery Module List and locate affected battery module(s). The battery module serial number is located on the sticker of each module. See Figure 1.

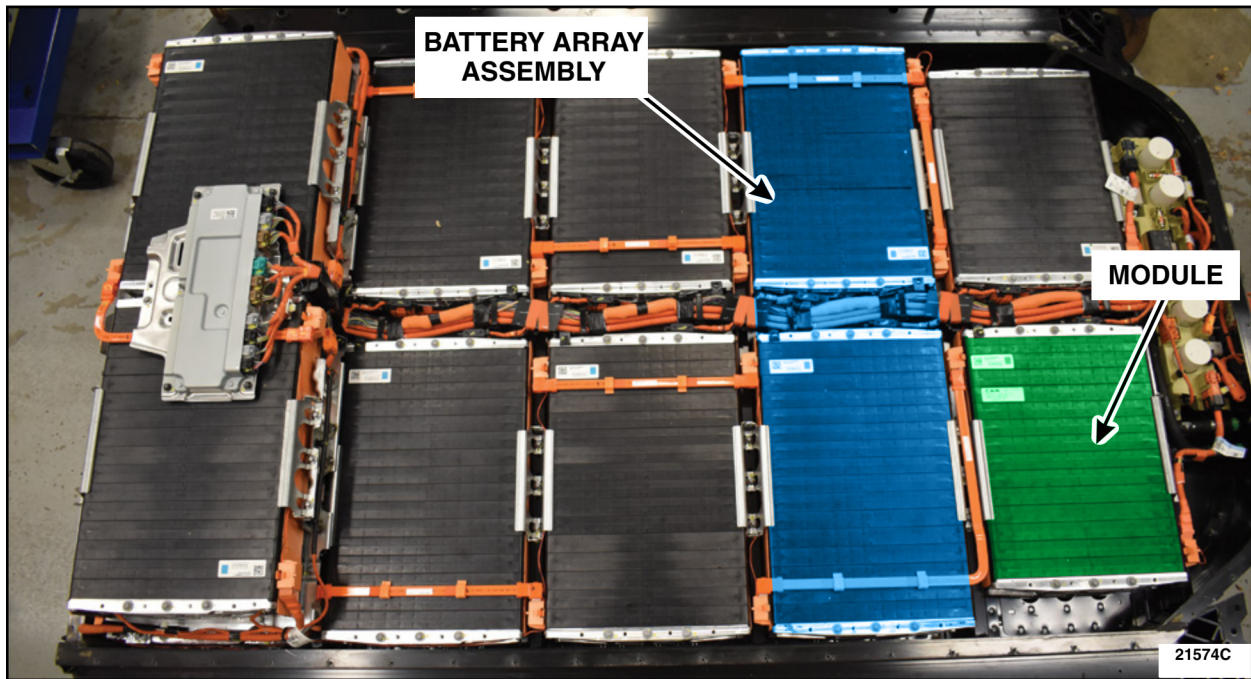
FIGURE 2

NOTE: Each row of modules is called a battery array assembly. The modules in a row need to be replaced as a pair. See Figure 2.

5. Remove the array with the affected module(s). Please follow the WSM procedures in Section 414-03A.

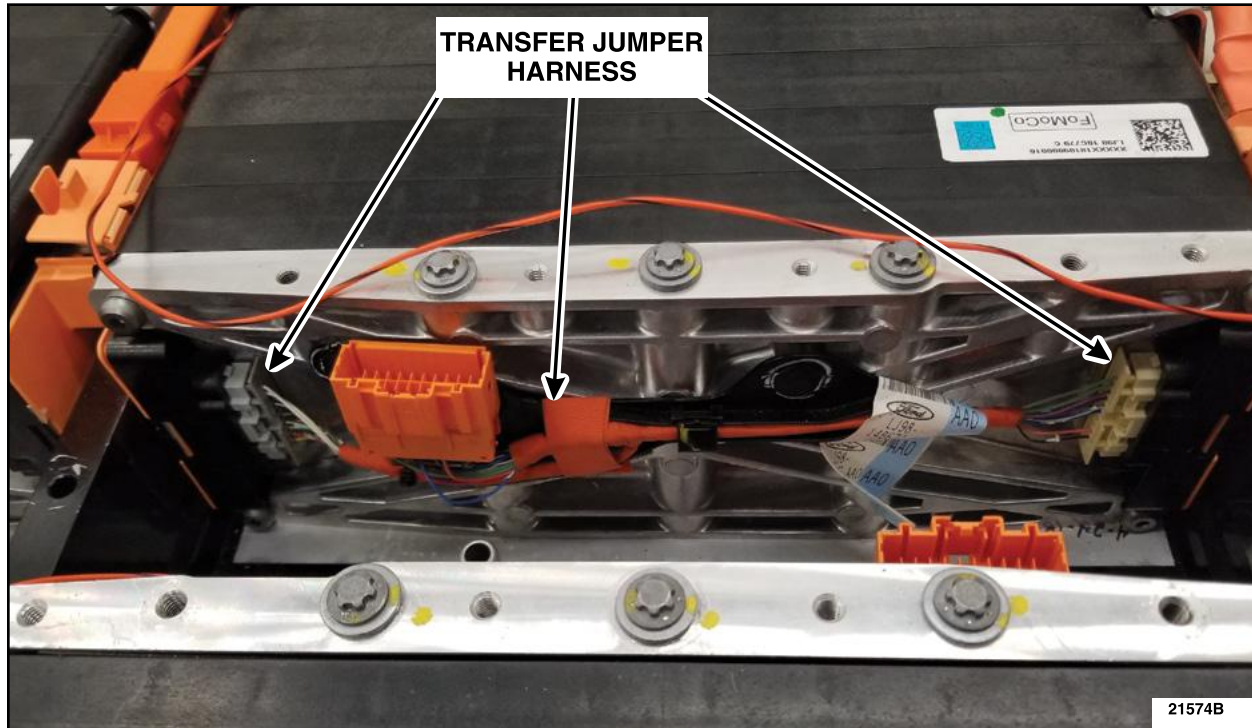
FIGURE 3

NOTE: This jumper harness is found on all five rows except for the fifth upper on extended range.

6. Transfer the jumper harness from the inboard side of the module to the *new* module. See Figure 3.
