SERVICE PROGRAM BULLETIN

APPLICABILITY: 2022 MY WRX

NUMBER: WRA-22

SUBJECT: WRX EyeSight® Reprogramming

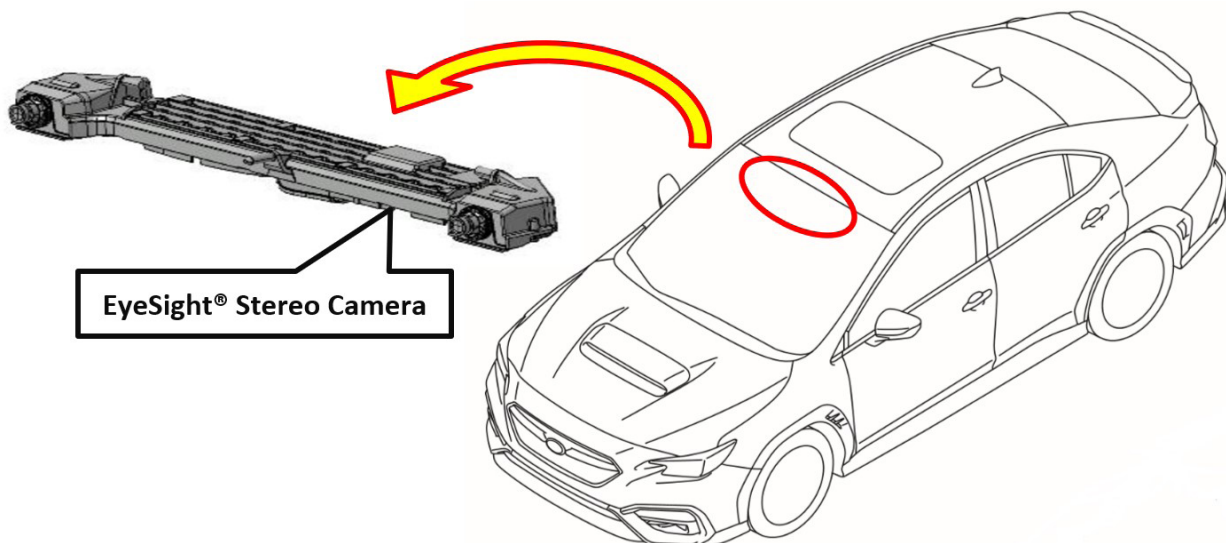
EyeSight® Stereo Camera Location:

The EyeSight® software in the vehicles included in this service program may erroneously cause the EyeSight® functions to temporarily stop working under certain operating conditions. EyeSight® functionality will be unavailable for the remainder of the drive cycle, the EyeSight® warning light will illuminate, and diagnostic trouble code (DTC) B28A6 will be stored. Following the next ignition cycle, the EyeSight® function returns to normal.

Subaru retailers will check and, if necessary, update the EyeSight® software as described in this bulletin at no cost to the customer.
