**PRODUCT CAMPAIGN BULLETIN**

**APPLICABILITY:** 2017-2019 MY Impreza  
2018-2019 MY Crosstrek

**NUMBER:** WRE-21R

**SUBJECT:** Ignition Coil Replacement

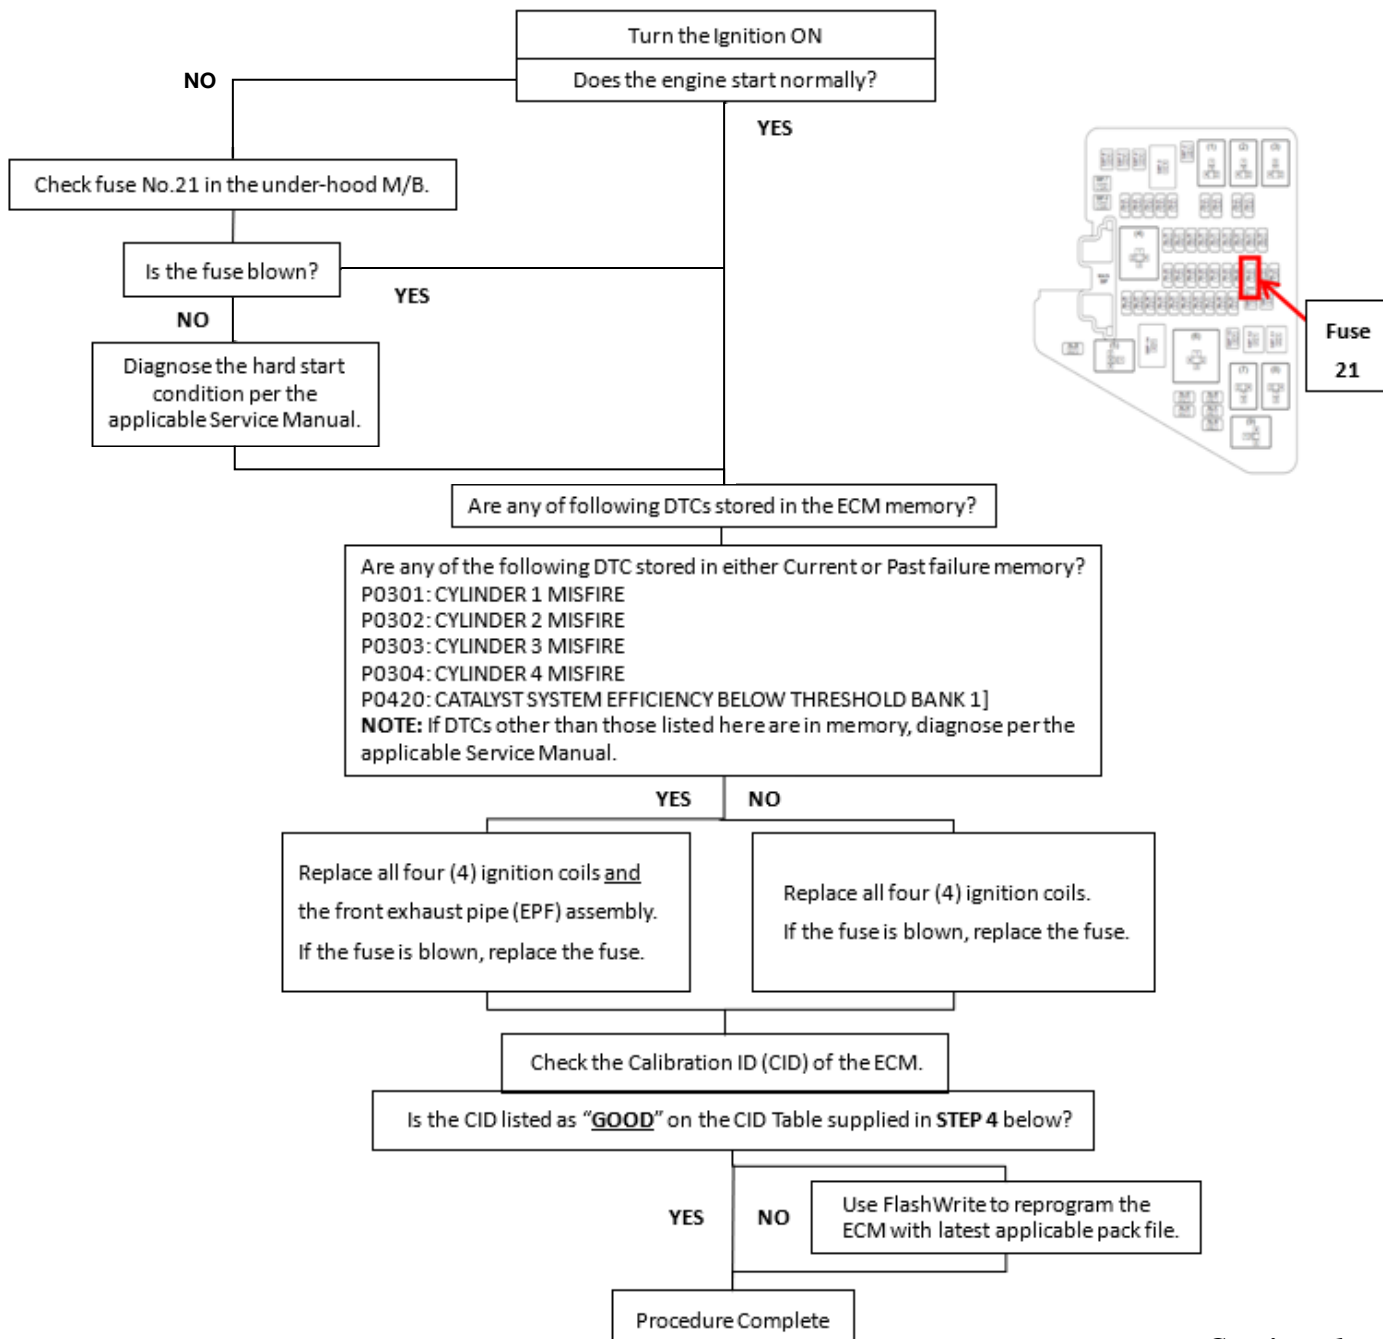
The following Flow Chart is provided as an overview of the procedures required to perform this Recall. A detailed Service Procedure is also supplied below.

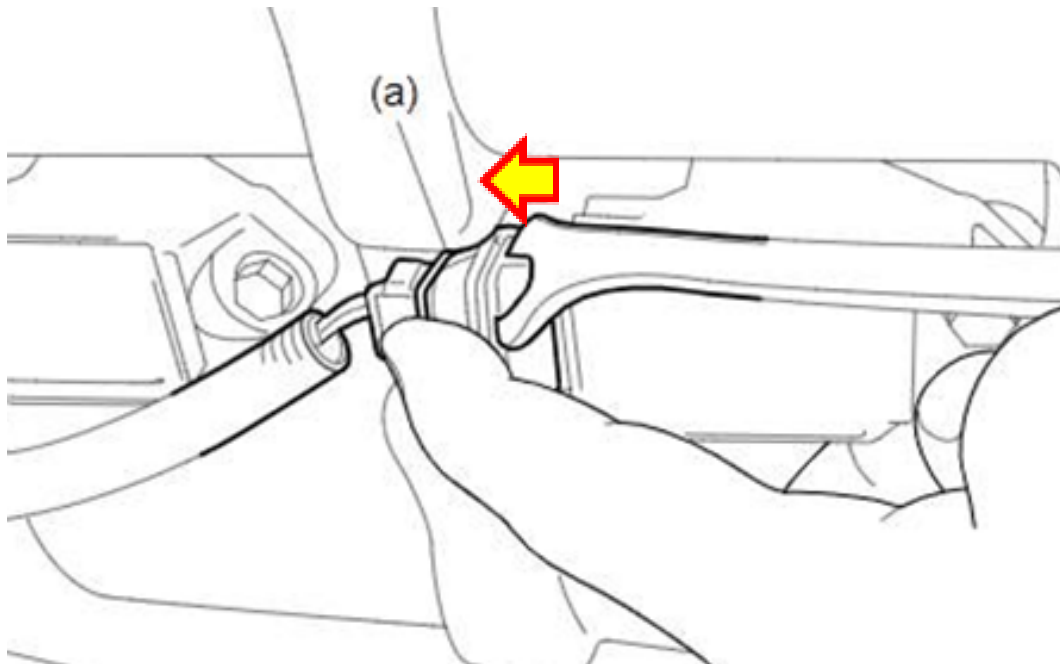
**TIP:** When disconnecting the harness connectors from the ignition coils, squeeze the wire retaining clip (a) and push the connector off using a trim clip tool as shown in the illustration below. **DO NOT** remove the wire retaining clip from the harness connector.

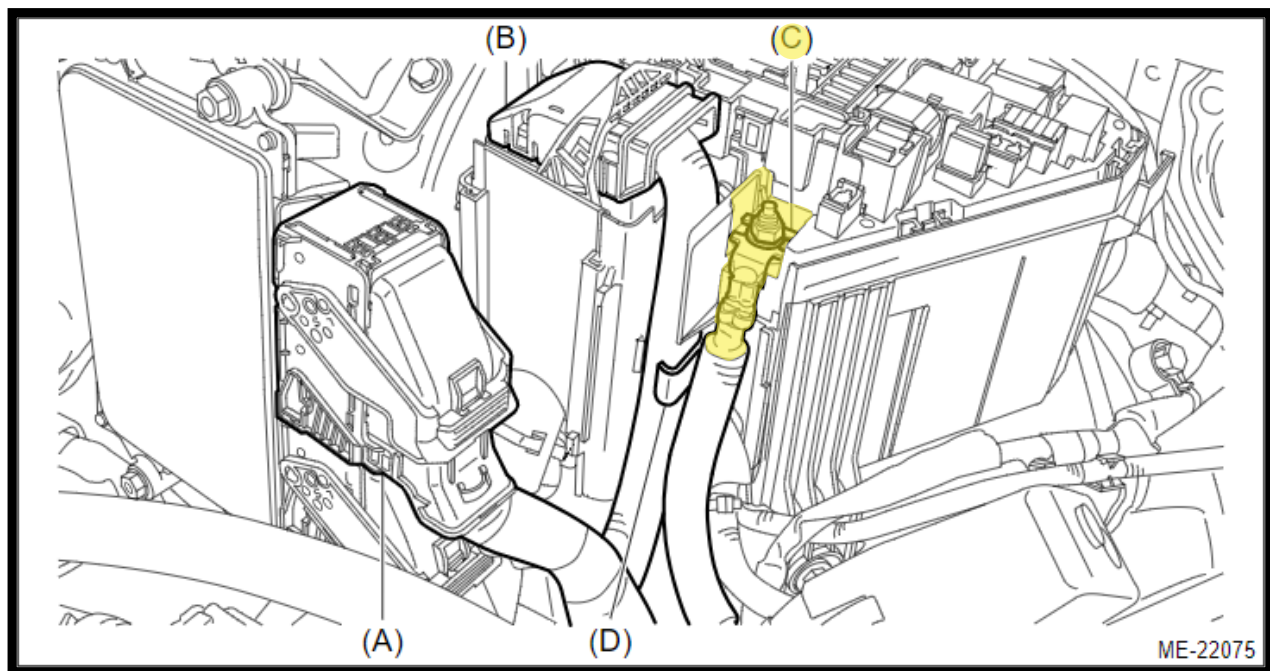
It is **CRITICAL** to confirm a secure connection of terminal (C) to the main fuse box. The terminal **MUST** be torqued to **7.5N·m (0.8kgf-m, 5.5ft-lb)**.
