# Service Update

## N222369401 Advanced Diagnostic Software (ADS) Improvements

**Release Date:** September 2022 **Revision:** 01  
**Revision Description:** This bulletin has been revised to include model years 2020 and 2021 for the Bolt EV. Please discard all previous copies of bulletin N222369401.

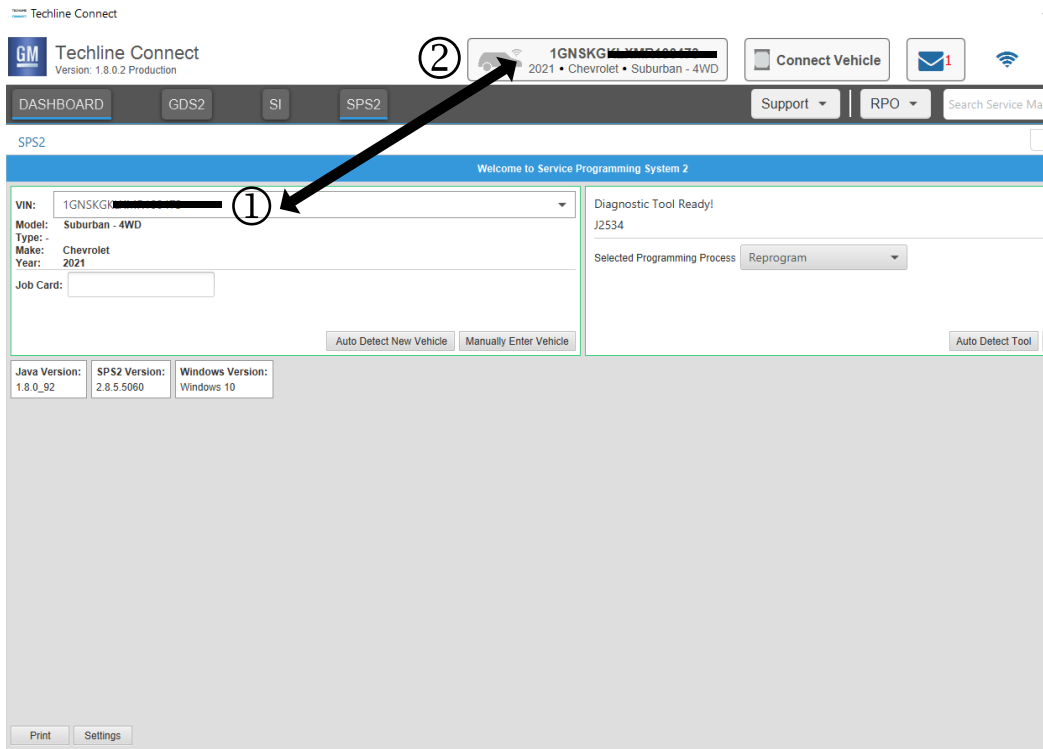
5743643

**Caution:** Be sure the VIN selected in the drop down menu (1) is the same as the vehicle connected (2) before beginning programming.

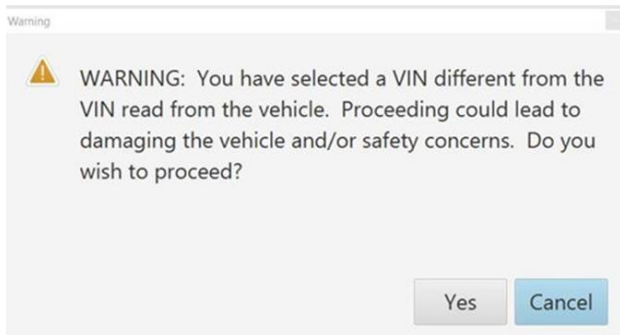
5877000

**Important:** If the vehicle VIN DOES NOT match, the message below will be shown.

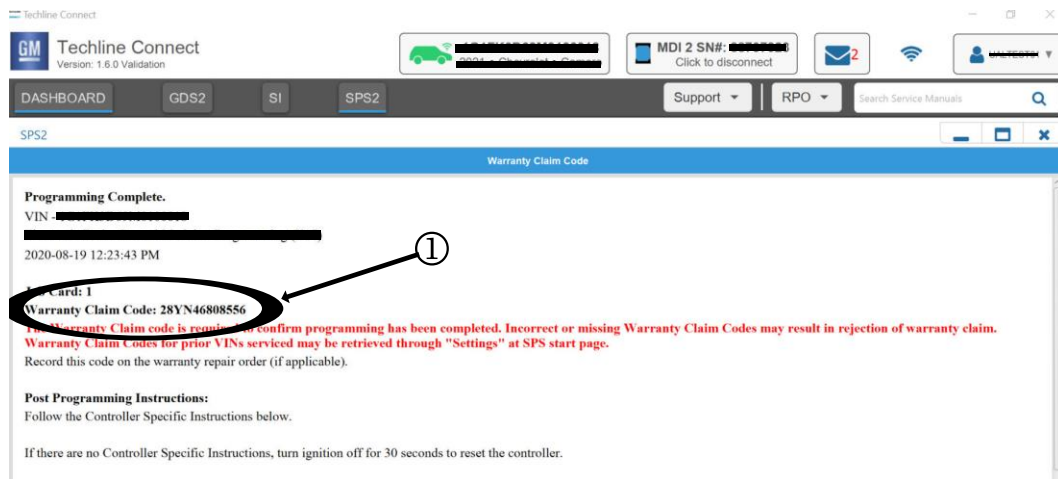
5644478

**Important:** To avoid warranty transaction rejections, you **MUST** record the warranty claim code provided on the Warranty Claim Code (WCC) screen shown above on the job card. Refer to callout 1 above for the location of the WCC on the screen.

2. Record SPS Warranty Claim Code on job card for warranty transaction submission.
