**SERVICE PROGRAM BULLETIN**

**APPLICABILITY:** 2022 MY WRX

**NUMBER:** WRA-22R

**SUBJECT:** WRX EyeSight® Reprogramming

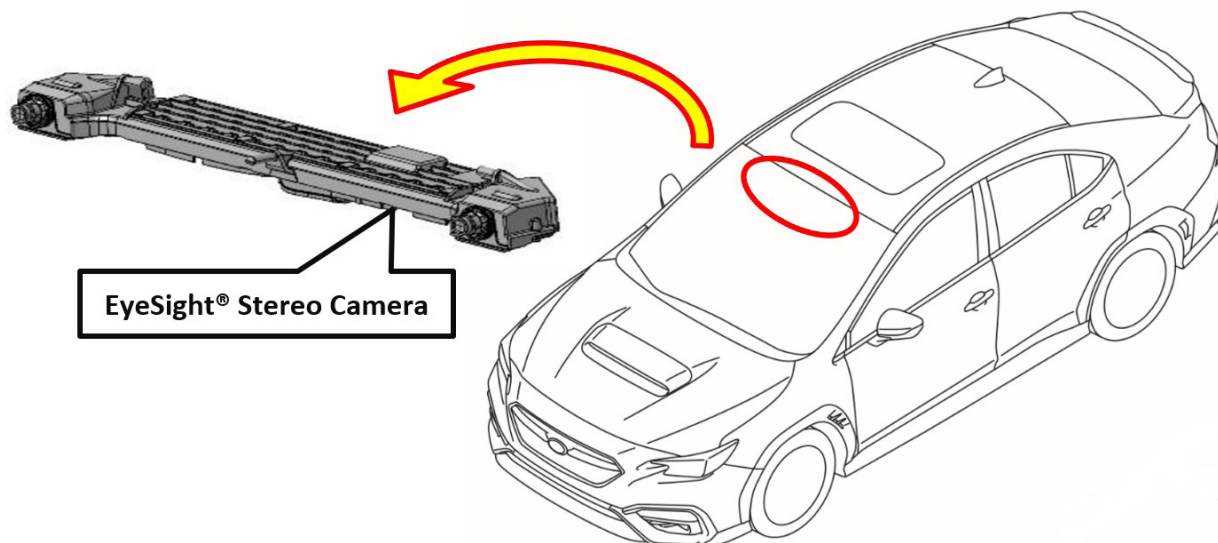
## **EyeSight® Stereo Camera Location:**

The EyeSight® software in the vehicles included in this service program may erroneously cause the EyeSight® functions to temporarily stop working under certain operating conditions. EyeSight® functionality will be unavailable for the remainder of the drive cycle, the EyeSight® warning light will illuminate, and diagnostic trouble code (DTC) B28A6 will be stored. Following the next ignition cycle, the EyeSight® function returns to normal.

Subaru retailers will check and, if necessary, update the EyeSight® software as described in this bulletin at no cost to the customer.

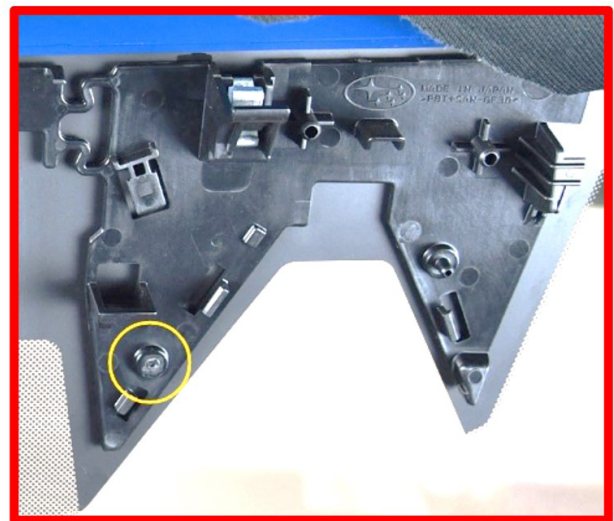
If EyeSight® stereo camera assembly removal is required, particular care must be taken while removing the cover in order to avoid damaging the camera bracket. If excessive force is applied to the camera cover during removal the camera cover may contact the lens hood alignment pins on the camera bracket, causing them to break. If this happens, the windshield will require replacement.

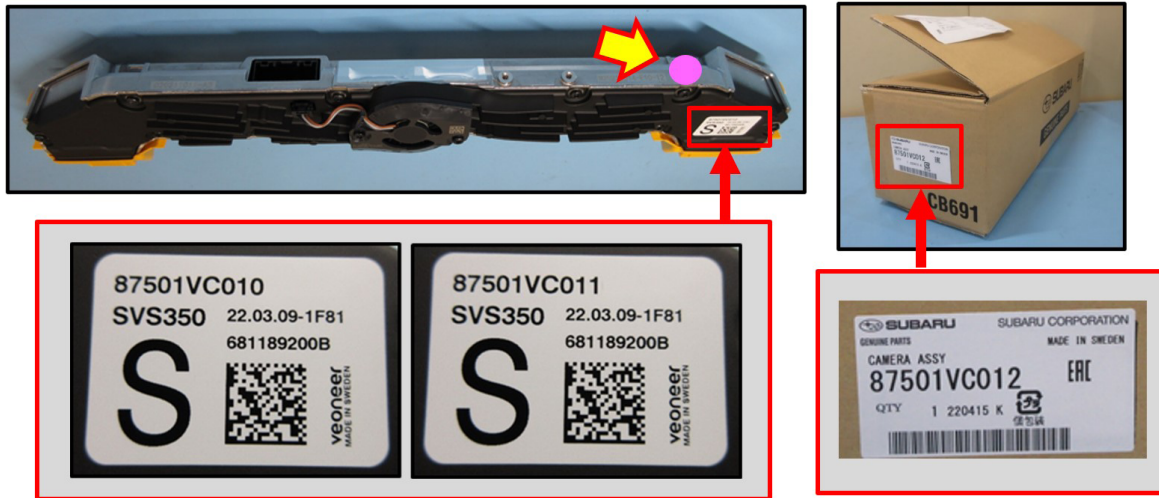
**IMPORTANT:** The part number labeled on the stereo camera assembly may be **87501VC010** or **87501VC011** even though the part number located on the outer box is **87501VC012**. If the part has a pink dot sticker as shown in the image below, this indicates that the software has been updated to the latest version and can be used in place of **87501VC012**.
