PRODUCT CAMPAIGN BULLETIN

APPLICABILITY: 2019-20MY Ascent
 2020-21MY Legacy 2.4L (turbo models)
 2020-21MY Outback 2.4L (turbo models)

NUMBER: WRK-21/22R
DATE: 07/05/22
REVISED: 09/30/22

SUBJECT: CVT Chain Guide Breakage

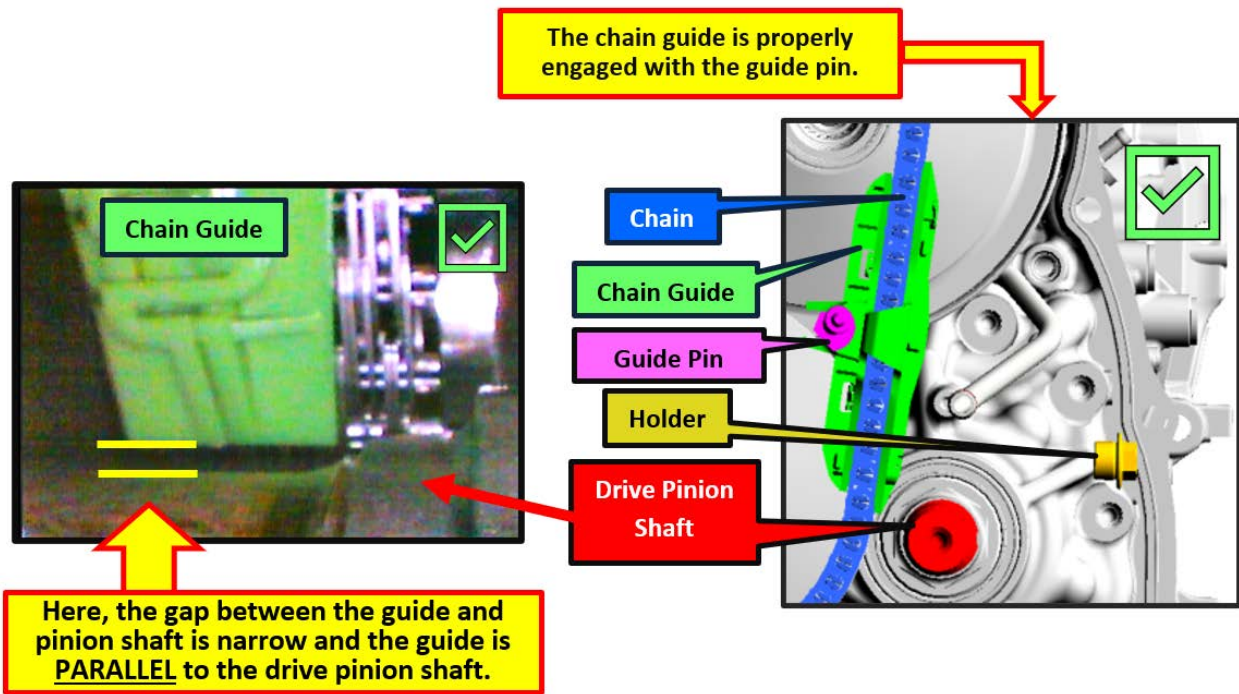
CORRECT GUIDE POSITIONING:

STEP 3E: Inspect the position of the lower end of the chain guide rail and the drive pinion shaft.

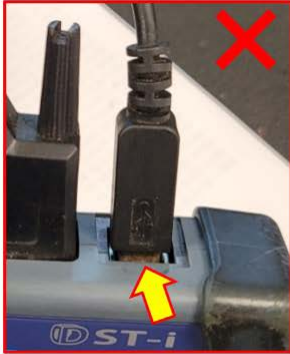
Corroded Connection

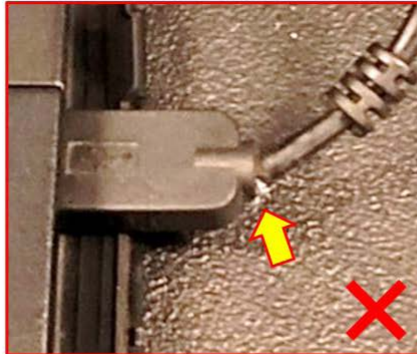
**Exposed Wiring &
Incorrect Cable**
