September 16, 2022

SUBJECT: **Harvest/Inspection Program 22H05**
 Certain 2021 Model Year 5 Door Bronco Vehicles
 Side Impact Sensor Retaining Stud and Nut Inspection

Harvest/Inspection Program 22H05
Certain 2021 Model Year 5 Door Bronco Vehicles
Side Impact Sensor Retaining Stud and Nut Inspection

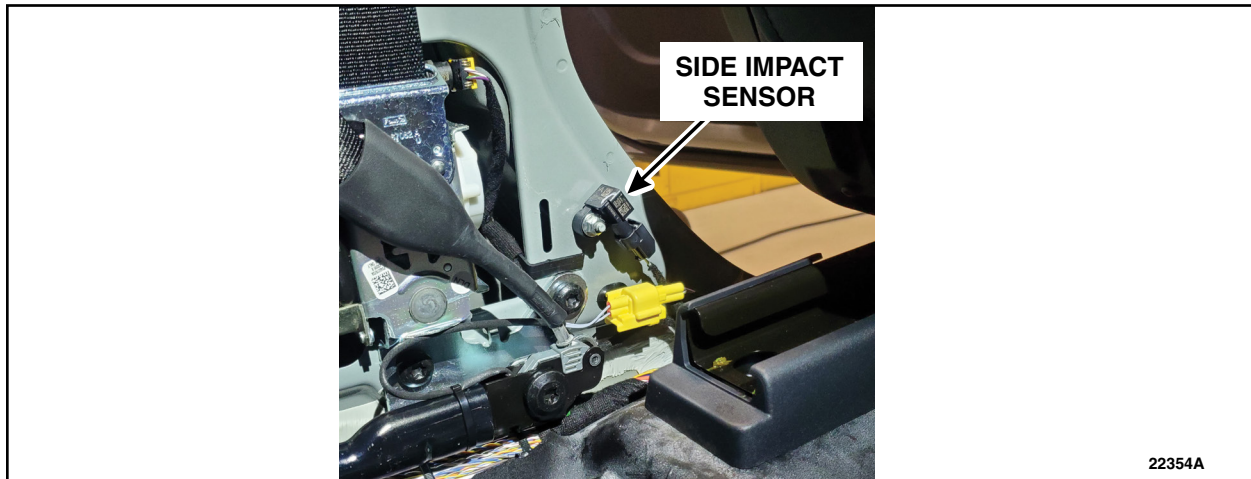
FIGURE 1

2. On both sides, locate and capture a clear photo of the side impact sensor. See Figure 1.

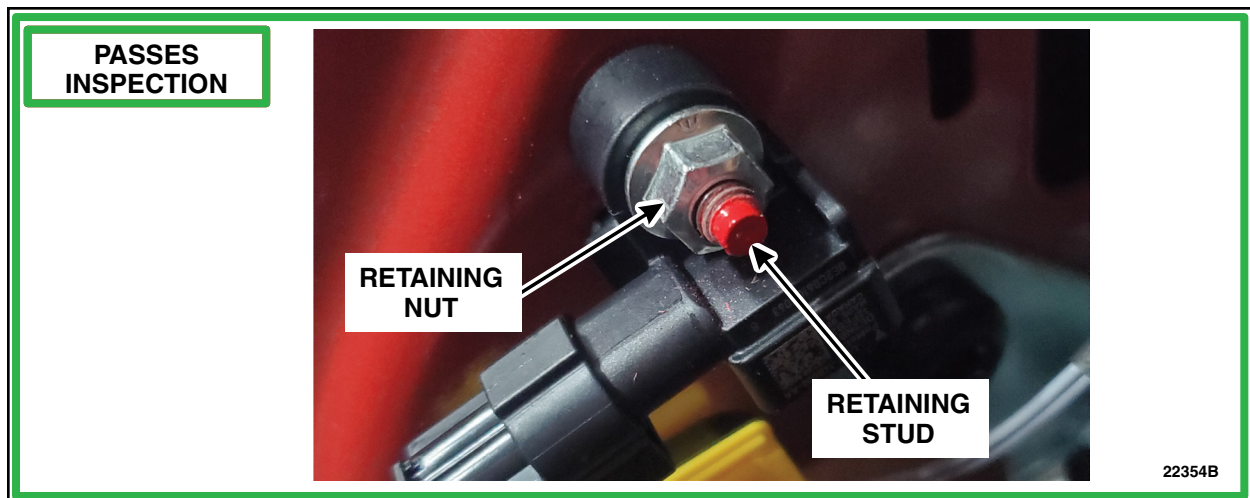
FIGURE 2

3. Inspect for the presence of the side impact sensor retaining stud and nut on both sides.
See Figures 2 and 3. Is the side impact sensor retaining stud and/or nut missing on either side?

- Nut ONLY Missing – Once verbal approval has been given by the SSSC, order a retaining nut (Part Number W520101-S437) through the normal part ordering process, refer to the dealer bulletin. Proceed to step 4.
- Nut AND Stud Missing – Once verbal approval has been given by the SSSC, order a retaining nut (Part Number W520101-S437) through the normal part ordering process, refer to the dealer bulletin. The SSSC will provide a new stud and stud installation instructions.
