N222383780 High Voltage Connector Fasteners Improperly Torqued

Release Date: October 2022 Revision: 00

Subject: N222383780 - Customer Satisfaction Program

Models: 2017-2019, 2022-2023 Chevrolet Bolt EV

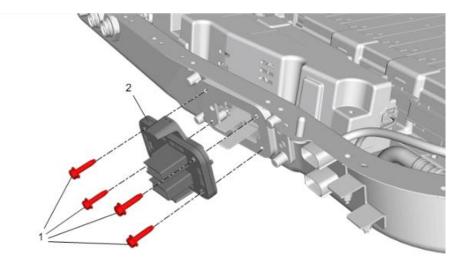
4504488

Condition	On certain 2017-2019, 2022-2023 Chevrolet Bolt EV, and 2022-2023 Bolt EUV vehicles may have a	
	condition in which fasteners used to secure an external connector to the high voltage battery pack may	
	not have been torqued to specification.	
Correction	Dealers will secure all suspect connections to the appropriate torque specification.

9. Tighten the 4 High Voltage Battery X3 Connector Black Bolts (1) to 9 Nm (80 lb in).
