Customer Satisfaction Program

N212354521 Heated Vented Seats Retrofit Due to Chip Shortage - Front Seats Only

Release Date: October 2022

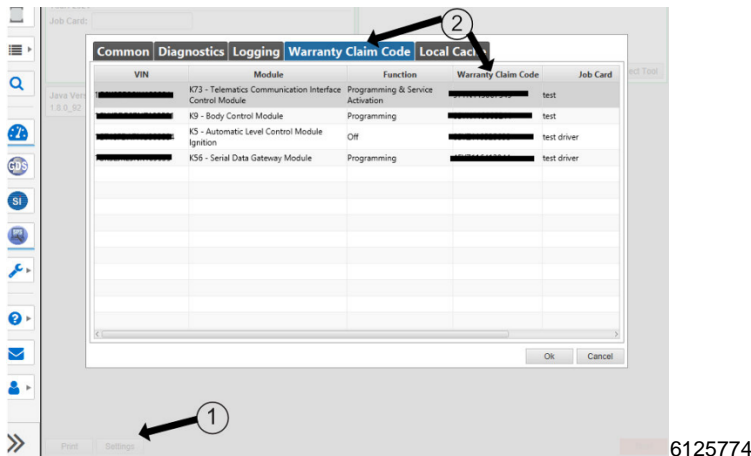
If the Warranty Claim Code was not recorded on the Job Card, the code can be retrieved in the SPS2 system as follows:

1. Open TLC on the computer used to program the vehicle.
2. Select and start SPS2.
3. Select Settings (1).
4. Select the Warranty Claim Code tab (2).

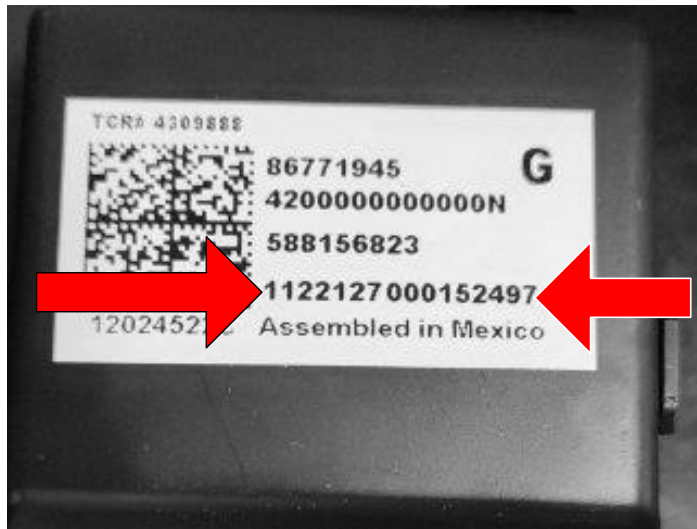
6098078

Record the serial number on the seat heater vent control module label.

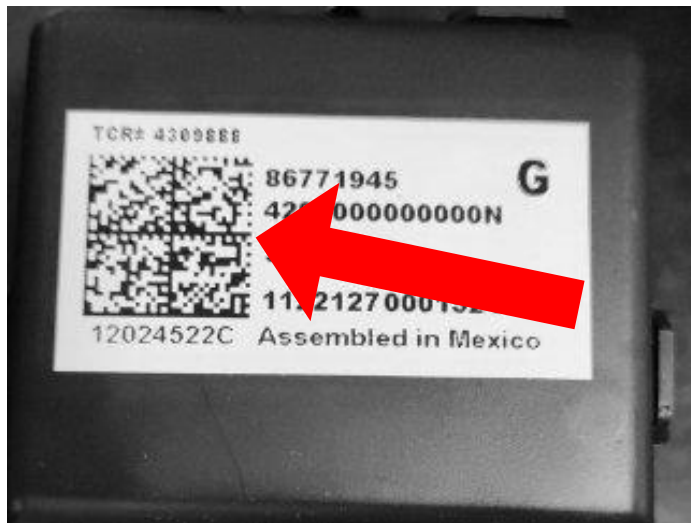
If the App is already loaded to your phone, simply:

1. Scan the VIN (door pillar QR code or windshield VIN barcode) and
2. Scan the new part (QR code) and
3. Check the information and if correct then, Submit.

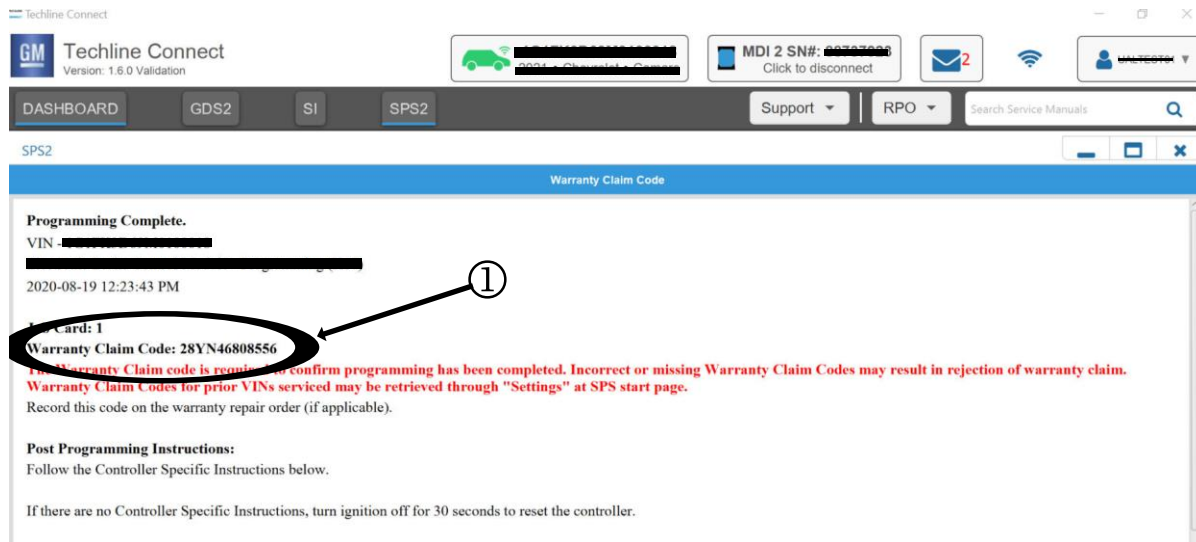
5644478

Note: The screenshot above is an example of module programming and may not be indicative of the specific module that is being programmed. Module selection and VIN information have been blacked out.

Important: To avoid warranty transaction rejections, you MUST record the warranty claim code provided on the Warranty Claim Code (WCC) screen shown above on the job card. Refer to callout 1 above for the location of the WCC on the screen.

7. Record SPS Warranty Claim Code on job card for warranty transaction submission.
