PRODUCT CAMPAIGN BULLETIN

APPLICABILITY: 2019-20MY Ascent
 2020-21MY Legacy 2.4L (turbo models)
 2020-21MY Outback 2.4L (turbo models)

NUMBER: WRK-21/22R
DATE: 07/05/22
REVISED: 10/31/22

SUBJECT: CVT Chain Guide Breakage

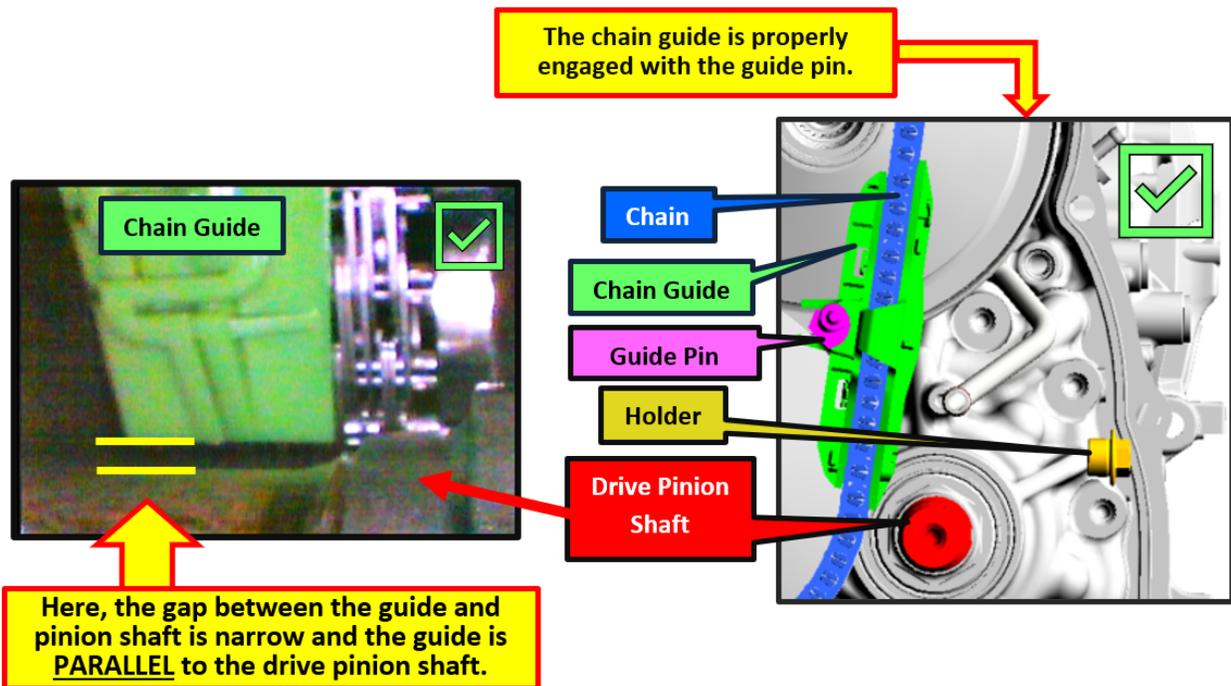
CORRECT GUIDE POSITIONING:

STEP 3E: Inspect the position of the lower end of the chain guide rail and the drive pinion shaft.

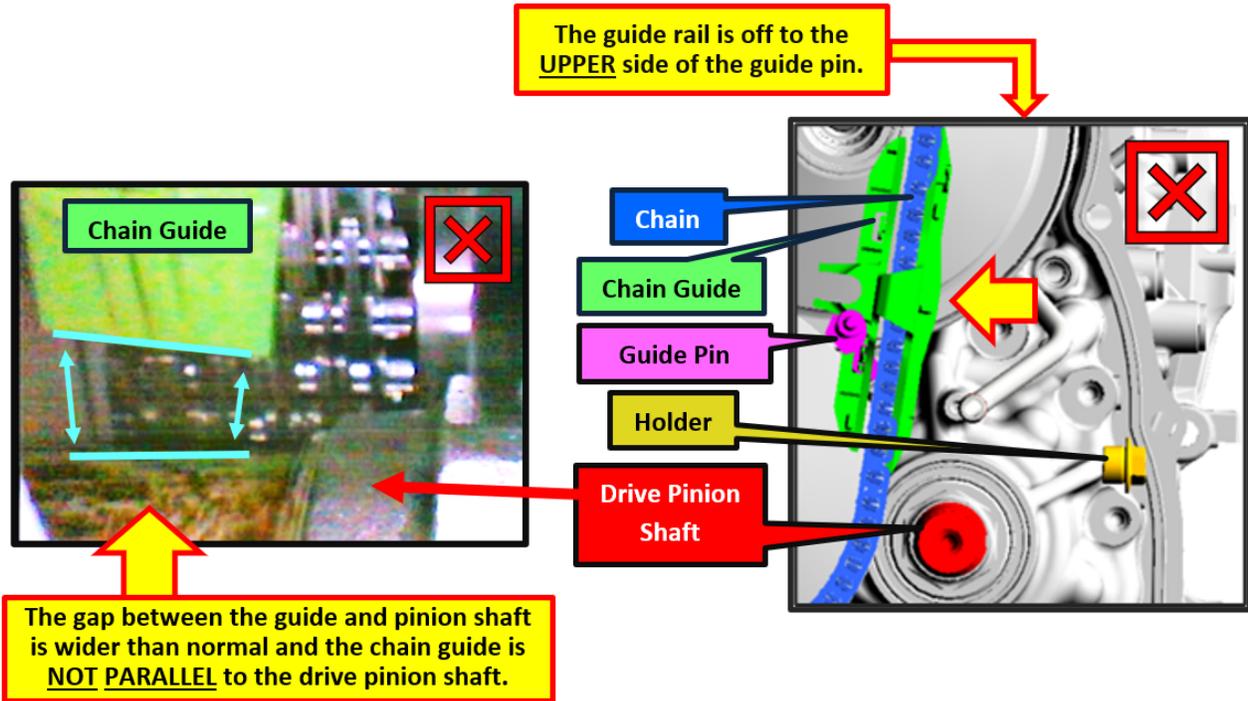
INCORRECT GUIDE POSITIONING 1:

Due to an improper program in the transmission control module (TCM), the CVT chain may slip, resulting in breakage of the chain guide. If the chain guide breaks, fragments of the guide could inhibit the shift select mechanism. If the vehicle continues operation with the drive chain slipping, over time the CVT drive chain could break.

STEP 4A: Replace the CVT assembly.

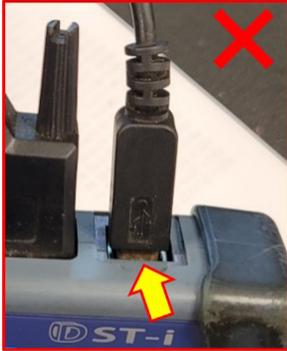
Confirm the PC being use for reprogramming is connected to a known good power source. Turn off any screen saver settings. Make sure the PC is not in power saving mode and is set to the normal power mode. Always inspect the DST-I/DST-010 and PC cables prior to programing. Confirm the cables are CORRECT and there is no exposed wiring, corroded connections, or loose fitment. See the example images below.
