**PRODUCT CAMPAIGN BULLETIN**

**APPLICABILITY:** 2019-2022MY Ascent

**NUMBER:** WRL-22R

**SUBJECT:** PTC Heater Ground Bolt

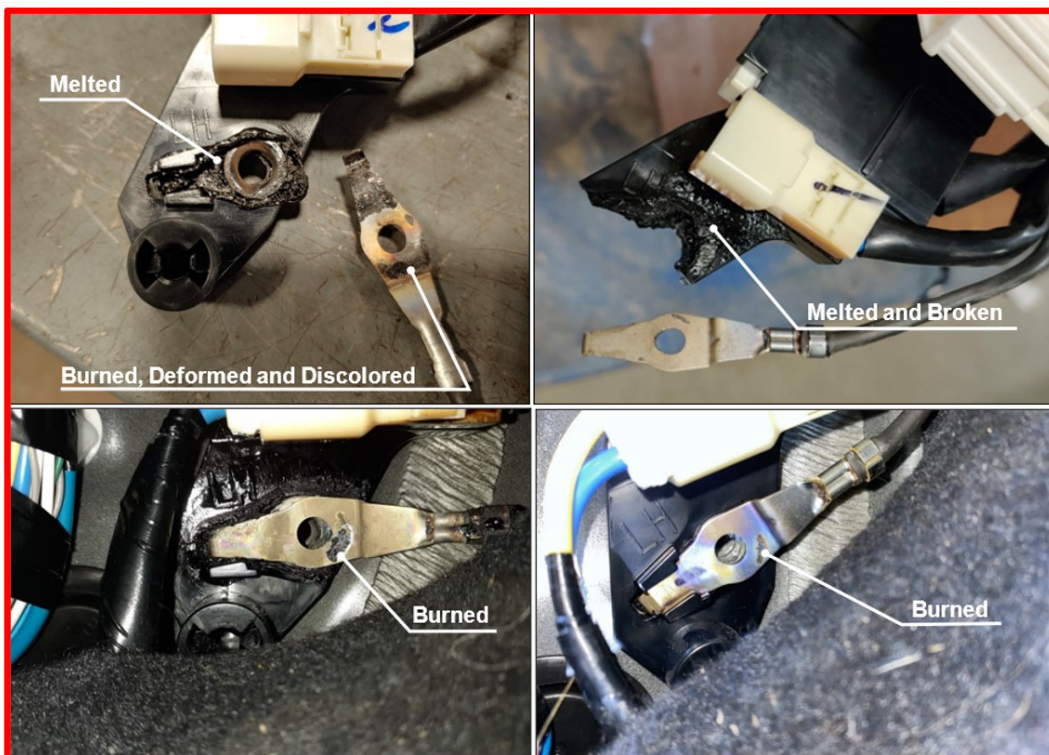
**STEP 11: CAREFULLY** inspect the PTC heater ground terminal and peripheral parts for any damage. See the example images of overheat damage below.

**IMPORTANT:** If any damage is found, a QMR will be required with detailed photos of the damage attached and the repair parts order information noted in the comments section.

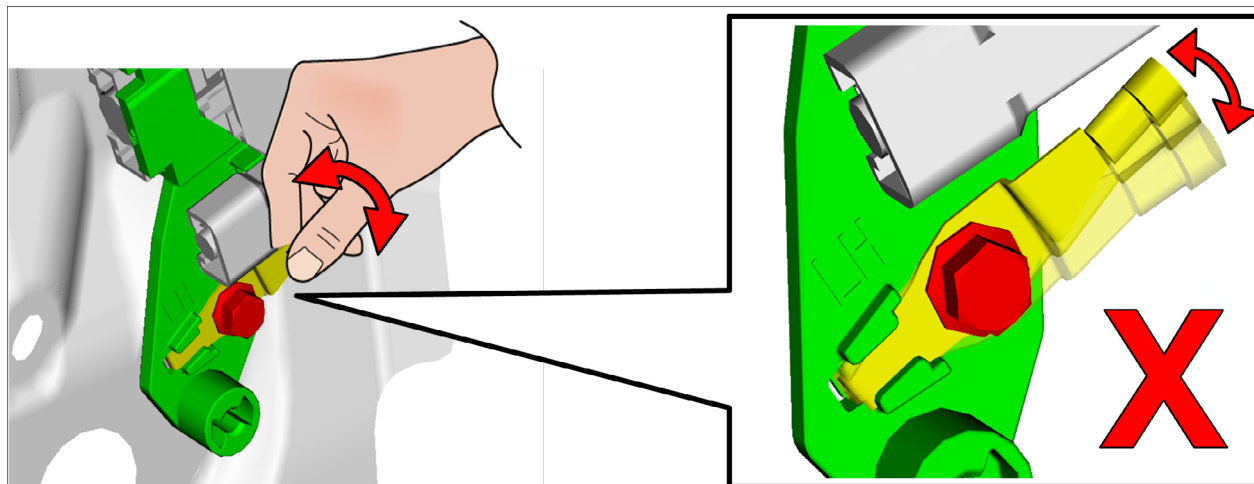
**CAUTION:** Any loose connection could cause a possible thermal event.

**STEP 26:** Confirm there is no movement with the ground terminal. Check for any loose contact by attempting to move the terminal with your fingers in an up/down direction. There is no need to pull the ground cable when checking for loose contact.
