SERVICE PROGRAM BULLETIN

APPLICABILITY: 2022MY Forester
2022MY WRX
2022-23MY BRZ

NUMBER: WRB-23

SUBJECT: Telematics Data Communications Module
Reprogramming

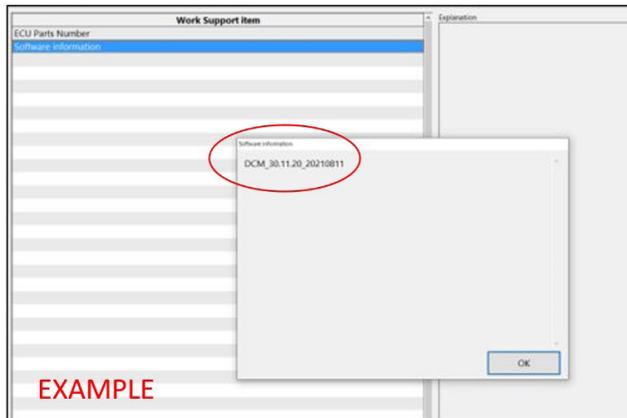
STEP 1: Connect the applicable Subaru Select Monitor (SSM) to the vehicle. Read the Subscription and Software Information of the DCM. Record this information for confirmation after reprogramming is performed.

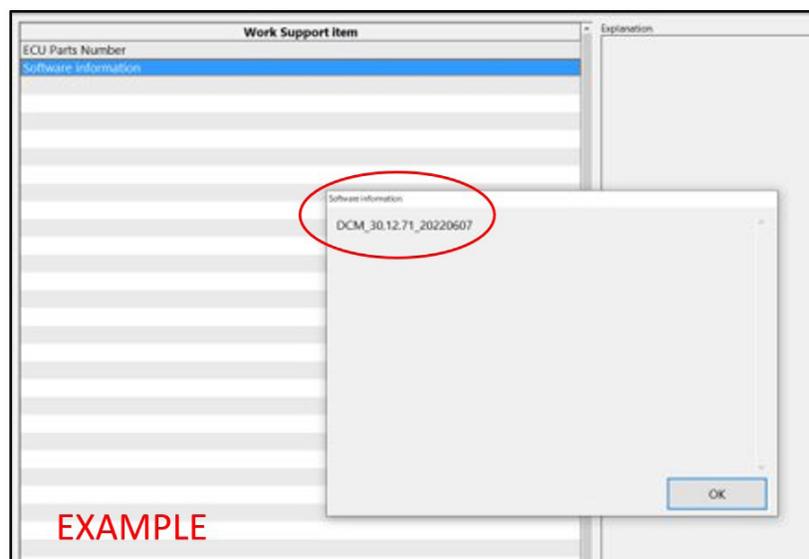
STEP 9: Using the applicable SSM, read the Software Information of the DCM.
