Important Information Regarding Service Program Bulletin WQC-39

FROM: Subaru of America, INC.

DATE: 11/14/2012

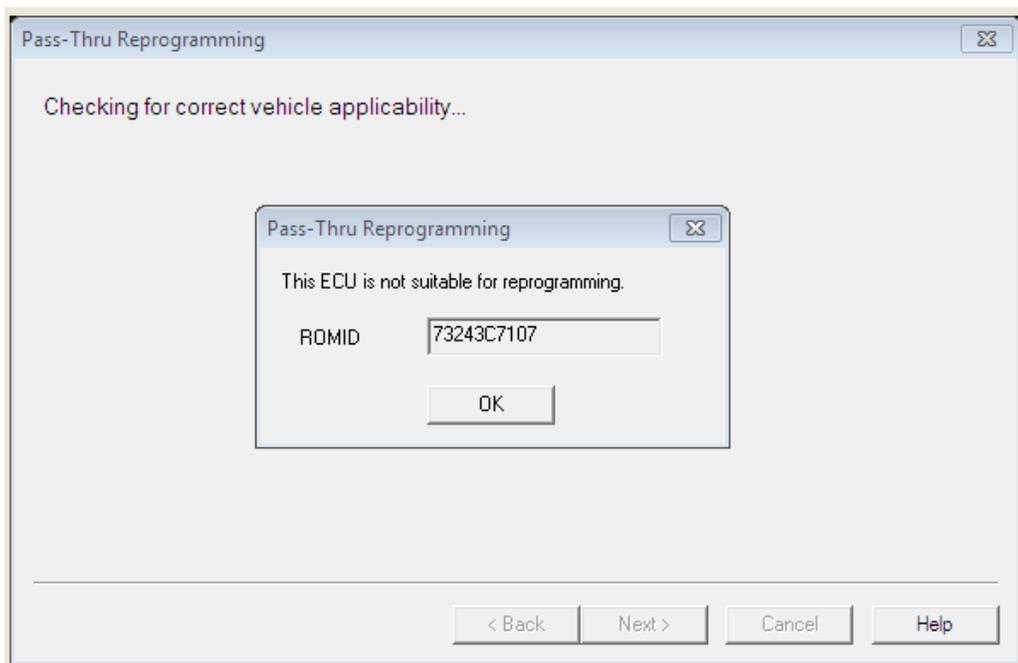
It has come to our attention some 2011 model year (MY) Legacy and Outback model vehicles affected by the WQC-39 Service Program may not require the ECM reprogramming update to correct the thermostat monitoring logic. As a result, there may be instances where a customer brings their vehicle into your Service Department for the WQC-39 ECM reprogramming procedure and it cannot be completed as indicated in the campaign bulletin. In those cases, when the Technician selects the appropriate file for reprogramming as listed in the Campaign Bulletin, the Select Monitor III returns a message stating the “ECU is not suitable for reprogramming” as shown in the illustration below.

If your Technician receives this “not suitable” message, we request the following steps be completed:

1. The Technician must confirm the Calibration Identification (CID) number of the ECM is included on the following “Ineligible” CID list below.
2. The Technician should then review the list to see if “Another Update” is available.
3. If “Another Update” is available, the Technician should install the ECM update and a **WARRANTY CLAIM** should be filed as indicated below. (The WQC-39 campaign should **NOT** be claimed in this case. It will be closed by SOA based upon your Warranty Claim submission.)
4. If there are no other updates for the vehicle as shown below, a **WARRANTY CLAIM** should be filed as indicated below. (The WQC-39 campaign should **NOT** be claimed in this case. It will be closed by SOA based upon your Warranty Claim submission.)
