PRODUCT CAMPAIGN BULLETIN

APPLICABILITY: 2019-20MY Ascent
 2020-21MY Legacy 2.4L (turbo models)
 2020-21MY Outback 2.4L (turbo models)

NUMBER: WRK-21/22R
DATE: 07/05/22
REVISED: 03/15/23

SUBJECT: CVT Chain Guide Breakage

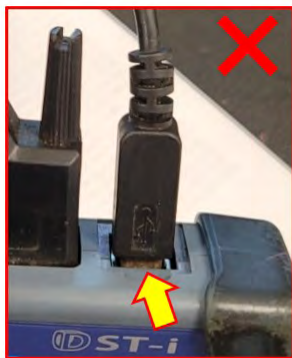
Corroded Connection

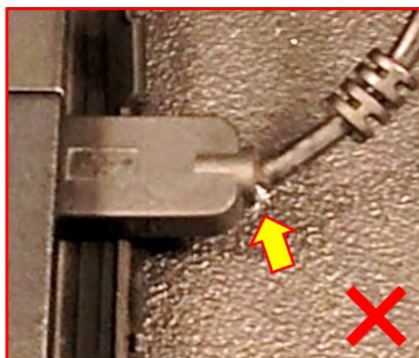
**Exposed Wiring &
Incorrect Cable**
