**PRODUCT CAMPAIGN BULLETIN**

**APPLICABILITY:** 2019-2022 Crosstrek Hybrid

**NUMBER:** WRD-23R

**SUBJECT:** 12V Inverter Connector Corrosion

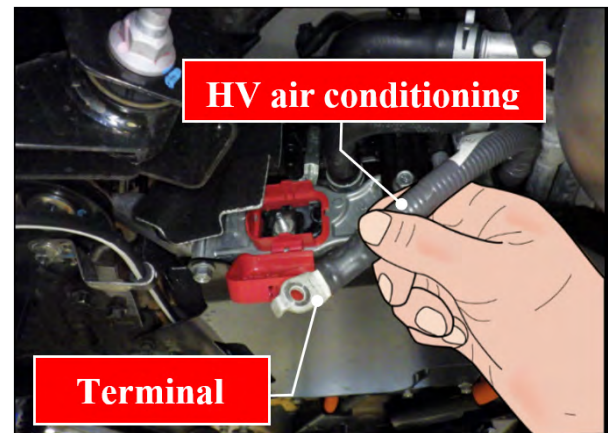
**STEP 9:** Perform a visual inspection of the High Voltage (HV) air conditioning wire terminal for corrosion and/or damage. See the example images below.

**NOTE:** White Deposits found on the terminal is considered acceptable.

Inspection Result		Next Step
<b>OK</b>	No Corrosion, Red Rust and/or Breakage found	Proceed to Service Procedure A
<b>NG</b>	Corrosion, Breakage, and/or Red Rust was found	Proceed to Service Procedure B

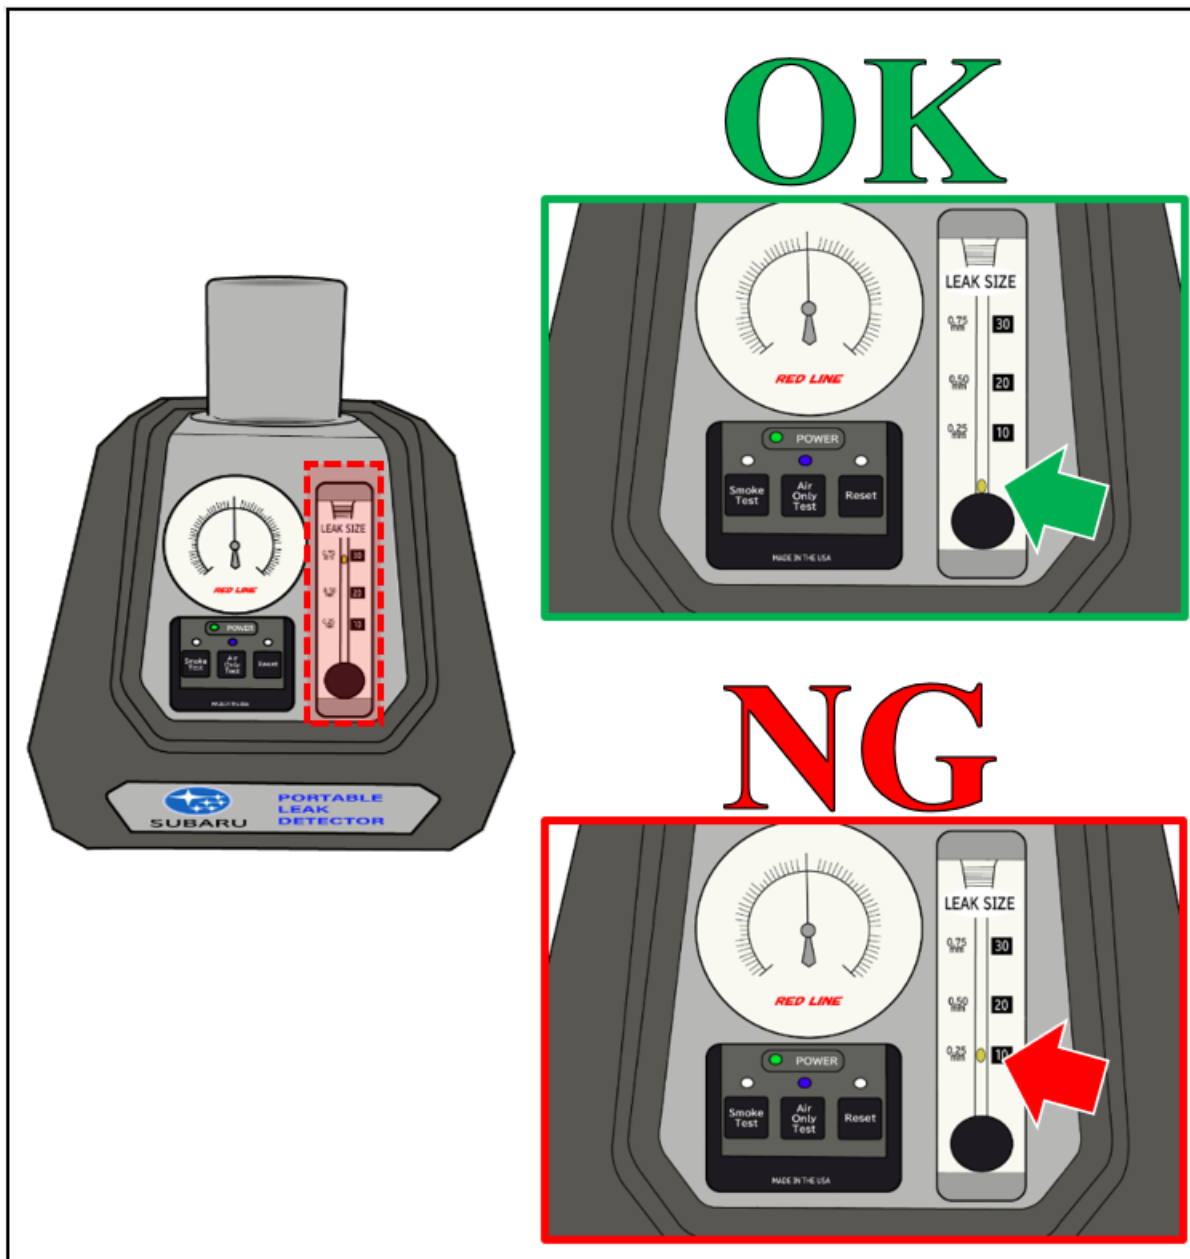
**STEP 45:** During the leakage test, confirm the float stays at the bottom.

**CAUTION:** If leakage is detected, check connection conditions, the testing equipment for damage and/or deformation of the inverter/converter lid then re-test. If no visible fault is found and leakage is still found, removed the inverter/converter lid, clean and reseal the lid then retest.
