PRODUCT CAMPAIGN BULLETIN

APPLICABILITY: 2023 Ascent

NUMBER: WRJ-23R

SUBJECT: Lower Control Arm Castle Nut / Improper Torque

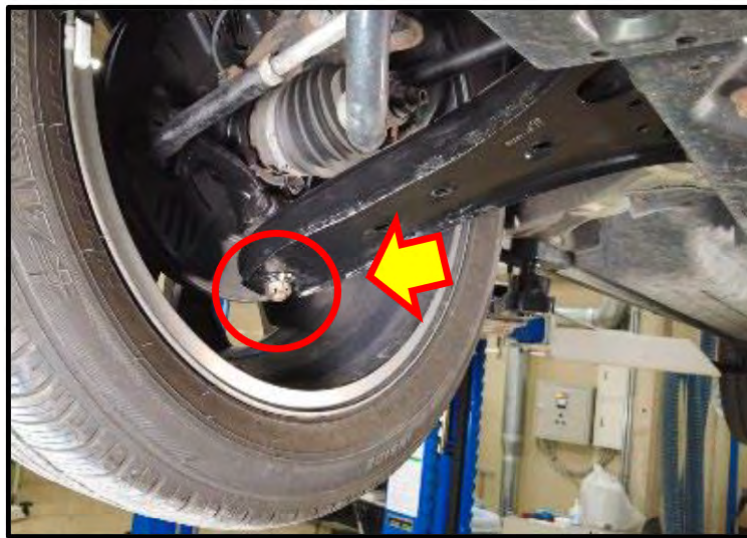
The affected vehicles may be equipped with either a left or right front lower control arm with an insufficiently tightened ball joint castle nut. Over time, the rotational movement of a loose castle nut could result in the sheering of the retention pin. Without a functional retention pin, the castle nut could eventually fall off completely, allowing the ball joint to separate from the lower control arm.

If the ball joint separates from the lower control arm while driving, the vehicle may experience a loss of control, increasing the risk of a crash.

Subaru dealers will inspect the five (5) affected vehicles and, if the castle nut is determined to be loose, replace the lower control arm assembly at no cost to the customer.

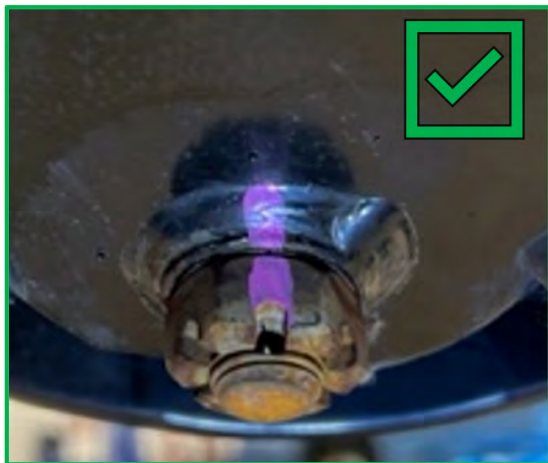
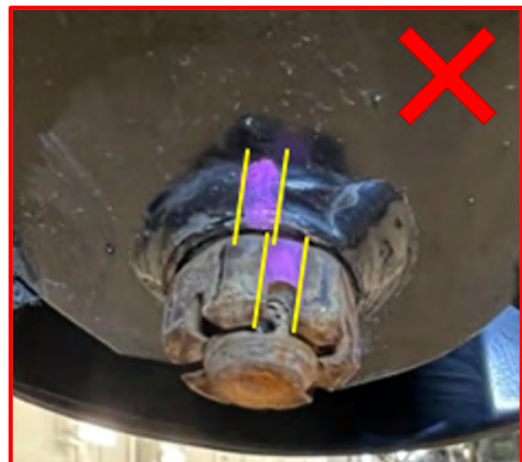
STEP 6: Perform a visual inspection of the markings made to the castle nut and lower control arm. If the markings indicate the castle nut has moved during the torque procedure, the lower control arm assembly will require replacement. If the markings indicate no movement, only the cotter pin will require replacement. See the images below.

NO: Replace the one-time use cotter pin. No further action is required.

STEP 7: Replace the affected front lower control arm assembly as per the applicable Service Manual. Refer to STIS [Suspension > FRONT SUSPENSION > Front Arm](#)
