SUBJECT: **Customer Satisfaction Program 22N19**
 Certain 2021 Model Year Expedition and Lincoln Navigator Vehicles
 Battery Junction Box One-Time Replacement

Customer Satisfaction Program 22N19
Certain 2021 Model Year Expedition and Lincoln Navigator Vehicles
Battery Junction Box One-Time Replacement

CERTAIN 2021 MODEL YEAR EXPEDITION AND LINCOLN NAVIGATOR VEHICLES — BATTERY JUNCTION BOX ONE-TIME REPAIR

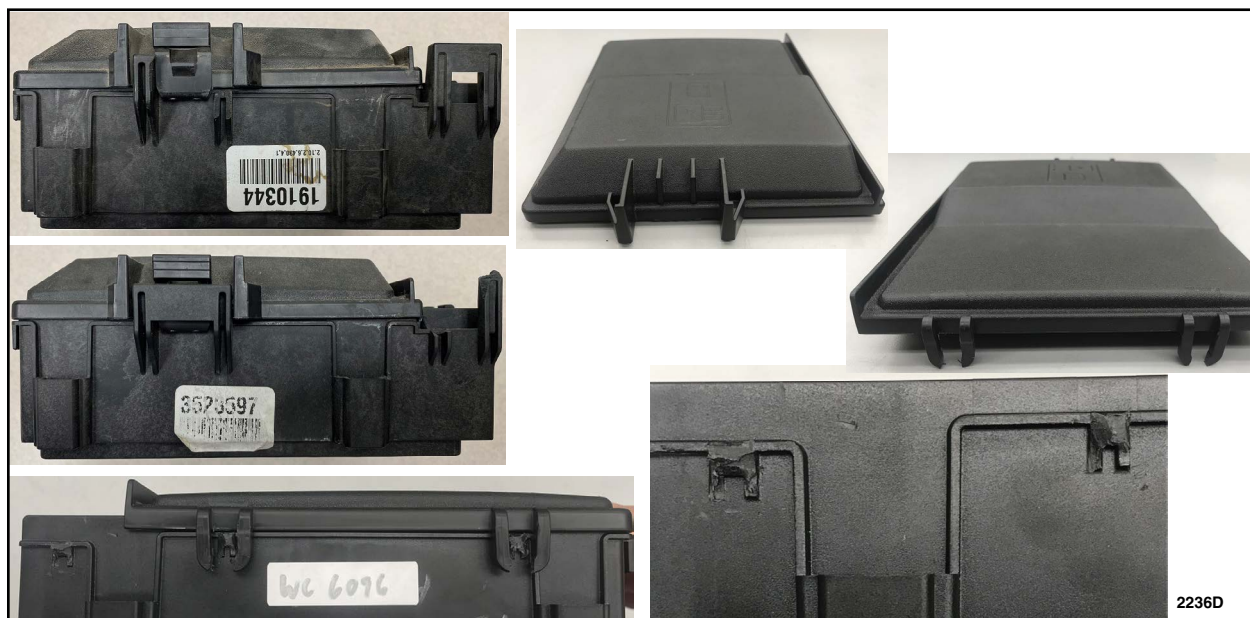
FIGURE 4

3. Check for any damage such as cracks, excessive warping, melting, broken hoop(s), and/or broken latch(es) on both covers. Is there any damage present on either cover? See Figure 4.

Yes - Replace damaged cover(s), proceed to Step 4.
