A total of 59,934 U.S. WRX STI vehicles will be affected by this recall, as listed below:

Model Year	Carline	Production Date Range
2015-2021	WRX STI	November 14, 2013 – October 21, 2021

**Subaru Safety Recall WRE-22  
NHTSA ID 22V-522  
September 2022**

Your vehicle may contain a defective back-up lamp switch, which may cause the back-up lamps to not illuminate, the rear-view camera (if equipped) to not display an image, and the select lever/gear position indicator in the combination meter to not display 'R' when driving in reverse.

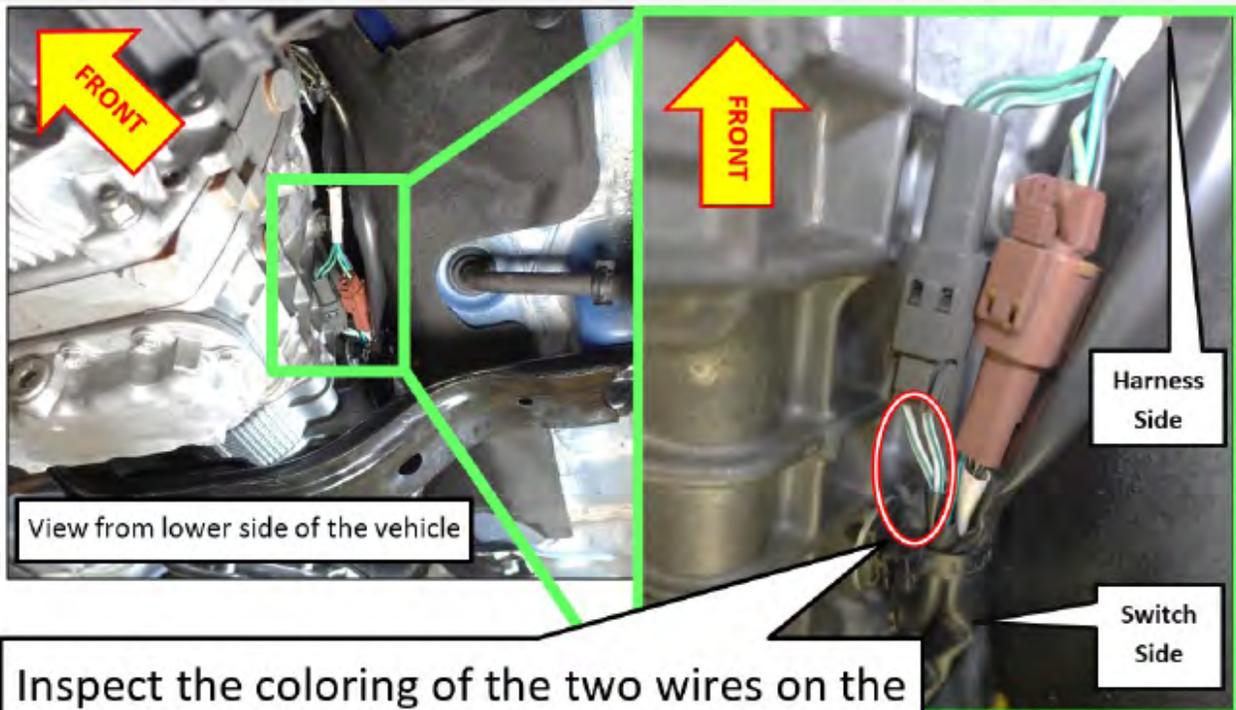
**STEP 4:** Perform a visual inspection of the wiring harness colors on the back-up lamp switch.

Inspect the coloring of the two wires on the switch side of the gray connector  
The black protection tube can be pulled back for inspection

**STEP 5:** Apply the visual inspection results from **STEP 4** to the table below to verify the next course of action.

Back-Up Lamp Switch Version	<b>OLD</b>	<b>NEW</b>
Back-Up Lamp Switch Replacement	<b>REQUIRED</b>	<b><u>NOT</u> REQUIRED</b>
Next Step	<b>Proceed to STEP 6</b>	No further action is required. Reinstall the removed parts in the reverse order of disassembly.
