PRODUCT CAMPAIGN BULLETIN

APPLICABILITY: 2021MY Crosstrek
 2022MY Forester
 2021-23MY Legacy
 2021-23MY Outback

NUMBER: WRQ-23R

SUBJECT: Safety Recall – Transmission Inhibitor Switch Replacement

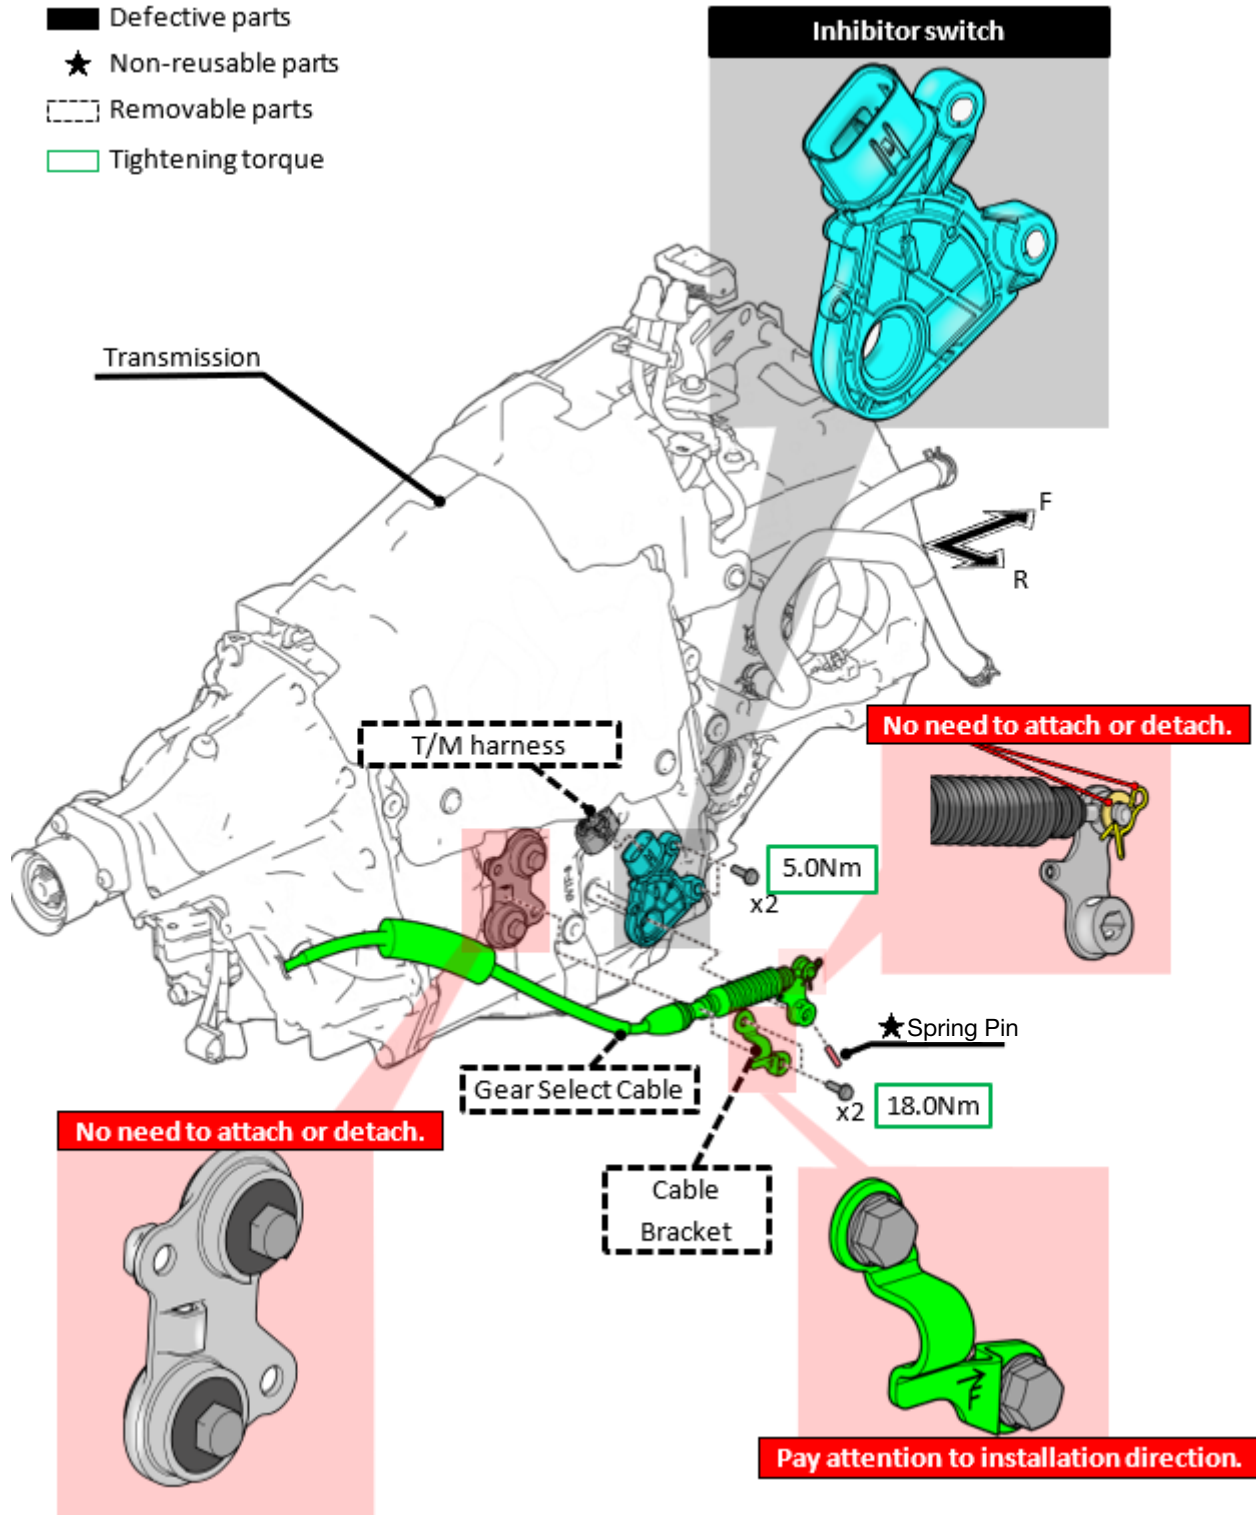
COMPONENT CONFIGURATION:

- Defective parts
- ★ Non-reusable parts
- ▭ Removable parts
- Tightening torque

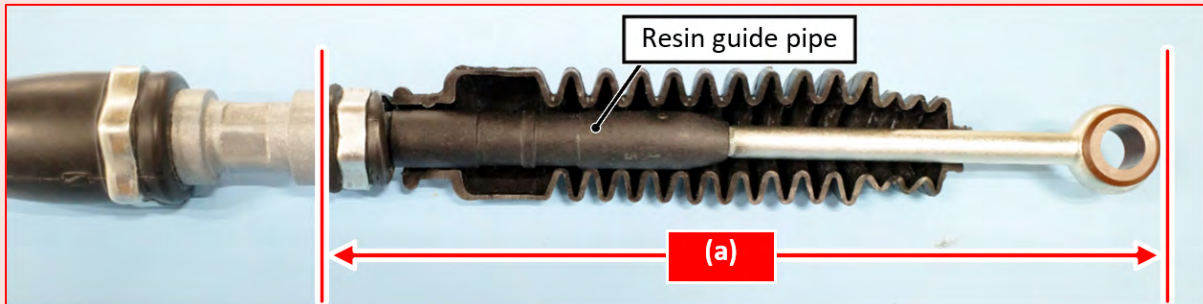
DO NOT apply an impact or a load to part (a) of the gear selector cable shown in the picture below. Doing so may damage the resin guide pipe inside the boot.

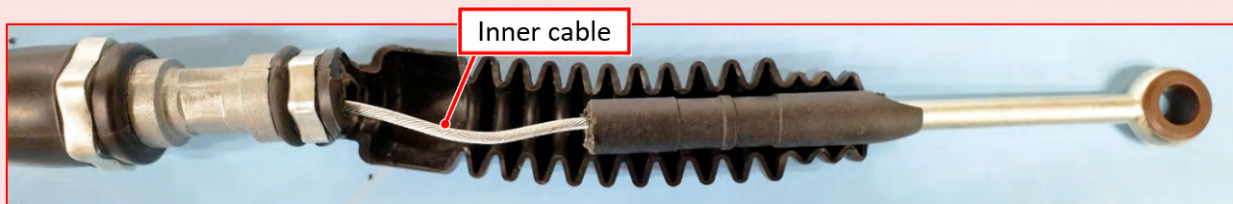
If the resin guide pipe is damaged, the inner cable can become slackened when operating the gear selector lever and the shifter arm become inoperative. As a result, the shift positions of the gear selector lever and the inhibitor switch do not match, causing malfunctions such as an engine no crank/no start condition.

Due to the resin guide pipe and the inner cable being unable to be seen, **CAREFULLY** remove and install the gear selector cable.

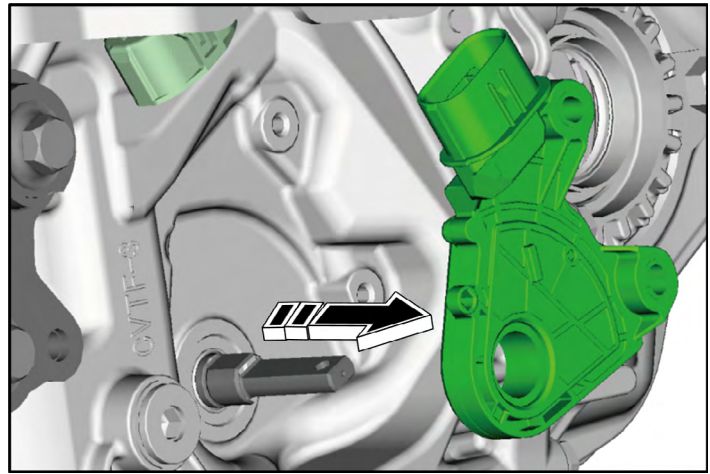
The vehicles included in this recall may contain an inhibitor switch that was manufactured with an insufficient weld between the switch stator and cover which may allow water intrusion.

Over time, moisture intrusion may cause the inhibitor switch to become inoperative. An inoperative inhibitor switch may result in the backup lamps not illuminating when in reverse gear, the rear-view monitor not displaying, the transmission gear select indicator in the instrument panel not being displayed, or inability to start the engine.

STEP 16: Remove and discard the original inhibitor switch.

TIP: The inhibitor switch may be difficult to separate from the shaft. Slightly rocking the switch back and forth can help make removal easier if this occurs.

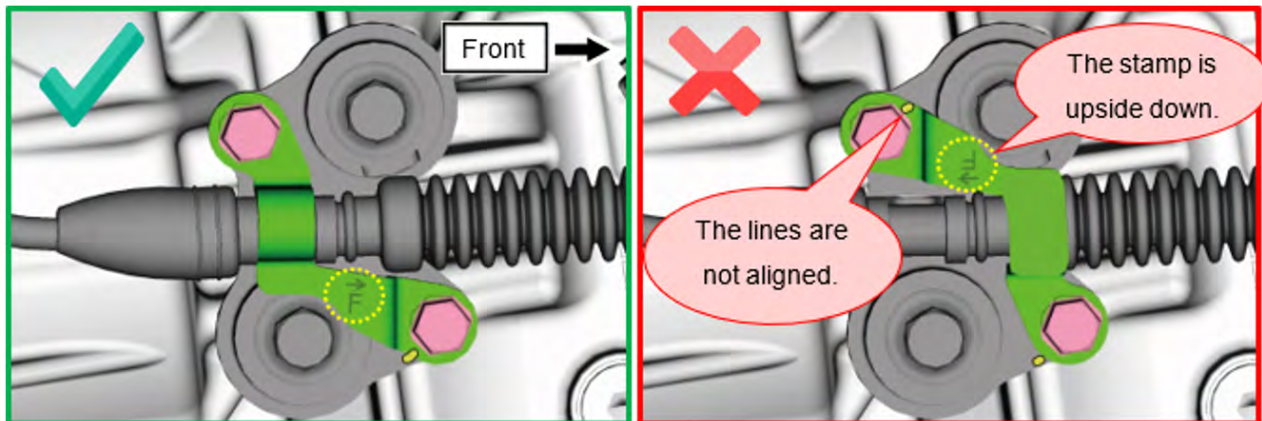
CAUTION: DO NOT install the cable bracket in the opposite position. Doing so will damage the gear selector cable.
