RE: [Service Campaign 2020070012 Launch Notification MY20 213 \(E-Class\) Check Front Right Inner Door](#)

# Service Campaign Bulletin

Campaign No. 2020070012, August 2020

**Check Front Right Inner Door**

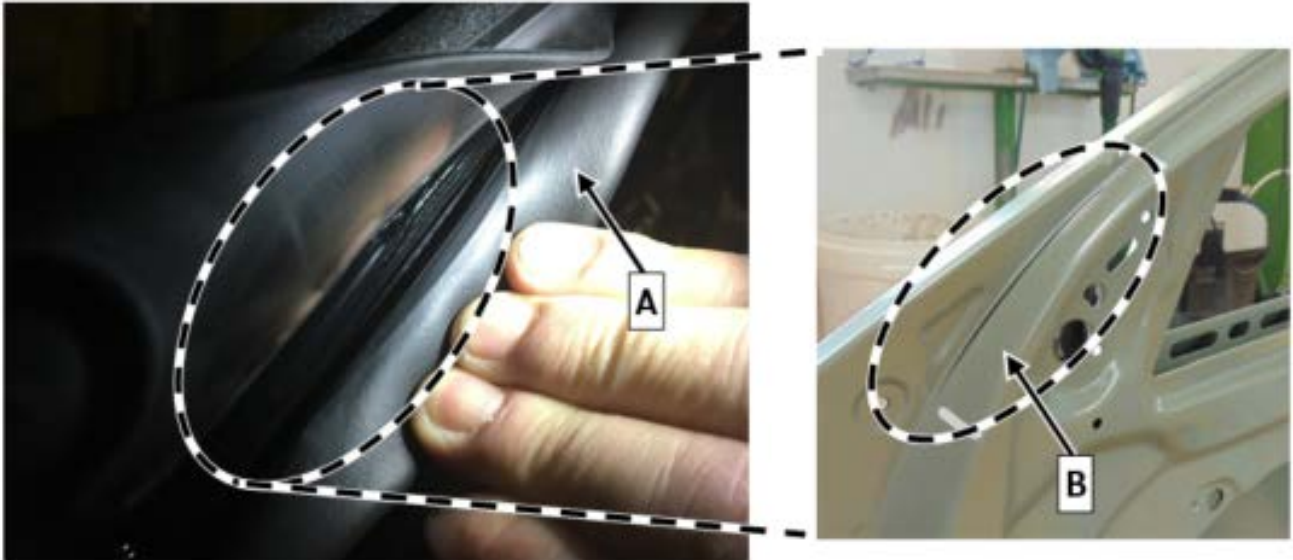
Figure 1 (Crack present)

1. Open right front door.
2. Gradually pull door frame seal (**A, figure 1**) in area of outside mirror to the side and check inner door panel (**B, figure 1**) for crack formation.

- a. Crack present (**figure 1**): Perform **work procedure**.
- b. Crack **not** present (**figure 2**): **End measure**.

1. Remove door trim at front door (AR72.10-P-1000LW).
2. Remove outside mirror (AR88.70-P-9000LW).
3. Remove seal of crank window (C, figure 3) in crack area from window frame.

4. Remove door frame seal (AR72.10-P-2120LW).
5. Drill ends of crack with a 3mm drill bit and deburr with a countersink.

**i** Drilling the ends of the crack prevents the crack from propagating/growing.
6. Apply anti-corrosion protection using primer stick in area of boreholes and on crack.

**i** Observe the flash-off time according to the manufacturer's specifications.
7. Cover crack and boreholes with seam seal.

**i** Observe the flash-off time according to the manufacturer's specifications.
8. Paint the affected location in the spot-repair process.
9. Assemble in reverse order.

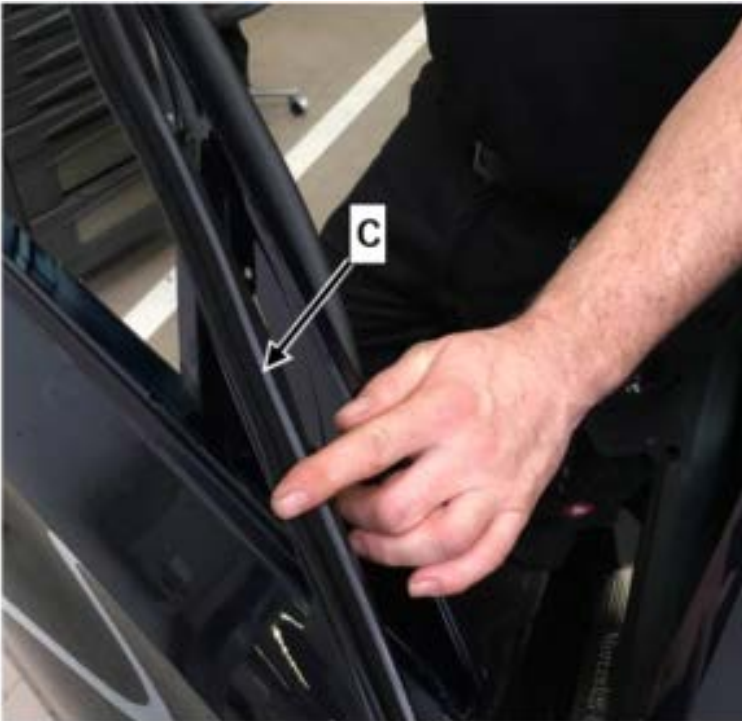
**Figure 3**

**i** **Seal of crank window** in area of outside mirror and in area of B-pillar cover at window frame **does not** have to be removed!

**i** **B-pillar cover at window frame does not** have to be removed.
