RE: **Service Campaign 2021030009 Launch Notification**  
**Check Side Wall Seam Seal on Inner Wheel Arches**  
**MY20 247 (GLB-Class)**

Campaign No. 2021030009, April 2021

SUBJECT: **Model GLB-Class (247 platform)**  
**Model Year 2020**

## **Check Side Wall Seam Seal on Inner Wheel Arches**

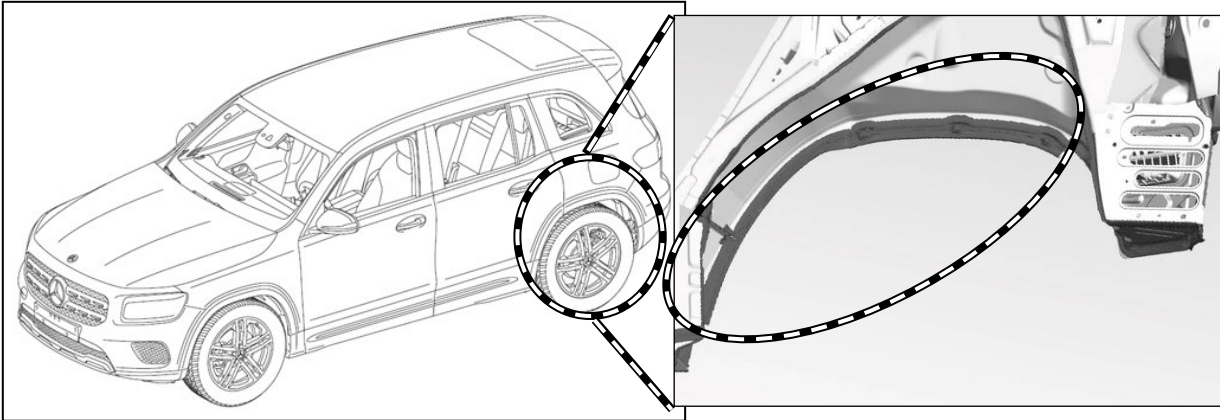
**Figure 1**

Mercedes-Benz AG ("MBAG"), the manufacturer of Mercedes-Benz, has determined that on certain MY 2020 GLB-Class (247) vehicles, the side wall seam seal in the left and right rear inner wheel arches does not correspond to our specifications. In this case, it is possible that water could enter into the area of the rear wheel arches. No safety relevance was determined. An authorized Mercedes-Benz dealer will check the side wall seam seal on inner wheel arches and correct, if necessary.

1. Remove right and left rear wheel arch liners.  
 For basic data, see **AR88.10-P-1302MFA**.
2. Use a mirror to check the left and right inner wheel arches for an incomplete seam seal (**Figure 1**).  
 There must be no defect on the seam seal.

- a. Side wall **seam seal** in inner wheel arch **not OK**: Carry out **work procedure**.
- b. Side wall **seam seal** in inner wheel arch **OK**: **End measure**.

1. Clean/prime the affected area of the seam seal.
  2. Rework the affected area of the seam seal with transparent seam seal.
  3. Assemble in reverse order.
-
