TO: Mercedes-Benz Dealer Principals, General Managers, Sales Managers, Service Managers, Parts Managers	FROM: Gregory Gunther, Department Manager, Vehicle Compliance and Analysis, Engineering Services
RE: Service Campaign Launch Notification Retrofit Damping on Front Axle and Replace Engine Lining MY22 EQS-Class (297 platform)	DATE: May 27, 2022

Campaign No. 2022050012, May 2022

SUBJECT: **Model EQS-Class (297 platform)**
Model Year 2022

Retrofit Damping on Front Axle and Replace Engine Lining

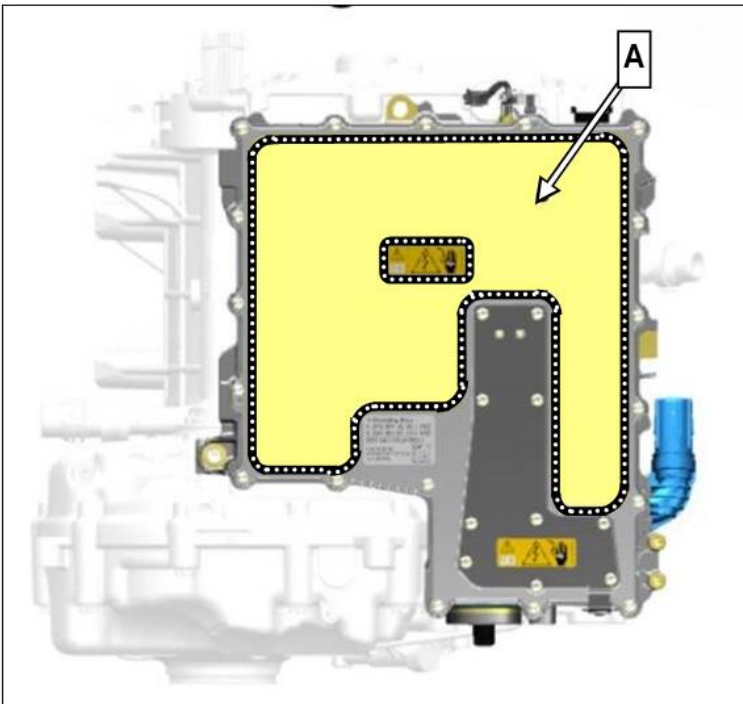
Figure 1

Mercedes-Benz AG ("MBAG"), the manufacturer of Mercedes-Benz, has determined that on certain MY 2022 EQS-Class (297 platform) vehicles, the damping on the front axle and rear engine compartment lining do not correspond to current specifications. Thus, it is possible the electronic drivetrain transmission may result in noise in the cabin.

For basic data, see AR61.20-P-1105EQS.
3. Retrofit damping (**A, Figure 1**) in area of power electronics control unit (N147/4) on front axle drive module.

Before installing the damping, the surface of the power electronics on the front axle drive module must be cleaned.
4. Replace rear engine compartment cover (**B, Figure 2**).
