TO: Mercedes-Benz Dealer Principals, General Managers, Sales Managers, Service Managers, Parts Managers	FROM: Gregory Gunther, Department Manager, Vehicle Compliance and Analysis, Engineering Services
RE: <b>Service Campaign Launch Notification</b> <b>Replace Transmission Bearing Cover</b> <b>MY20-21 GLA-Class and GLB-Class (156/247 platform)</b>	DATE: December 9, 2022

Campaign No. 2022110007, December 2022

SUBJECT: **Model GLA-Class and GLB-Class (156/247 platform)**  
**Model Year 2020-2021**

## **Replace Transmission Bearing Cover**

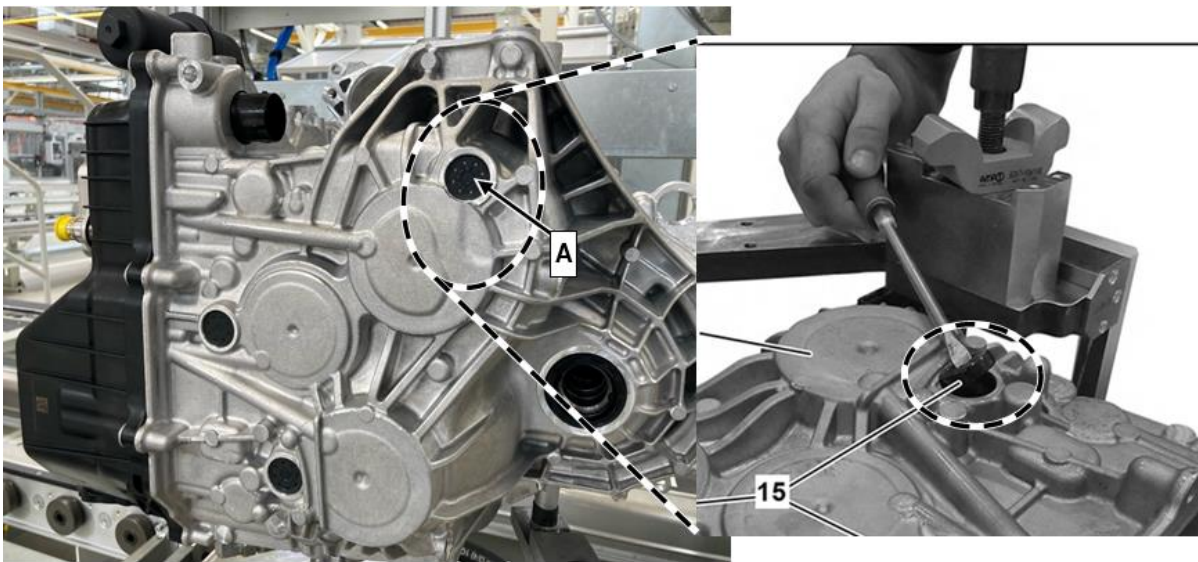
Figure 1

Mercedes-Benz AG ("MBAG"), the manufacturer of Mercedes-Benz vehicles, has determined that on certain MY 2020-2021 GLA-Class and GLB-Class (156/247 platform) vehicles, the transmission bearing cap cover does not correspond to current specifications. Over time, the transmission bearing cover may loosen, which may result in minor oil loss. An instrument cluster transmission light will still alert the user if it falls below the threshold and alert the driver if the transmission oil overheated. The indicator light will alert the driver to drive with caution. A risk of fire can be ruled out. An authorized Mercedes-Benz dealer will replace the transmission bearing cover.

1. Remove engine with transmission.
  - i** For basic data, see AR01.10-P-2401\*.
  - i** \* Select the WIS document according to the vehicle model.
2. Remove bearing cap (A, Figure 1) from transmission using a suitable tool.
  - i** The bearing cap will be replaced by a **new aluminum bearing cap**.

3. Insert new aluminum bearing cap up to end stop and hammer in slightly.
  4. Assemble in reverse order.
-
