TO: Mercedes-Benz Dealer Principals, General Managers, Sales Managers, Service Managers, Parts Managers	FROM: Gregory Gunther, Department Manager, Vehicle Compliance and Analysis, Engineering Services
RE: Service Campaign Launch Notification Inspect Lower A-Pillar in Wheel Arch MY22 GLA (247 platform)	DATE: March 24, 2023

Campaign No. 2023030001, March 2023

SUBJECT: **Model GLA (247 platform)**
Model Year 2022

Check Lower A-Pillar in Wheel Arch

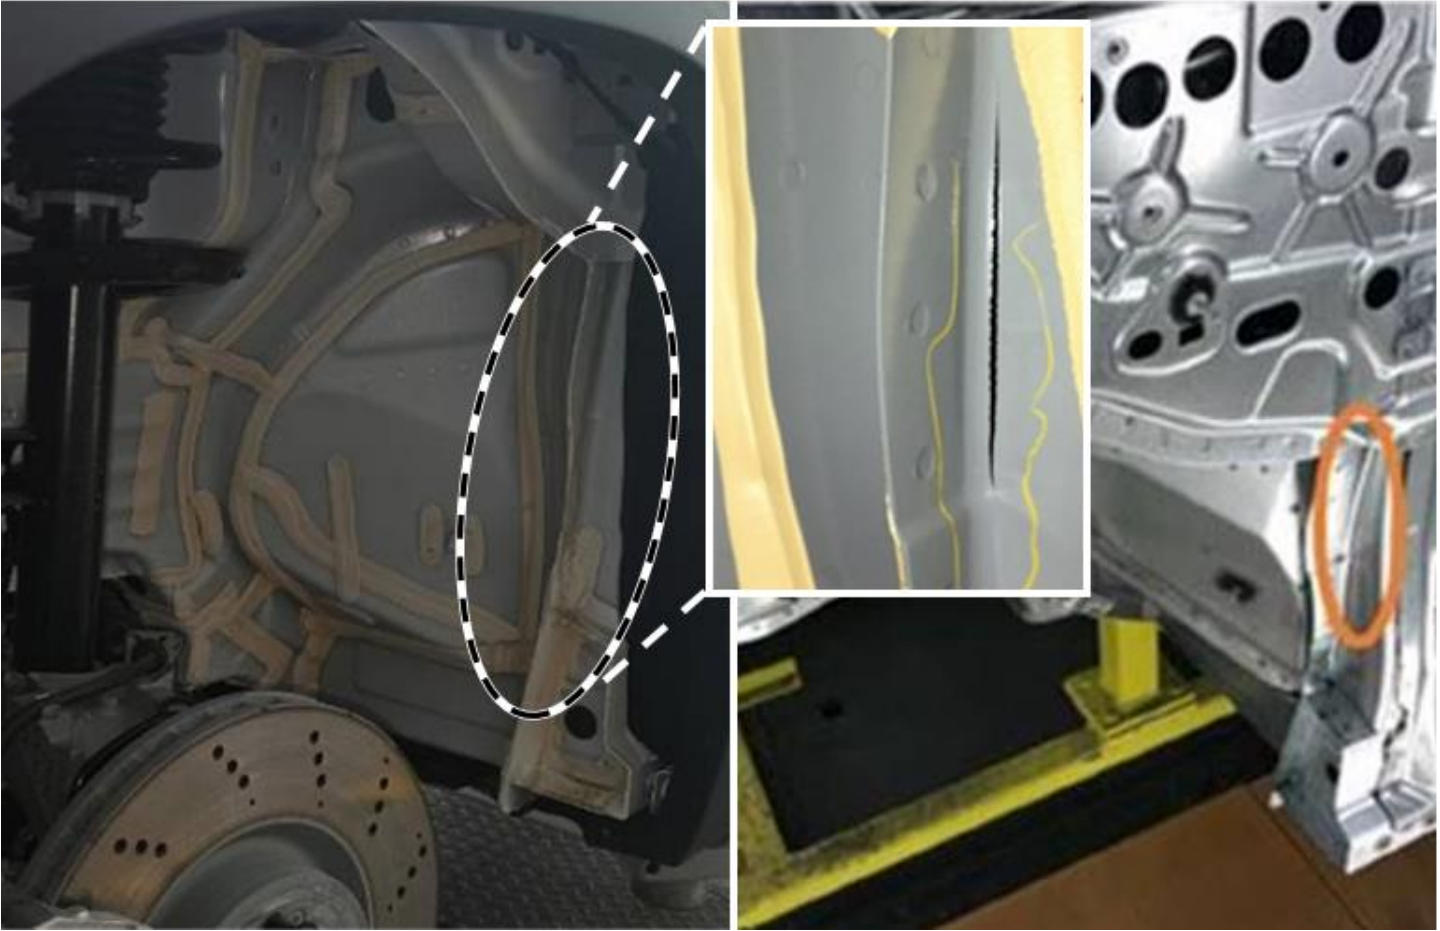
Figure 1

Mercedes-Benz AG (“MBAG”), the manufacturer of Mercedes-Benz, has determined that on certain MY 2022 GLA (247 platform) vehicles, a crack may have formed on the A-pillar in the vicinity of the wheel arch. The possibility exists that water ingress may occur and corrosion may form on the left longitudinal member. An authorized Mercedes-Benz dealer will check the affected A-pillar area and rework if necessary.

1. Remove/install bulkhead under left front fender.
i For basic data for model 247, see AR88.10-P-1301MFA.
2. Check A-pillar in marked area (figure 1) for cracks or sheet metal constrictions.

- a. **No** crack or sheet metal constriction present at outer A-pillar: **End measure.**
- b. Crack or sheet metal constriction present at outer A-pillar: **Carry out work procedure**

1. Drill off crack/sheet metal constriction at left outer A-pillar at ends using a 3 mm drill bit.
2. Seal crack at left outer A-pillar via the MAG/MIG welding process.
3. Clean A-pillar in processed area and rework with seam sealant.
4. Carry out anticorrosion protection according to the Mercedes-Benz manufacturer specifications.
