Service Campaign Bulletin

Campaign No. 2023050002, May 2023

SUBJECT: Model GLC (253 platform) Model Year 2023

Repair Seam Seal at A-Pillar

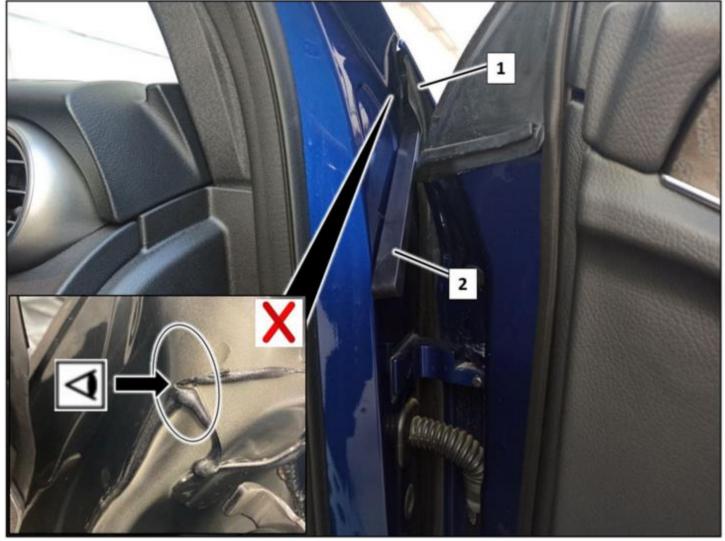
Mercedes-Benz AG ("MBAG"), the manufacturer of Mercedes-Benz, has determined that on certain Model Year ("MY") 2023 GLC (253 platform) vehicles, the seam seal on a small portion of the right A-pillar does not correspond with current production specifications. It cannot be ruled out that a leak may occur due to an inconsistency in this seam seal. An authorized Mercedes-Benz dealer will repair the seam seal at the A-pillar.

Figure 1: Example of seam seal with defect.

- 1. Open right front door.
- 2. Fold back A-pillar cover (1, Figure 1) in upper area and fix in place with a suitable plastic wedge (2, Figure 1).

- Clean the affected area (see arrow in Figure 1).
 Silicone remover can be used for example.
- Apply activator to affected area (see arrow in Figure 1).
 Observe manufacturer's specifications for product!

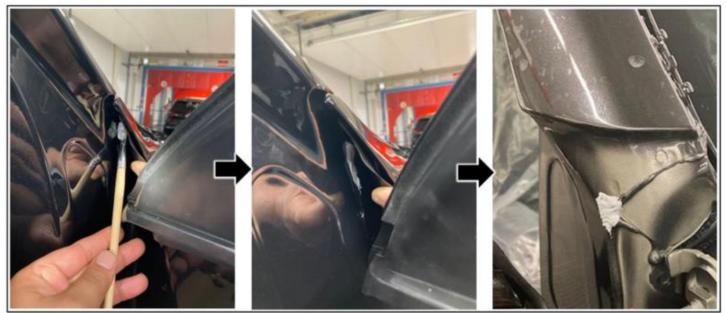
Figure 2: Refinish seam seal.

Apply seam seal in affected area (Figure 2) with a suitable brush.
 Observe manufacturer's specifications for product!

- 6. Once the applied seam seal has dried, fold back A-pillar cover (1, Figure 1) again and slightly press on.
- i Via the residual stress of the material, the A-pillar cover (1, Figure 1) will lie flat again on its own after a short time.
- **7.** Close right front door.
