TO: Mercedes-Benz Dealer Principals, General Managers, Sales Managers, Service Managers, Parts Managers	FROM: Gregory Gunther, Senior Manager, Vehicle Compliance and Analysis, Engineering Services
RE: Service Campaign Launch Notification Update Software for Various Control Units – Wave 1 MY22-23 EQS (297 platform)	DATE: August 22, 2023

Campaign No. 2023070020, August 2023

SUBJECT: **Model EQS (297 platform)**
Model Year 2022-2023

Update Software for Various Control Units

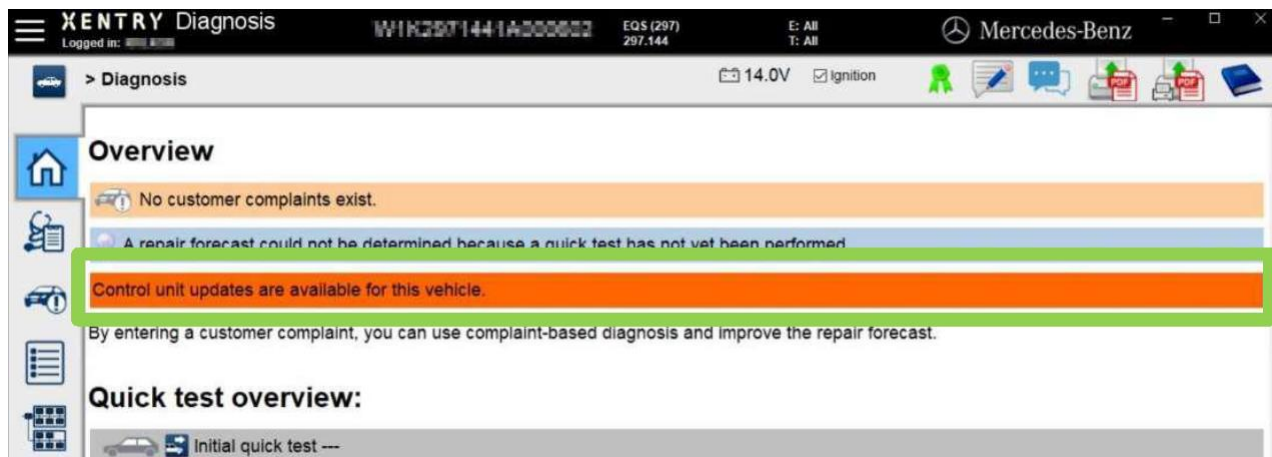
Figure 1

i Via the **orange** special menu item,
start "**Control unit updates are available for this vehicle**" (Figure 1).
