SAFETY RECALL

BULLETIN Fuel Tank Breather Tube

Voluntary Safety Recall Campaign

Reference: PC494 Date: November 18, 2016

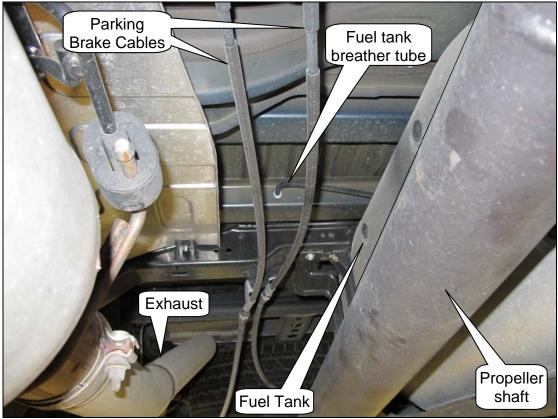
Figure 1

- 1. Set and raise the vehicle on a suitable lift.
- 2. Locate the fuel tank breather tube (breather tube). See Figure 1.

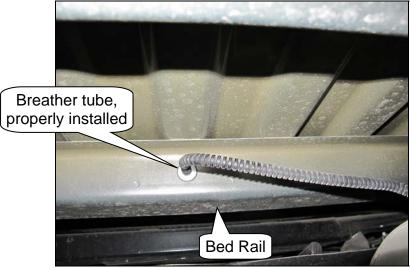
Figure 2

- 3. Inspect the breather tube.
 - a. If the breather tube is properly connected to the bed rail (see Figure 2), STOP HERE. No further inspection or repairs are necessary.

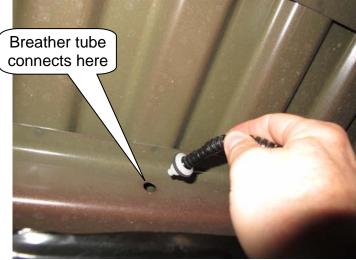
Figure 3

- b. If the breather tube is not connected but can easily reach the bed rail connection hole and does NOT have a cap fitted to it (see Figure 3):
 - b1. Connect the breather tube to the bed rail connection hole (see Figure 3). Inspection/repairs are complete.

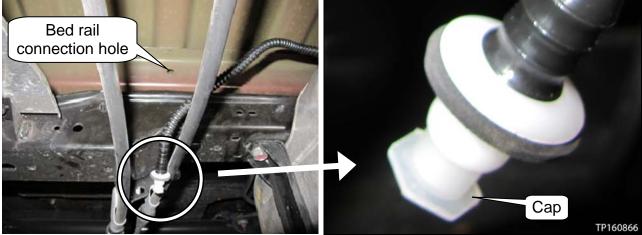
c. If the breather tube is not connected but can easily reach the bed rail connection hole and it DOES have a cap fitted to it (see Figure 4 and 5):

- c1. Measure the bottom of the fuel tank (see Figure 6, 7, and 8).
- c2. If the measurement is less than 10 mm, remove the cap, and then connect the breather tube to the bed rail connection hole.
- c3. If the measurement is 10mm or greater, replace the:
 - Breather tube
 - Fuel tank, and
 - The fuel level sensor with fuel pump and O-ring seal.
 - Refer to the Electronic Service Manual (ESM), section FL-Fuel System, for fuel tank and related components replacement.

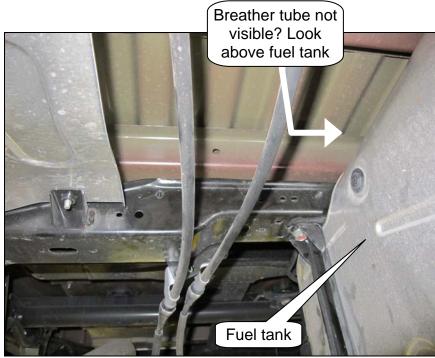
Figure 9

- e. If the breather tube cannot be seen (see Figure 9):
 - e1. Carefully reach above the fuel tank, find the breather tube, and then go back to step 3.
