Re: Recall Campaign No. 92V-071 -
Fuel Injection Lines
Ferrari 348 and Mondial T models

**VEHICLE SAFETY DEFECT
INITIAL INFORMATION REPORT**

**348 ts/tb & Mondial t - Fuel injection lines
Recall No. 147**

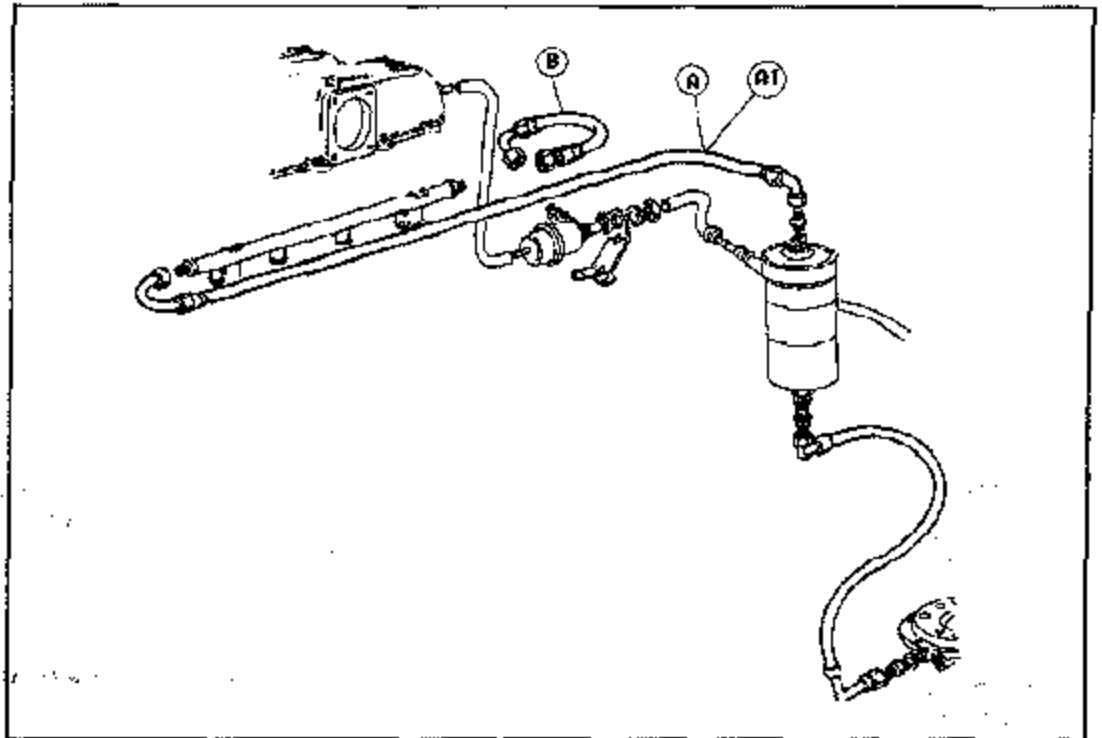
Fig.#1

- CONDITION:** The aluminum fuel line fittings on certain fuel Injection lines can corrode under extreme environmental conditions. Should such condition remain unnoticed, the result could be breakage of the aluminum fuel line fitting resulting in fuel leakage.

- REMEDY:** Replacement of the Fuel injection system lines "A & B" with the modified fuel lines (shown on Fig 1, page 6).
- PARTS:** Quantities required for each vehicle and identification of the new Fuel lines with the new part numbers, are shown on the Parts List Table "A" on Page 8). The new part fittings are now aluminum with a non-corrosive coating.

- 5) Remove both fuel lines "A & B" as shown in Fig.# 1 and replace with new lines.
- 6) Inspect 1/4 bank Fuel Injection return line for any damage due to contact with the timing cover. If damage is found the line must be replaced using the procedure "C - Procedure for replacement of fuel return line" found on page # 7 of this booklet. If no damage is found, please insure that the return line is secured on the clip found on the timing cover (Fig.#3). Also the Return Fuel line must not contact the Timing cover or A/C Compressor lines.

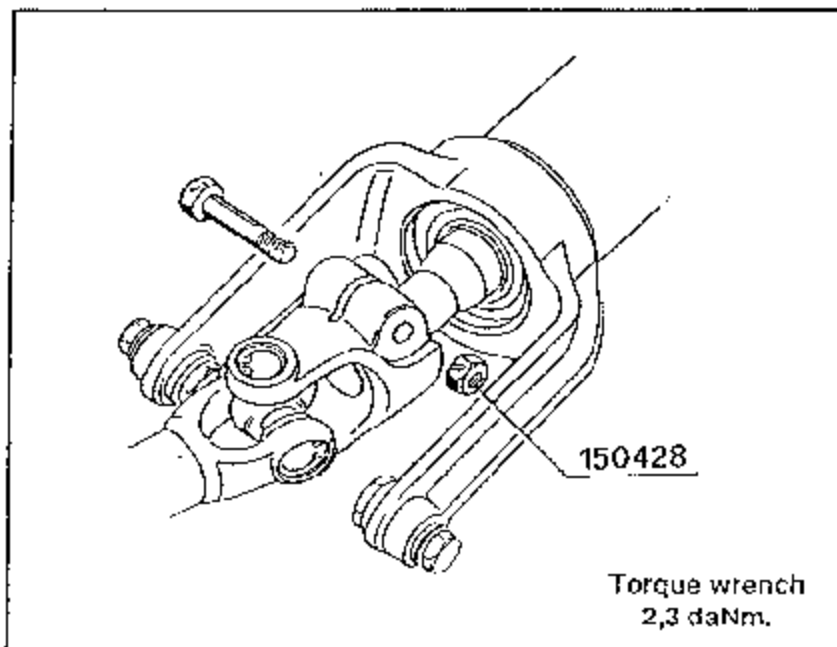
Fig.#1a

CONDITION: *The upper steering column locknut was manufactured with a lower class of material and self-locking properties. This may result in a loss of tightening torque on the upper steering column fastener. Should such condition remain unnoticed and the use of the car be prolonged for an extensive period of time, loosening of the fastener could occur resulting in play in the steering system and consequential impairment of handling.*

REMEDY: Replacement of the Upper steering column locknut with the improved self-locking nut (shown on Fig 1, page 11).

- A. Preliminary: The replacement self-locking nut (Fig.#1a) is supplied as a spare part (PN# 150428) by the Ferrari North America parts department.
- B. Procedure for installation
- 1) Cover interior (seat and carpeting).
 - 2) Remove 13mm locknut from upper steering column fastener and replace with new 13mm self locking nut (PN# 150428) as shown in fig.# 1 below.
 - 3) Check that the steering column shaft is properly inserted into the steering column extension. Fastener must go through the groove provided in the steering column shaft.
 - 4) Torque self-locking nut to 2.3 daNm (17 lbs/ft).
 - 5) Check for binding in steering system. If there is binding, check system for faults.
 - 6) Remove all protective covers from interior and insure that the area is clean.

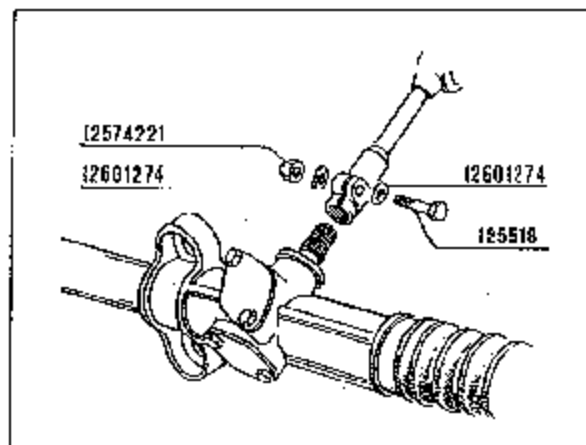
Fig.#1b

CONDITION: On 348 ts/tb vehicles with Vehicle Identification Number lower than 86212, the *steering box extension fastener* was manufactured with a lower class of material and self-locking properties. This may result in a loss of tightening torque on the upper steering column fastener. Should such condition remain unnoticed and the use of the car be prolonged for an extensive period of time, loosening of the fastener could occur resulting in play in the steering system and consequential impairment of handling.

REMEDY: Replacement of the Steering box extension fastener with the improved fastener (shown on Fig 1, page 13).

A. Preliminary: The replacement Fastener, bolt and washers (Fig.#1) are supplied as a spare parts by the Ferrari North America parts department using the part numbers listed on "parts" section of page 12.
