SUBJECT: Recall Campaigns No. 92V-071, 92V-072 and  
92V-073

**REF. NO. 147  
FUEL INJECTION LINES**

Ferrari S.p.A., the manufacturer of Ferrari automobiles, has determined that certain defects exist in certain 1989, 1990 and 1991 model year Ferrari vehicles.

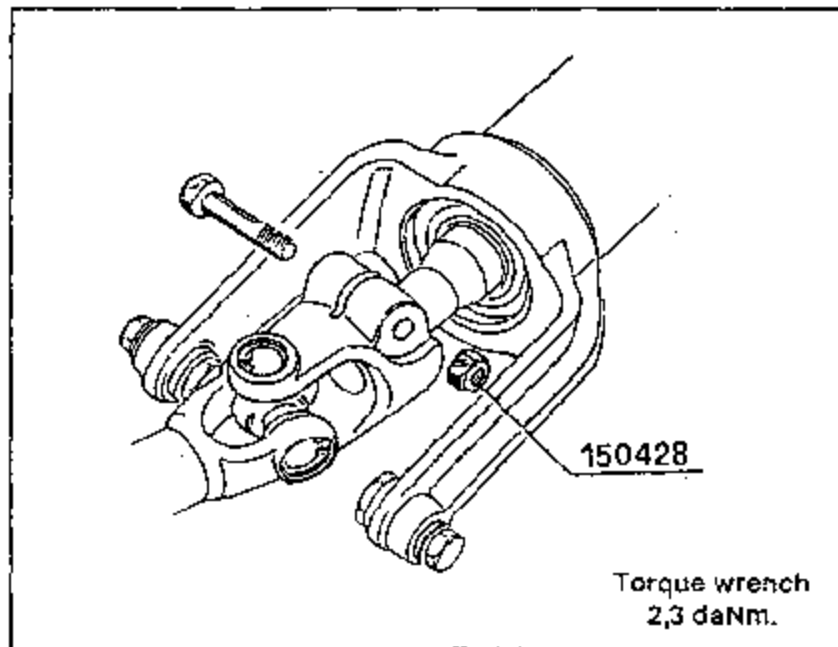
**Fig.#1a**

CONDITION: The *upper steering column locknut* may have been manufactured with a lower class of material and self-locking properties. This may result in a loss of tightening torque on the upper steering column fastener. Should such condition remain unnoticed and the use of the car be prolonged for an extensive period of time, loosening of the fastener could occur resulting in play in the steering system and consequential impairment of handling.

REMEDY: Replacement of the Upper steering column locknut with the improved self-locking nut (shown on Fig 1, page 11).

- A. Preliminary: The replacement self-locking nut (Fig.#1a) is supplied as a spare part (PN# 150428) by the Ferrari North America parts department.
- B. Procedure for installation
- 1) Cover interior (seat and carpeting).
  - 2) Remove 13mm locknut from upper steering column fastener and replace with new 13mm self locking nut (PN# 150428) as shown in fig.# 1 below.
  - 3) Check that the steering column shaft is properly inserted into the steering column extension. Fastener must go through the groove provided in the steering column shaft.
  - 4) Torque self-locking nut to 2.3 daNm (17 lbs/ft).
  - 5) Check for binding in steering system. If there is binding, check system for faults.
  - 6) Remove all protective covers from interior and insure that the area is clean.

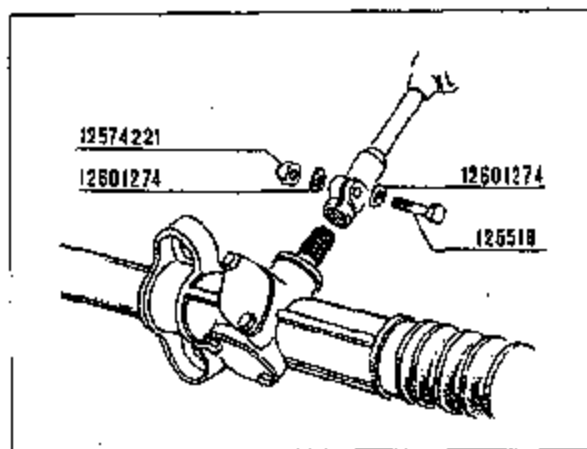
**Fig.#1b**

CONDITION: On 348 ts/tb vehicles with Vehicle Identification Number lower than 86212, the *steering box extension fastener* may have been manufactured with a lower class of material and self-locking properties. This may result in a loss of tightening torque on the upper steering column fastener. Should such condition remain unnoticed and the use of the car be prolonged for an extensive period of time, loosening of the fastener could occur resulting in play in the steering system and consequential impairment of handling.

REMEDY: Replacement of the Steering box extension fastener with the improved fastener (shown on Fig 1, page 13).

- 5) Install new fastening bolt along with the two washers and locknut as shown in fig.# 1 below.
  - 6) Torque Fastener nut to 1.2 daNm (9 lbs/ft).
  - 7) Replace carpeting around area of steering extension.

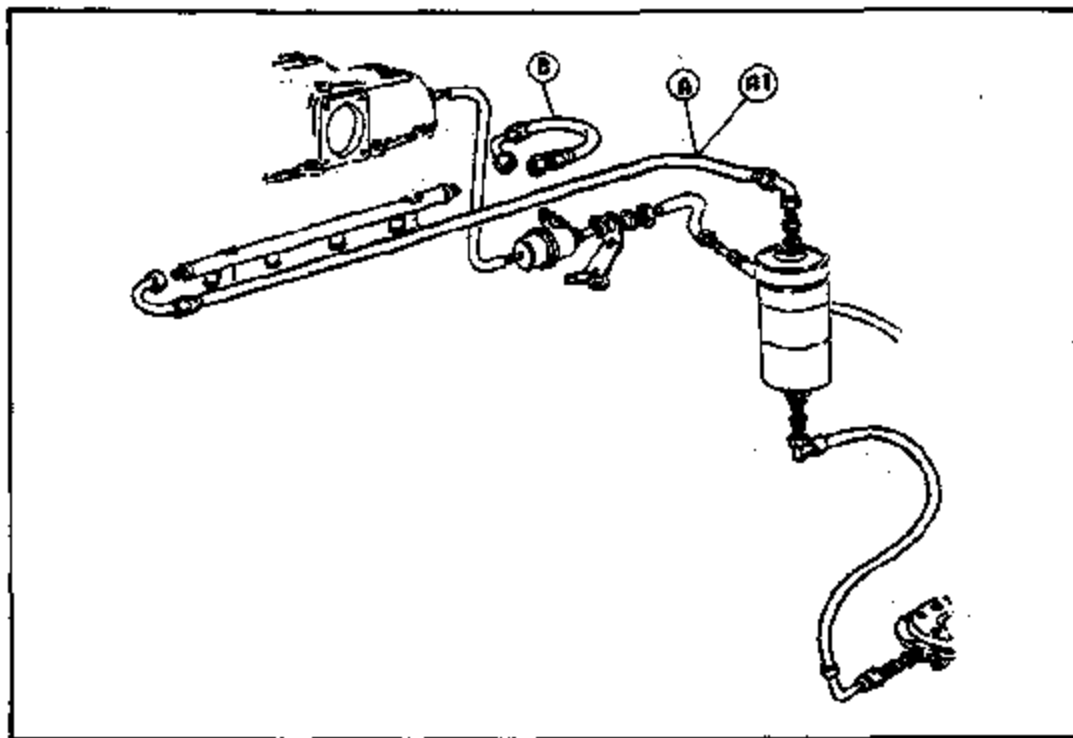
Fig.#1

- CONDITION:** The aluminum fuel line fittings on certain fuel Injection lines may corrode under extreme environmental conditions. Should such condition remain unnoticed, the result could be breakage of the aluminum fuel line fitting resulting in fuel leakage.

- 5) Remove both fuel lines "A & B" as shown in Fig.# 1 and replace with new lines.
- 6) Inspect 1/4 bank Fuel Injection return line for any damage due to contact with the timing cover. If damage is found the line must be replaced using the procedure "C - Procedure for replacement of fuel return line" found on page # 7 of this booklet. If no damage is found, please insure that the return line is secured on the clip found on the timing cover (Fig.#3). Also the Return Fuel line must not contact the Timing cover or A/C Compressor lines.
