SUBJECT: Recall Campaigns No. 92V-071, 92V-072 and
92V-073

RECALL CAMPAIGN

**REF. NO. 147
FUEL INJECTION LINES**

**REF. NO. 148
UPPER STEERING COLUMN
LOCKNUT**

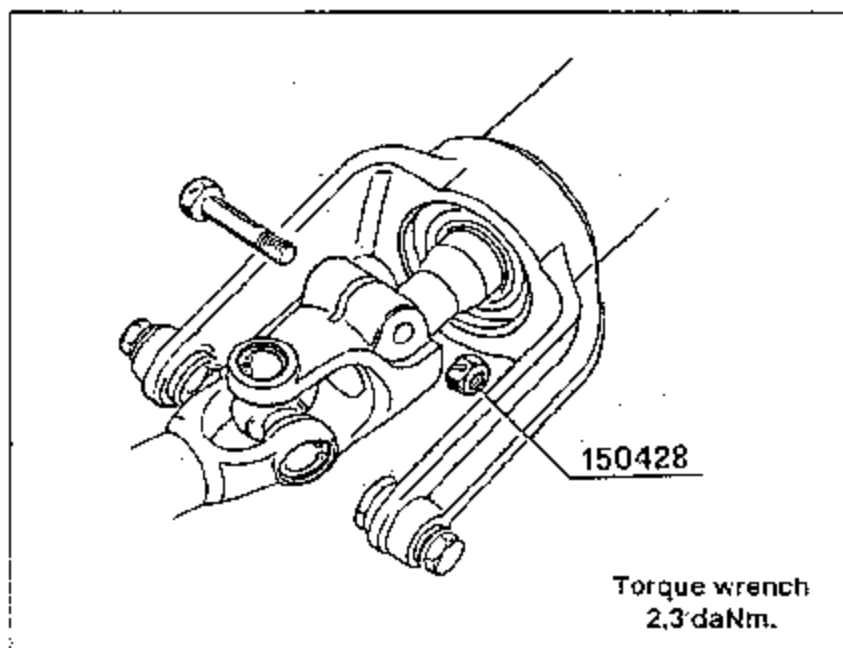
Fig.#1a

- Ferrari Testarossa, Model Year 1990 and 1991, starting from serial number 85658 up to serial number 87483 included.
- CONDITION:** The *upper steering column locknut* may have been manufactured with a lower class of material and self-locking properties. This may result in a loss of tightening torque on the upper steering column fastener. Should such condition remain unnoticed and the use of the car be prolonged for an extensive period of time, loosening of the fastener could occur resulting in play in the steering system and consequential impairment of handling.

- REMEDY:** Replacement of the Upper steering column locknut with the improved self-locking nut (shown on Fig 1, page 11).
- PARTS:** Only one locknut (PN# 150428) required for each vehicle.

A. Preliminary: The replacement self-locking nut (Fig.#1a) is supplied as a spare part (PN# 150428) by the Ferrari North America parts department.

- 1) Cover interior (seat and carpeting).
- 2) Remove 13mm locknut from upper steering column fastener and replace with new 13mm self locking nut (PN# 150428) as shown in fig.# 1 below.
- 3) Check that the steering column shaft is properly inserted into the steering column extension. Fastener must go through the groove provided in the steering column shaft.
- 4) Torque self-locking nut to 2.3 daNm (17 lbs/ft).
- 5) Check for binding in steering system. If there is binding, check system for faults.
- 6) Remove all protective covers from interior and insure that the area is clean.

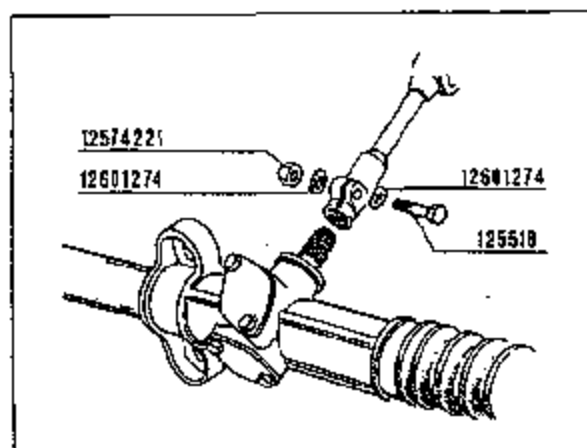
Fig.#1b

CONDITION: On 348 ts/tb vehicles with Vehicle Identification Number lower than 86212, the *steering box extension fastener* may have been manufactured with a lower class of material and self-locking properties. This may result in a loss of tightening torque on the inner steering column

- A. Preliminary: The replacement Fastener, bolt and washers (Fig.#1) are supplied as a spare parts by the Ferrari North America parts department using the part numbers listed on "parts" section of page 12.

- 5) Install new fastening bolt along with the two washers and locknut as shown in fig.# 1 below.
 - 6) Torque Fastener nut to 1.2 daNm (9 lbs/ft).
 - 7) Replace carpeting around area of steering extension.

- 8) Check for binding in steering system. If there is binding, check system for faults.
 - 9) Remove all protective covers from interior and insure that the area is clean.

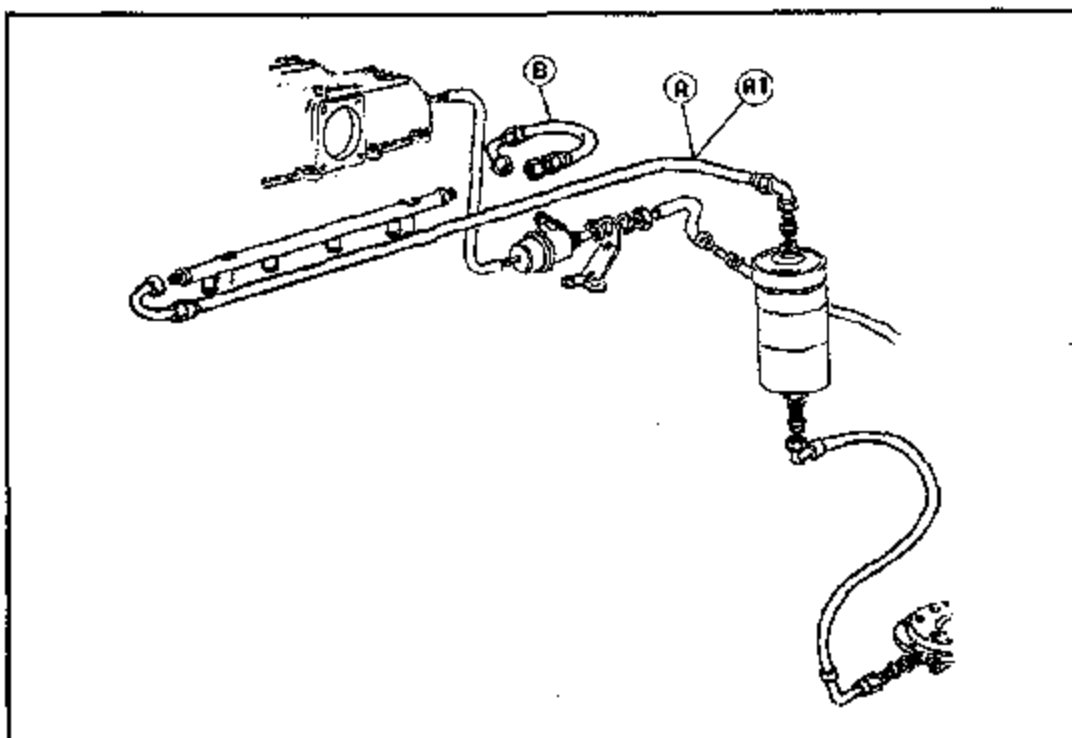
Fig.#1

CONDITION: The aluminum fuel line fittings on certain fuel Injection lines may corrode under extreme environmental conditions. Should such condition remain unnoticed, the result could be breakage of the aluminum fuel line fitting resulting in fuel leakage.

REMEDY: Replacement of the Fuel injection system lines "A & B" with the modified fuel lines (shown on Fig 1, page 6).

- 5) Remove both fuel lines "A & B" as shown in Fig.# 1 and replace with new lines.
- 6) Inspect 1/4 bank Fuel Injection return line for any damage due to contact with the timing cover. If damage is found the line must be replaced using the procedure "C - Procedure for replacement of fuel return line" found on page # 7 of this booklet. If no damage is found, please insure that the return line is secured on the clip found on the timing cover (Fig.#3). Also the Return Fuel line must not contact the Timing cover or A/C Compressor lines.

- 7) Repeat procedure #4 through #6 for 5/8 bank fuel lines.
- 8) Replace fuel tank filler cap.
- 9) Start engine, run for 30 seconds and then shut off. Check for leaks.
