VEHICLE SAFETY DEFECT  
INITIAL INFORMATION REPORT  
512 - FUEL SUPPLY LINES  
RECALL No. 150

REF. NO. 150  
FUEL SUPPLY LINES  
512 TR

**SUBJECT:** Recall Campaign No. 150  
Ferrari 512 TR Fuel Supply Lines

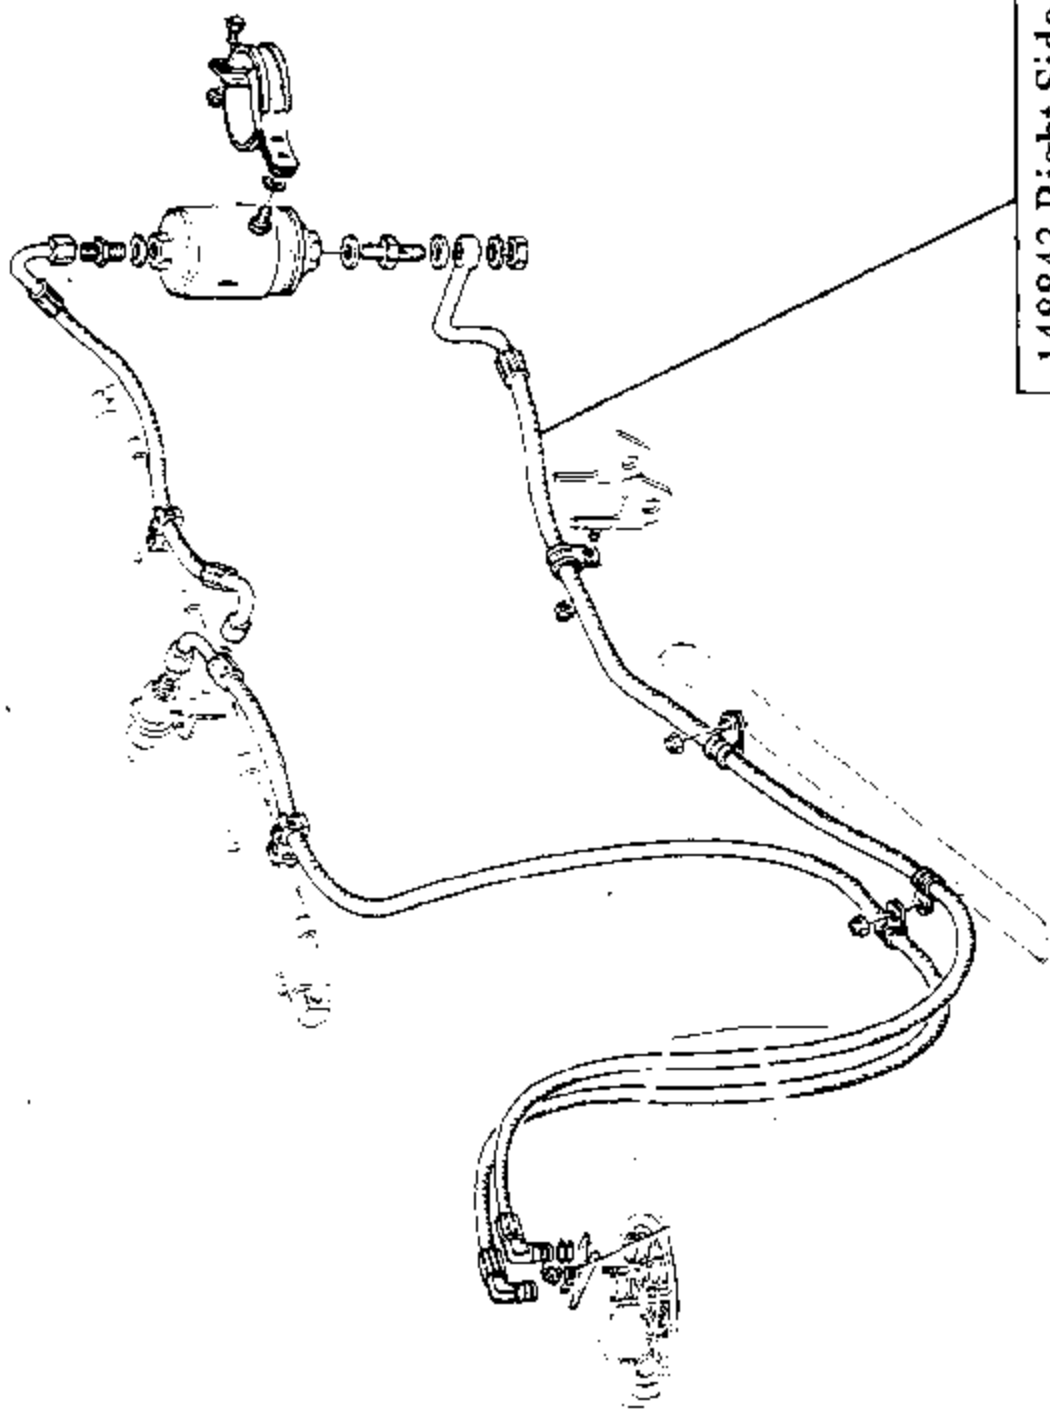
148843 Right Side  
148844 Left Side

**CONDITION:** The metal fuel supply line banjo fittings may fracture if the nut attaching the lines to the fuel filter is tightened in excess of the required torque. Should such a condition occur, the result would be leakage of fuel from the fractured line.

**REMEDY:** Replacement of the two fuel supply lines with modified fuel supply lines that are now constructed with a stronger banjo fitting which is resistant to fracture.

148843 right side  
148844 left side  
Note: The old lines are blue anodized aluminium
