NSA-111bdh
95V-079

**VEHICLE SAFETY DEFECT
INITIAL INFORMATION REPORT
INTERNATIONAL HORN EMBLEM
RECALL No. 151**

REF. NO. 151
INTERNATIONAL HORN EMBLEM
456 GT, 512 M, F 355 B

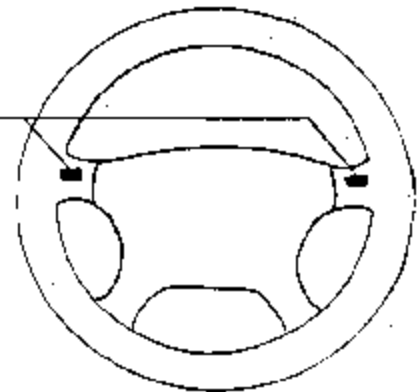
Position of the horn that will be 12 mm long.

First practice holding the stamper on the sample leather pieces (which are enclosed) for a period of 3 seconds, maintaining an even pressure. When satisfied with the testing on the sample leather pieces, place the stamper on the steering wheel in the position shown on the diagram below.

CAUTION: Any time exceeding 3 seconds will start to visibly burn the leather on the steering wheel.

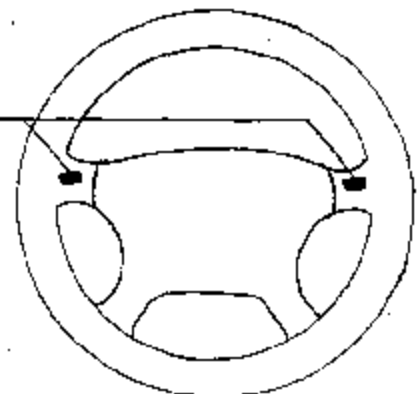
Position of the horn that will be 12 mm long.

CAUTION: ANY TIME EXCEEDING 3.0 SECONDS WILL START TO VISIBLY BURN THE LEATHER ON THE STEERING WHEEL.

- 7) When satisfied with the testing on the sample leather pieces, place the stamper on the steering wheel for a period of 3.0 seconds, maintaining an even pressure in the position shown on the diagram below, with the correct orientation.
- 8) This procedure requires 0.2 hours.
- 9) Switch off converter and allow tool to cool before storing.
