Ferrari North America, Inc.

98V-088 (U)

VEHICLE SAFETY DEFECT
INITIAL INFORMATION REPORT
FUEL INJECTION LINES
(DUAL FUEL PUMP VEHICLES)
RECALL No. 161

SUBJECT : Recall Campaign No. 161
Ferrari F355 Fuel Injection Lines

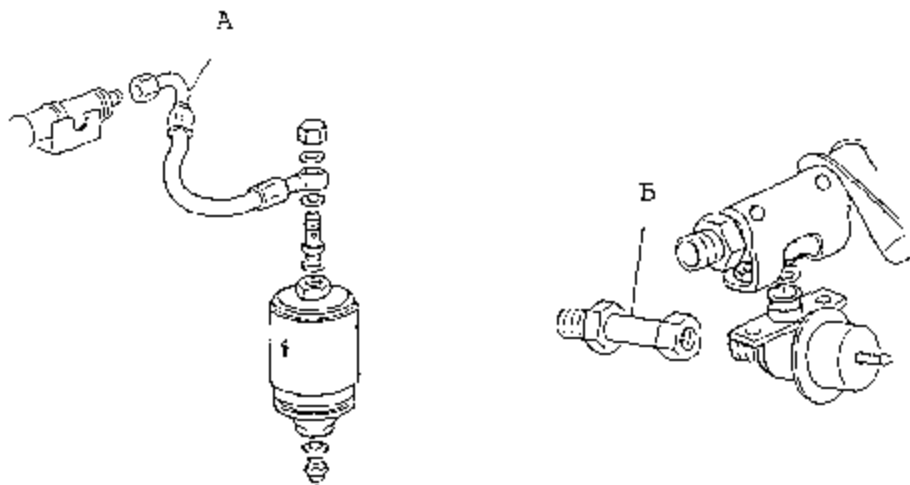
CONDITION : The aluminum nuts fitted on the fuel injection lines will fracture if the nut is tightened in excess of the required torque specified by Ferrari. Should such a condition occur, the result would be leakage of fuel from the fractured nut.

- 1) Disconnect battery (main switch).
- 2) Cover rear fenders with fender covers.
- 3) Remove fuel tank fill cap to release pressure from the fuel tank
- 4) Disconnect the RH fuel rail line "A" from the RH fuel filter
- 5) Remove the fuel line from the vehicle noting its routing position
- 6) Install the new fuel rail line "A" tightening to a torque of 25 Nm (18.44 lb. ft.)

- 7) Remove the RH fuel pipe extension "B" from the pressure regulator
- 8) Install the new fuel pipe extension "B" tightening to a torque of 25 Nm (18.44 lb.ft.)
- 9) Repeat items 4 - 9 for the LH side
