VEHICLE SAFETY DEFECT  
INITIAL INFORMATION REPORT  
F355 POWER STEERING COLUMN CONNECTION  
RECALL No. 163

REF. NO. 163  
POWER STEERING COLUMN  
CONNECTION  
F 355

## RECALL CAMPAIGN NO. 163

## INSTRUCTIONS FOR THE POWER STEERING COLUMN CONNECTION

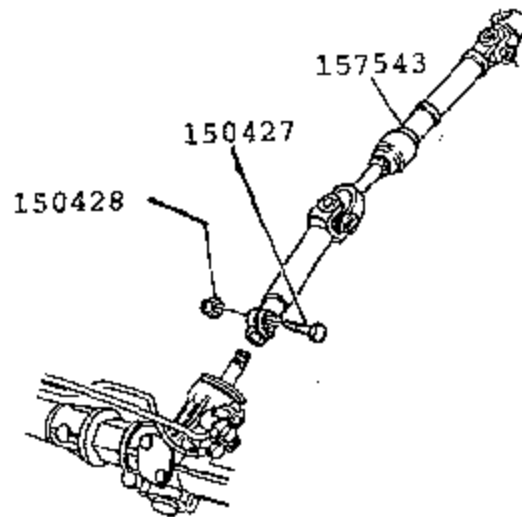
### A: Procedure for Installation

**CONDITION :** The torque of the power steering column nut may be insufficient. Should such a condition occur, impairment of the vehicle handling may result.

- 1) Check the alignment and positioning of the splines on the steering column extension (Part Number 157543) Adjust if necessary.
- 2) Check the correct tightening of the nut/bolt (Part Numbers 150427 / 150428) applying the tightening torque of 23 Nm.

**NOTE: FOR IDENTIFICATION PURPOSES, PLEASE PAINT THE NUT (PART NUMBER 150427) WITH YELLOW PAINT.**
