On Ferrari vehicles, 1998 model F355 F 1 Spider with Vehicle Assembly Numbers between 29088 and 30041, damage to the fuel tank may have occurred during installation of the soft top mechanism covers.

VEHICLE SAFETY DEFECT
INITIAL INFORMATION REPORT
F355 FI SPIDER FUEL TANK INSPECTION
RECALL No. 162

SUBJECT : Ferrari F355 Fuel Tank Replacement Recall No. 162/2

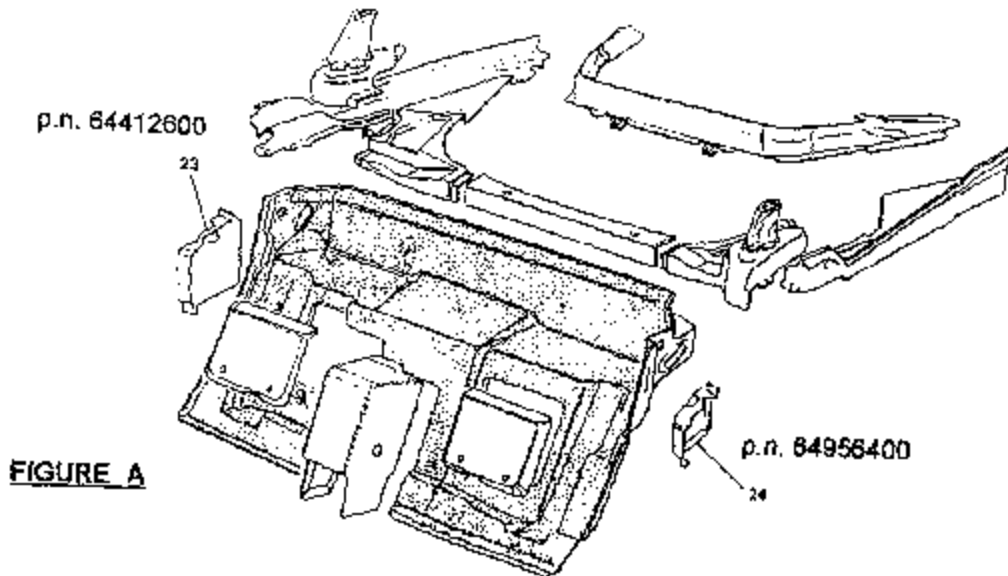
- 1 Disconnect battery (main switch).
- 2 Unscrew self-tapping lower fixing screws which attach interior covers p.n. 64412600 and p.n. 64956400 (reference item # 23 and item # 24 in figure A).
- 3 Cover rear fenders with fender covers.
- 4 Remove fuel tank fill cap to release pressure from the fuel tank.
- 5 Take the fuel cap p.n. 4816 and drill a hole in the center to enable the fitting of a nipple in order to connect a hand held pump with pressure gauge. We would suggest the use of a suitable coolant system pressure tester. The coolant tank fitting will have to be removed and the drilled fuel cap with fitting attached.
- 6 Check all connections between pressure gauge and fuel cap.

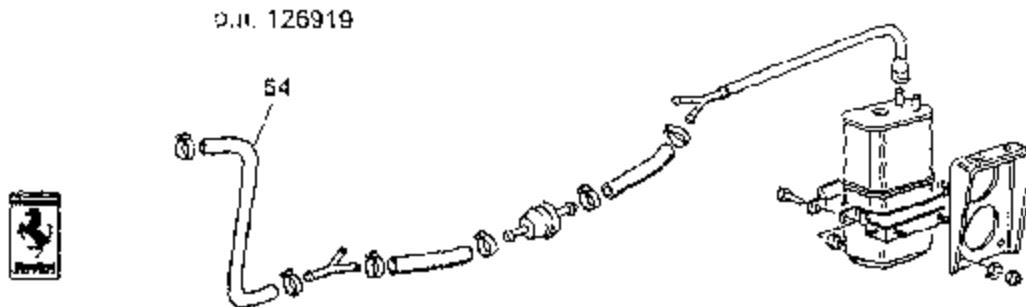
FIGURE B

- 7 Install the modified fuel cap onto the fuel filler neck, making sure it is properly sealed.
- 8 Using adequate hose clamp pliers, compress the hose p.n. 126919 (reference fuel line #54 in figure B.) This operation is necessary in order to avoid any loss of pressure during the test.

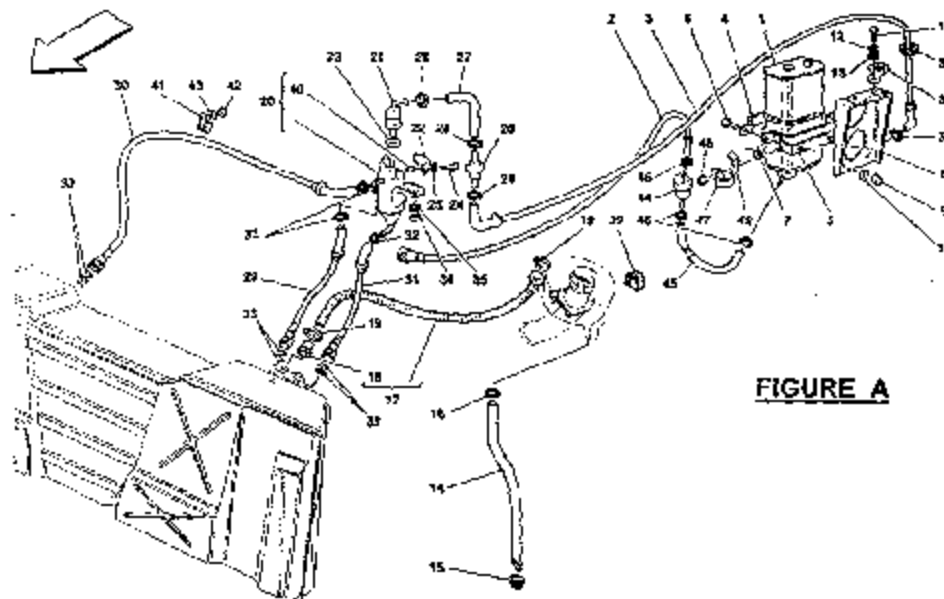
- 1 Disconnect battery (main switch).
- 2 Cover rear fenders with fender covers.
- 3 Remove fuel tank fill cap to release pressure from the fuel tank.
- 4 Lift vehicle and remove fuel tank access panel. Drain the fuel from the tank into an approved fuel container.
- 5 Remove fuel tank vapor lines at top of fuel tank utilizing special tool part number 95970126. (Items No.30, No.29, No. 31, and No.17 In figure A)

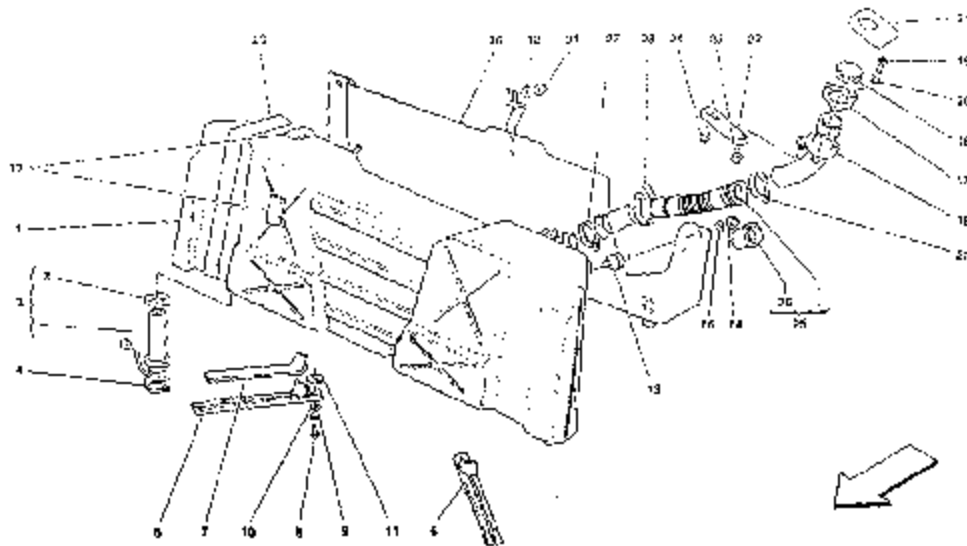
FIGURE B

- 6 Loosen fuel tank fill tube clamp at top and disconnect tube from fuel tank. (Item No.27 in figure B)
- 7 Remove fuel supply and return lines from fuel pump assembly.
- 8 Shift gear box into third gear and disconnect shift rod under fuel tank.
- 9 Place a transmission type jack under the fuel tank and remove fuel tank securing straps.
- 10 Drop the fuel tank taking care to disconnect the fuel pump connections and to take note of the fuel line routing through the chassis.
