RECALL CAMPAIGNS

NAME OF MANUFACTURER : FERRARI

SUBJECT OF RECALL : FUEL SUPPLY/RETURN LINES

RECALL CAMPAIGN NUMBER : 98V-268

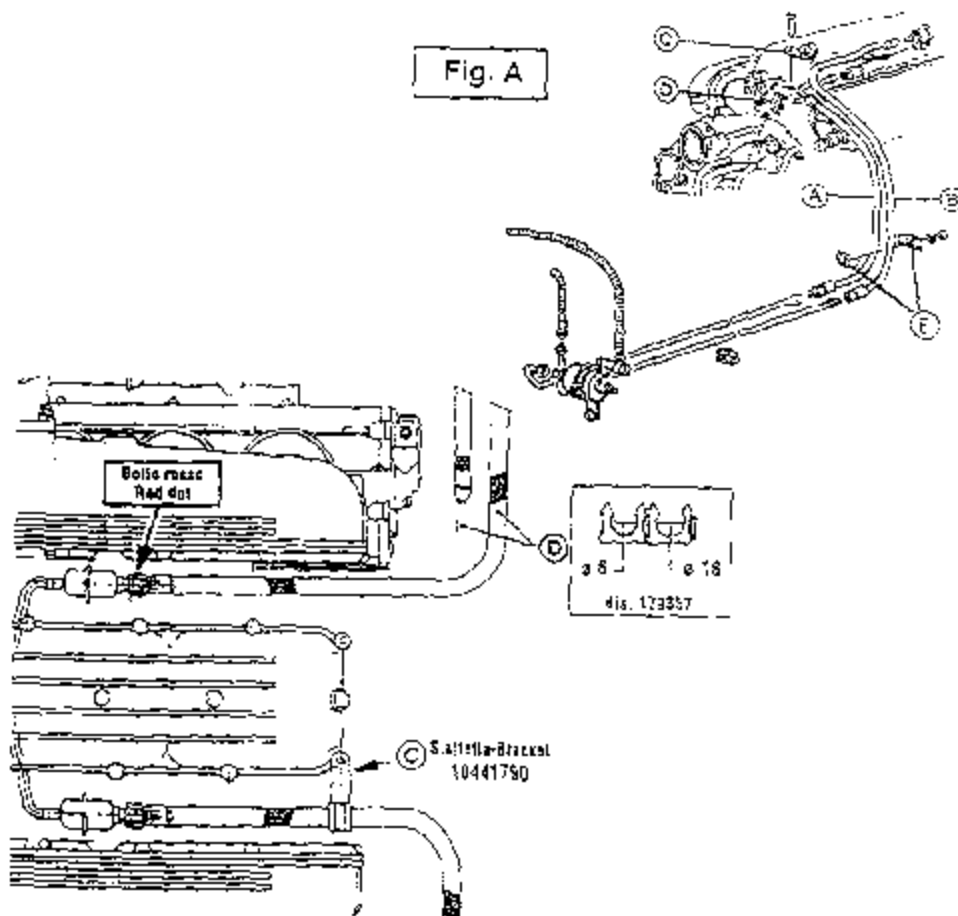
Fig. A

CONDITION : The fuel supply and return lines may leak where the ferrule of the union meets the flexible pipe.

Should such a condition occur, the result would be leakage of fuel from the fractured line, in which case, the risk of fire would exist.

7) Release the supply and return hoses from their retaining clips.
(Item "E" in figure "A")

8) Remove the left side fuel lines
(Items "A" and "B" in figure "A")

9) Remove the right side fuel lines
(Items "A" and "B" in figure "A")

10) Install the new right side supply (part number 178525) and right side return (part number 179164) fuel lines tightening the unions to a torque of 2.5 Nm.

11) Install the new left side supply (part number 178522) and left side return (part number 179356) fuel lines tightening the unions to a torque of 2.5 Nm.

NOTE: THE NEW RETURN LINES (part numbers 179164 and 179356) HAVE BEEN MANUFACTURED IN A DIFFERENT SHAPE AND MUST BE ATTACHED TO THE CENTER INTAKE MANIFOLD USING THE NEW BRACKET (part number 10441790) ITEM "C" IN FIGURE "A"

12) Install the new retaining clips (part number 179357) item "D" in figure "A"

13) Reattach the supply and return hoses to their retaining clips.
(Item "E" in figure "A")

16) Identify updated vehicles with a dab of red paint applied to the union of the return line near the pressure regulator (see figure "A")

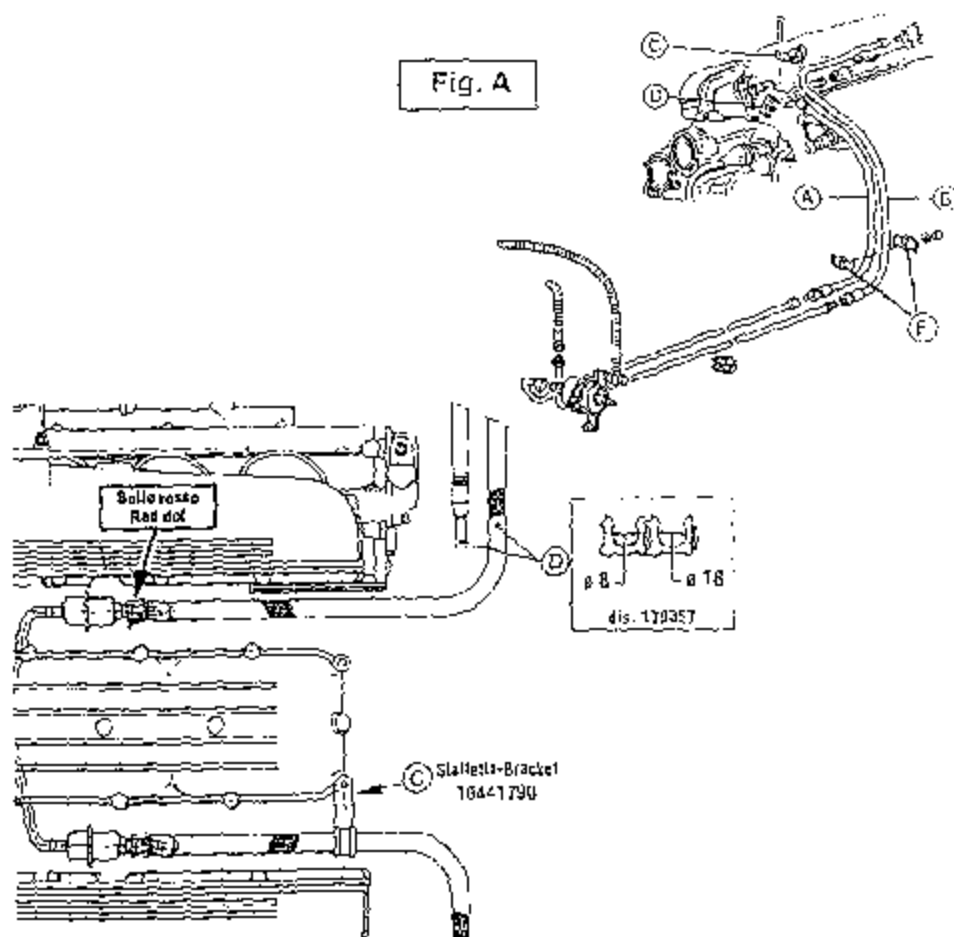
CONDITION : The fuel supply and return lines may leak where the ferrule of the union meets the flexible pipe.

Should such a condition occur, the result would be leakage of fuel from the fractured line, in which case, the risk of fire would exist.

- 6) Remove front and center under panels
Remove the rear section of the front inner fender panels
- 7) Release the supply and return hoses from their retaining clips.
(Item "E" in figure "A")
- 8) Remove the left side fuel lines
(Items "A" and "B" in figure "A")
- 9) Remove the right side fuel lines
(Items "A" and "B" in figure "A")

- 10) Install the new right side supply (part number 178525) and right side return (part number 179164) fuel lines tightening the unions to a torque of 34 Nm.(25 lb.ft.)
- 11) Install the new left side supply (part number 178522) and left side return (part number 179356) fuel lines tightening the unions to a torque of 34 Nm.(25 lb.ft.)

NOTE: THE NEW RETURN LINES (part numbers 179164 and 179356) HAVE BEEN MANUFACTURED IN A DIFFERENT SHAPE AND MUST BE ATTACHED TO THE CENTER INTAKE MANIFOLD USING THE NEW BRACKET (part number 10441790) ITEM "C" IN FIGURE "A"

- 12) Install the new retaining clips (part number 179357) item "D" in figure "A"
- 13) Reattach the supply and return hoses to their retaining clips.
(Item "E" in figure "A") Do not over tighten
- 14) Reconnect the battery (main switch)
- 15) Replace the fuel tank fill cap

- 16) Identify updated vehicles with a dab of red paint applied to the union of the return line near the pressure regulator (see figure "A")
- 17) Reinstall the rear section of the front inner fender panels
- 18) Reinstall front and center under panels
- 19) Reinstall the front wheels and lower vehicle.
