Dealer Service Instructions for:

Safety Recall R22 / NHTSA 15V-282

Left Side Air Bag Inflatable Curtain Rear Bolt

2015 (LA) Dodge Challenger

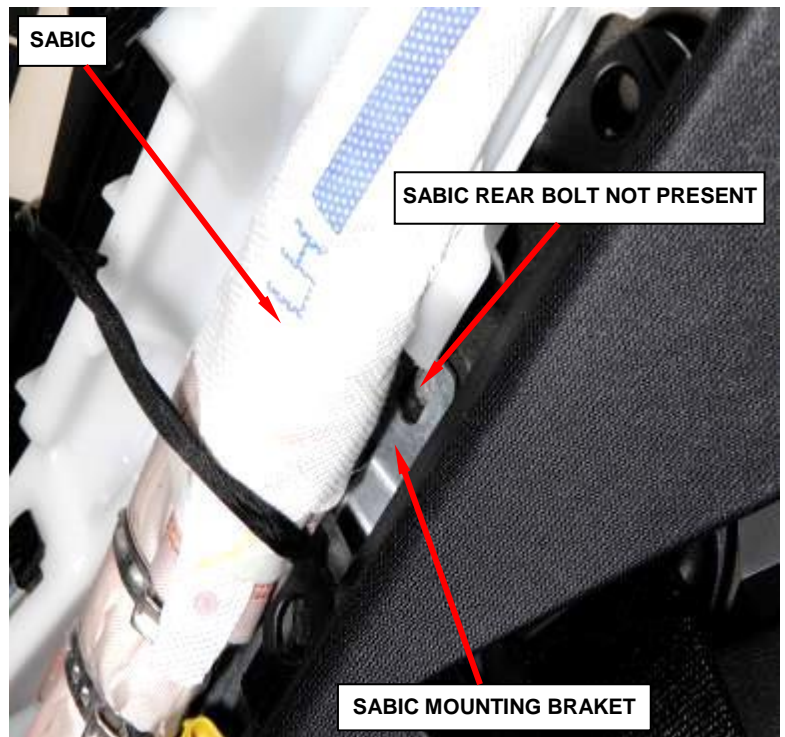
The left side “C” pillar Side Air Bag Inflatable Curtains (SABIC) on about 70 of the above vehicles may have been built with a loose or missing left rear SABIC bolt. The loose or missing left rear SABIC bolt could cause an increased chance of injury during certain crash conditions.

**Figure 3 – SABIC Rear Bolt Not Present**

7. Remove the left C-pillar trim panel.
8. Inspect for the presence of a SABIC rear bolt:
 - If the SABIC rear bolt is not present, continue with **Step 9 (Figure 3)**.
 - If the SABIC rear bolt is present, continue with **Step 10 (Figure 4)**.
9. Install a new SABIC rear bolt.

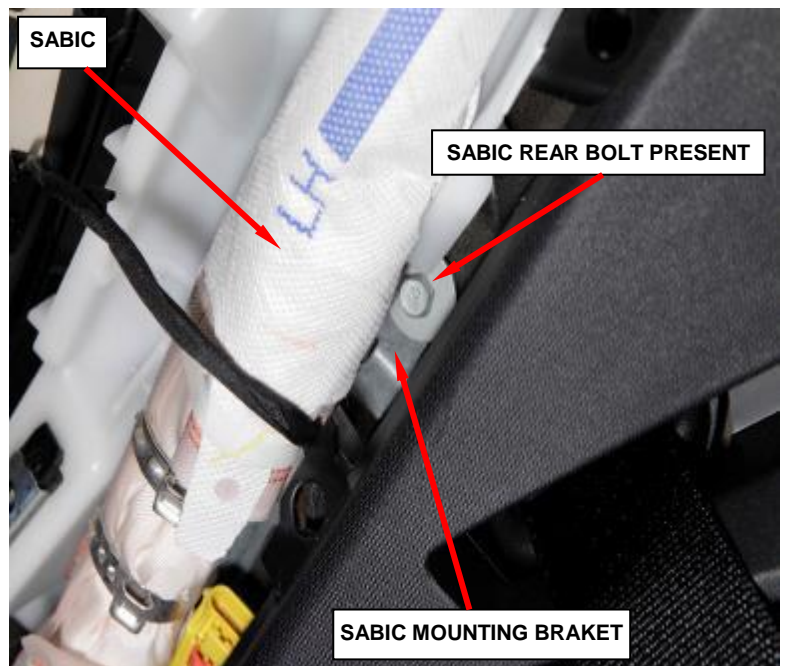
**Figure 4 – SABIC Rear Bolt Present**

10. Tighten the SABIC rear bolt to 62 in. lbs. (7 N·m).

NOTE: If the SABIC rear bolt was present, verify that the existing bolt is tightened to 62 in. lbs. (7 N·m).
