September 2015

Dealer Service Instructions for:

Safety Recall R36 / NHTSA 15V-459 Steering Wheel Wiring

Models

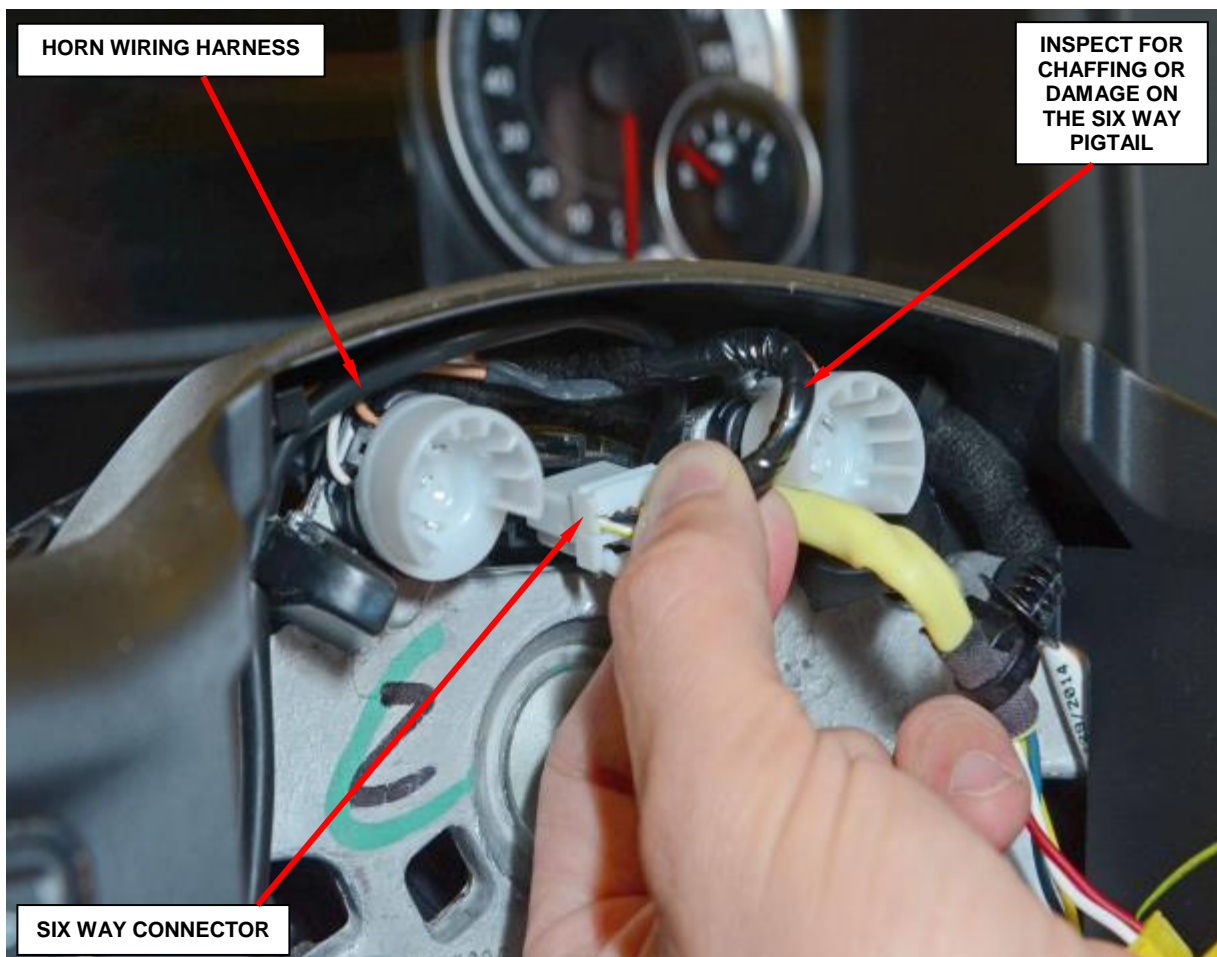
Figure 4 – Inspect For Wire Pigtail Damage

The steering wheel wire harness on about 1,060,000 of the above vehicles may become chaffed by the driver airbag module retainer spring ends. A chaffed steering wheel wire harness could cause an electrical short and/or an inadvertent driver airbag deployment. Inadvertent driver airbag deployment, during certain driving conditions, may increase the risk of a crash and/or vehicle occupant injury.

12. Inspect the wiring harness for chaffing or damage on the six way pigtail and repair as necessary (Figure 4).

NOTE: If bare wire or chaffing is present, tape the wire using vinyl electrical tape.
